The City of Calgary's early Experiences with use of Fiberglass Grids for Asphalt Pavement Rehabilitation

Venkat Lakkavalli P.Eng., Pavement Engineering, Construction, Roads – City of Calgary, Alberta, Canada
Sam Bhat & Jimmy Thomas, Titan Environmental Containment Limited, Manitoba, Canada

Geosynthetics 2018- 2nd International Conference on Technology and Application of Geosynthetics

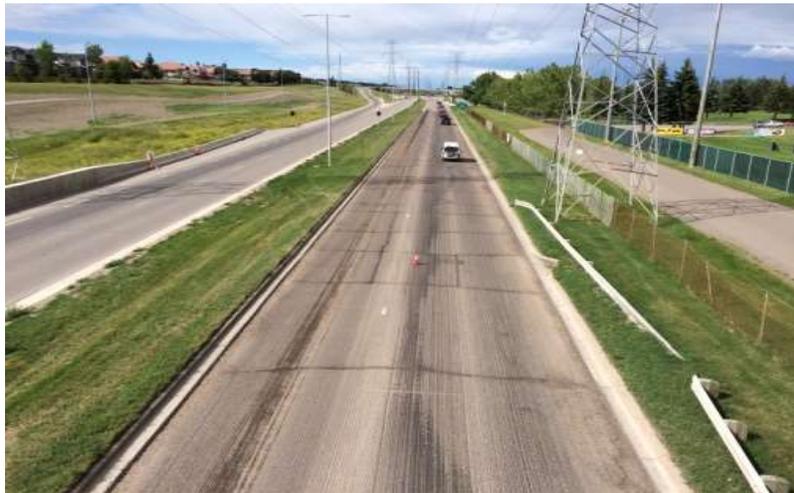
Sarcee Trail is a four lane divided arterial road with two lanes in each direction. The section selected for pilot project was two northbound lanes (NBL), about 1 km in length. Observed pavement distresses were extensive and medium to high severity transverse cracking, semi continuous medium severity longitudinal cracking and frequent medium severity block cracking. Transverse cracks were generally spaced at 7-10 m intervals and about 15-30 mm in width. Average rutting was less than 6 mm.

Figure 1 - General pavement condition of Sarcee Trail after cold milling of ACP

A detailed pavement investigation was conducted which indicated an overlay need of 40 mm. Due to curb and gutter constraints, overlaying was not a viable option. Reconstruction was cost prohibitive and road closures and traffic detour management would have become very challenging. The larger problem was the functional deficiency of the road due to numerous surface distresses. Engineering study, based on life cycle cost analysis recommended the conventional treatment to cold mill 100 mm of existing pavement and inlay with 100 mm ACP. The geosynthetic alternative proposed was to cold mill 70 mm, install a fiberglass grid composite TE-FGS10 and inlay 70 mm ACP. The resulting net saving was about 14 % compared to conventional treatment. The general condition of the pavement after cold milling of ACP is depicted in figure 1.

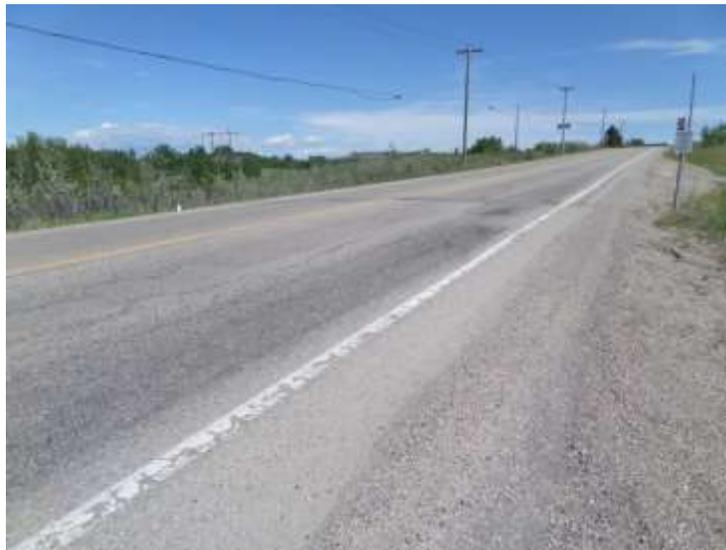
Figure 2 - General pavement condition on 101 Street

Pavement boreholes indicated that the ACP thickness was about 100-125 mm, placed on medium to high frost susceptibility subgrade material. However there were two short stretches at approaches to intersection in the NBL that had granular base course (GBC) layer. The road connects Highway 8 on the south and to the gravel pit and asphalt and concrete plant to the north. Hence, the route is predominantly used by heavy trucks. Observed pavement distresses were extensive and high severity transverse cracking, semi continuous medium severity fatigue cracking and frequent centerline cracking. Transverse cracks were generally spaced at 20 m intervals and about 25-50 mm in width most of them were sealed. The average rutting was less than or equal to 9 mm.

To address fatigue cracking several asphalt skin patches were placed. However, the moisture trapped in the subgrade was pumping up under heavy truck loading, causing the disintegration of patches. New patches were not lasting more than a few weeks, requiring significant maintenance in spring and summer seasons.

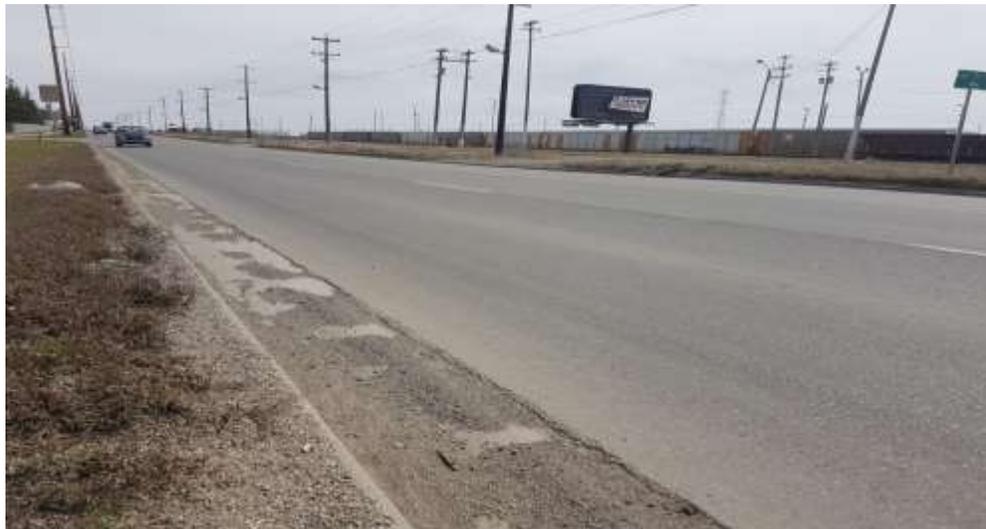
Figure 3 - General pavement condition on 50th Ave.

GPR tests, pavement coring and bore holes indicated ACP thickness of about 250-300 mm with 400 mm of GBC. Observed pavement distresses were predominantly extensive and medium severity rutting, few transverse cracks of medium severity and few and low to medium severity fatigue cracking. Typical rutting was about 9 mm and 20 mm at approach to 25 Ave. intersections.

The ACP overlay need was 80 mm, but due to similar constraints as that of Sarcee Trail, reconstruction was not considered. The adopted treatment was to mill the existing distressed pavement to the specified depth, place first lift of asphalt (40 mm), install a fiberglass grid with polymeric coating TE-

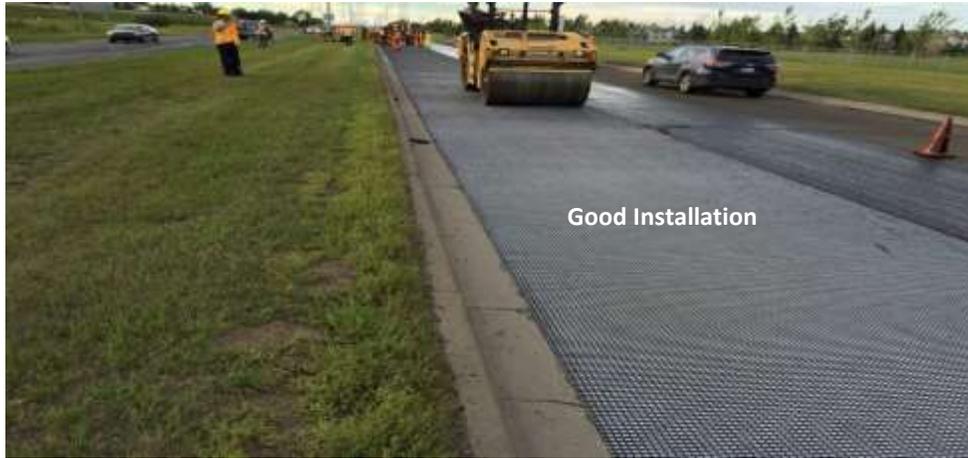
Figure 4 - Sarcee Trail Grid Installation – well placed and bonded

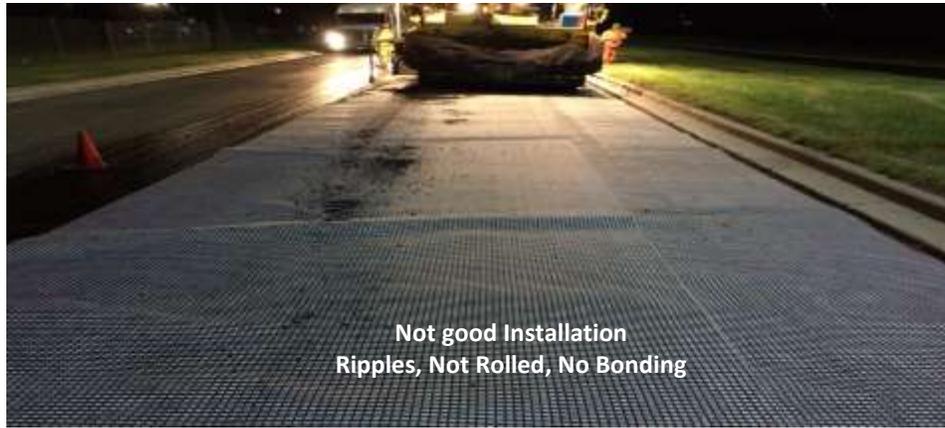
Figure 5 - Sarcee Trail Grid Installation – not well placed

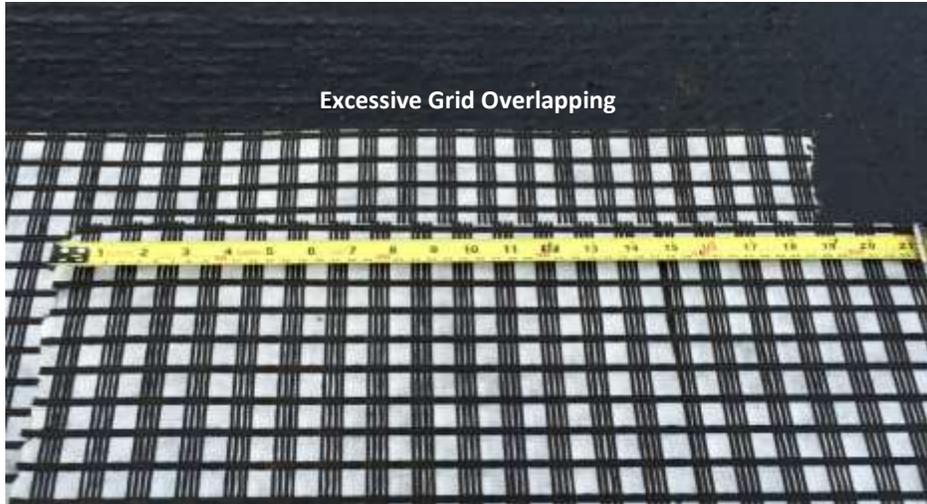
Figure 6 - Sarcee Trail Grid Installation – Excessive Overlapping corrected on site

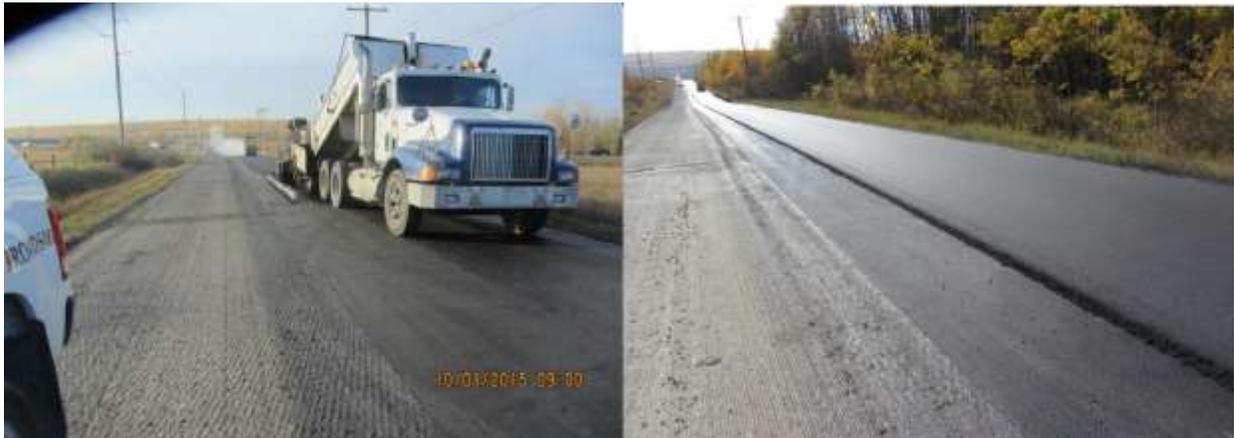
Figure 7 - 101 Street paving on Installed Grid

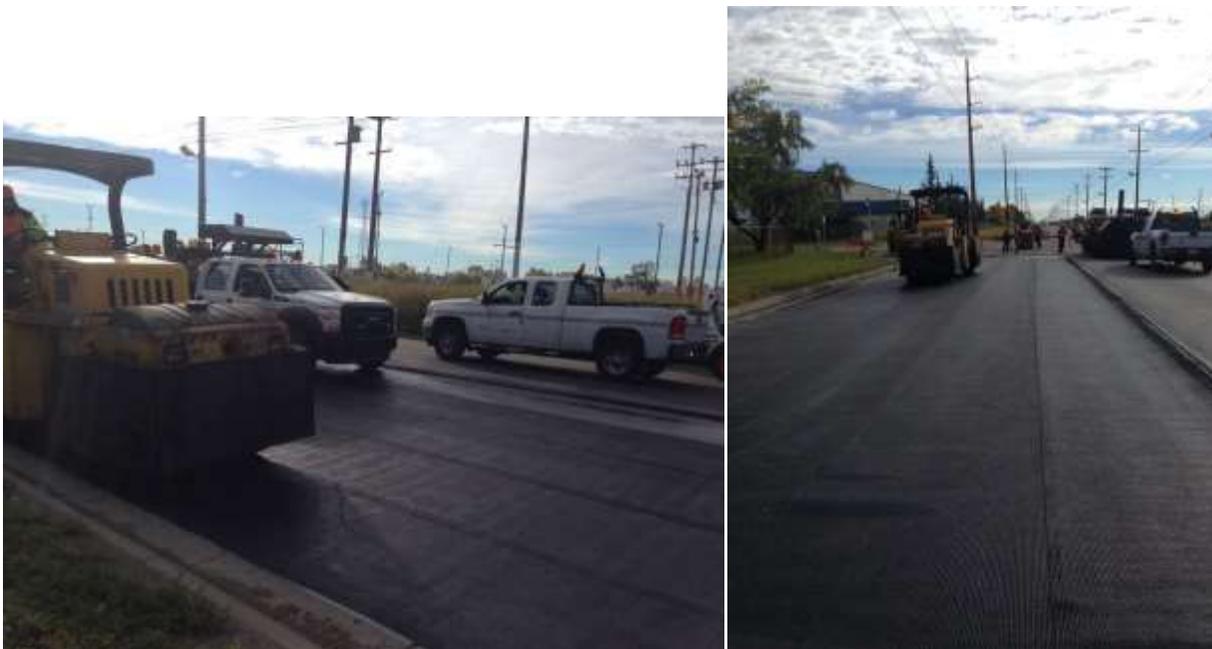
Figure 8 - 50 Ave. Grid Installation and Paving

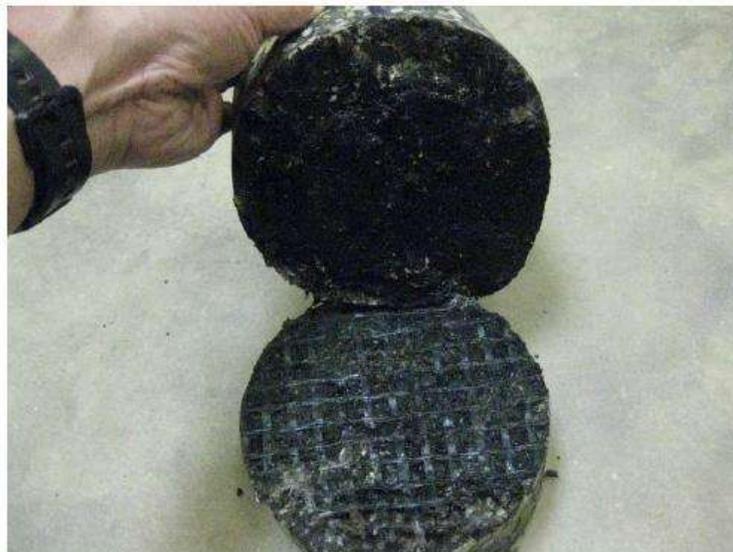
Typical failure mode is illustrated in figure 11. Slipping occurred by separation of the nonwoven geotextile from the fiberglass. This suggests that the interface strength provided by a composite may be low because of the relatively low bond strength between the grid and geotextile components of the composite.

Figure 11 - Typical failure mode by slipping at the interface between fiberglass grid and nonwoven geotextile

The interface test results suggest that fiberglass grid composites should be used with caution since these products may have low interface strength due to the low bond strength between the grid and

nonwoven textile components. The advantages of having a geotextile – bonding to milled surfaces and functioning as moisture barrier – may be offset by the poor interface shear strength. In the case of fiberglass grids, there is a large open area across which the old and new asphalt pavements could develop good bond.

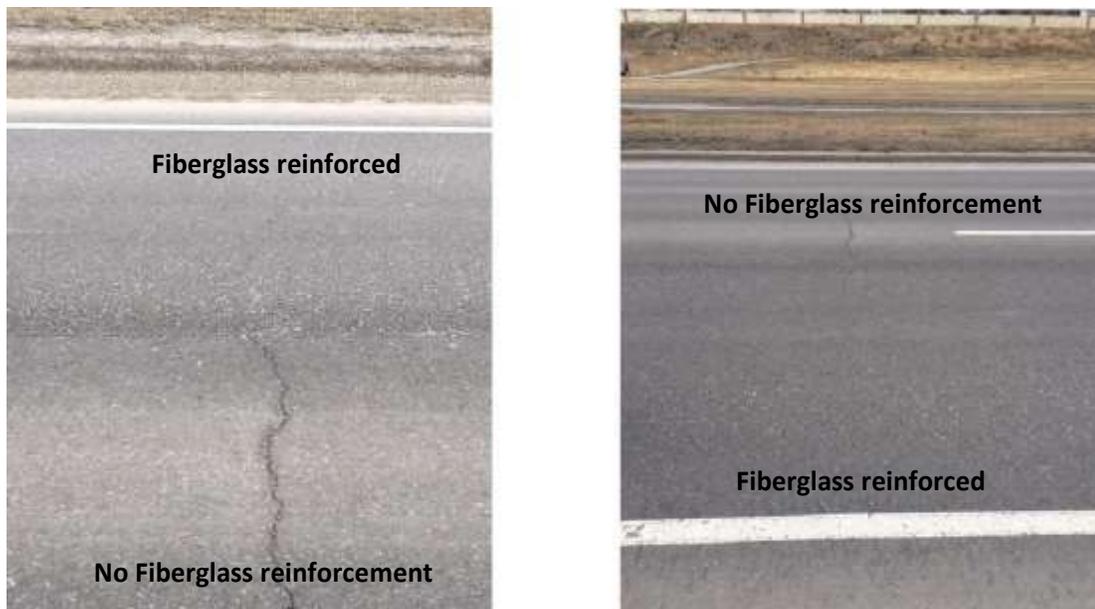
The road, in general was in very good condition and offers very good riding quality. Some surface distresses were evident in the non-reinforced lane (curb lane). As seen in figure 12 , transverse cracks have propagated in the non-reinforced section and it stops at the joint where fiberglass grid reinforcement starts. This pattern was very much consistent along the section. About 25% of the cracks have propagated. Only two of those cracks were found on the fiberglass grid section. Although at a few locations segregation was observed, longitudinal and fatigue cracks or rutting were not noticeable on the wheel paths in the reinforced sections. There was slight separation/gap between the pavement surface and the curb & gutter likely due to lack of tack coat on the vertical edge.

Figure 12 - Sarcee Tr. – Transverse crack originates in non-reinforced median lane and stops at the fiber reinforced curb lane

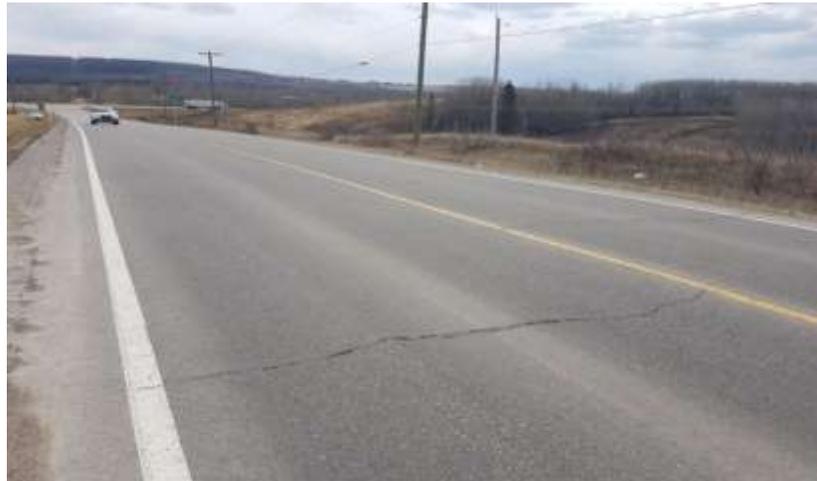
Pavement distress was identified during the visual inspection in 2017. While in 2016 Fall inspection only about five (5) transverse cracks had reflected through, in 2017 about 47 cracks were observed in between Glenmore and Lower Springbank Road and 13 were found between Lower Springbank and 17 Av SW. These cracks were of slight severity as shown in figure 13. It is important to mention that no drainage concerns were found on the site. No wheel path rutting was observed as shown in figure 14, and no loose aggregate situation was present on the surface.

Figure 13 - 101 Transverse crack have propagated through on 101 Street

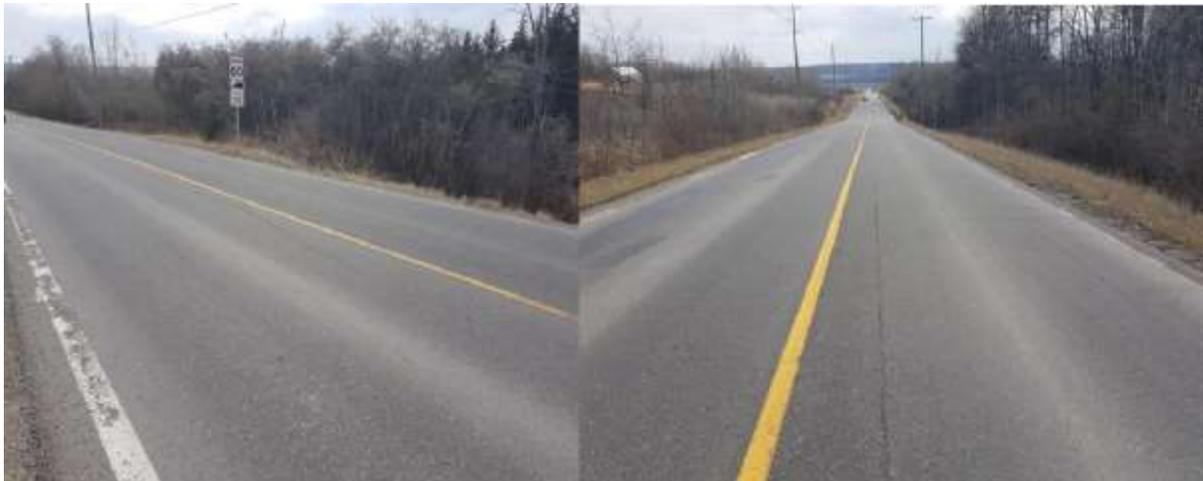
Figure 14 - General condition of 101 Street

The pavement surface was generally in good condition; transverse and longitudinal cracks were between 6- 12 mm wide, some reflecting cracks were identified; alligator cracking was not evident in wheel paths. Seems like minor patching has been done on the surface, some oxidation of the pavement surface was present, and few low severity depressions were visible.

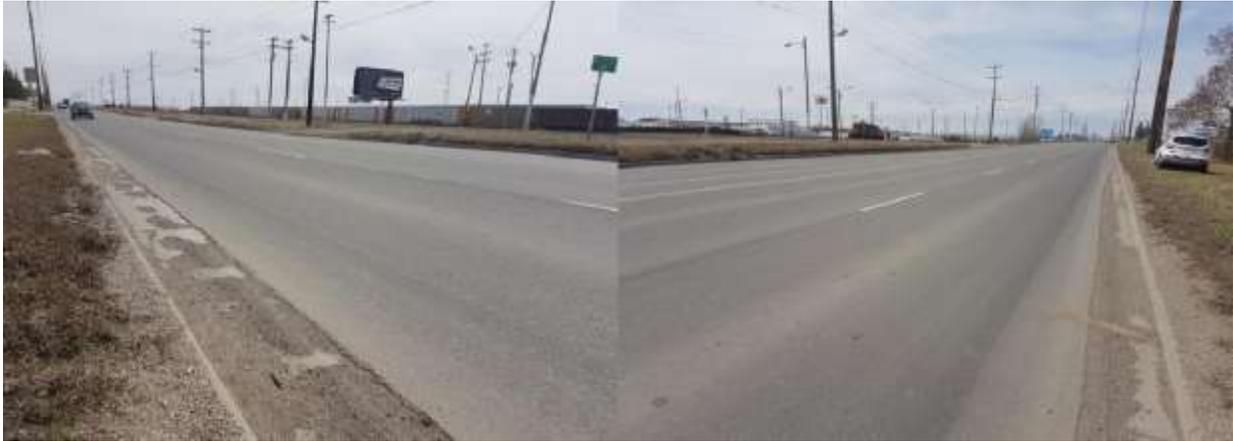
According to the traffic patterns and road classification, the pavement is in excellent condition as shown in figure 15; the surface appears to be very smooth and is almost free of distress except for one longitudinal crack of about 8 m long and one half lane width transverse crack (less than 4 mm width) on the westbound and is in half lane from crown. This section of the road has some check-cracking before the railway intersection (westbound) and besides the curb and gutters on some spots, might be due to some compaction issues. No rutting in wheel paths was visible.

Figure 15 - General condition of 50 Ave.
