## REMEDIATION

In March 2017, CC Hydro™ was used to line 4 irregular shaped water ponds and two tank storage areas for wildlife in the Shaybah Wildlife Sanctuary in Saudi Arabia.

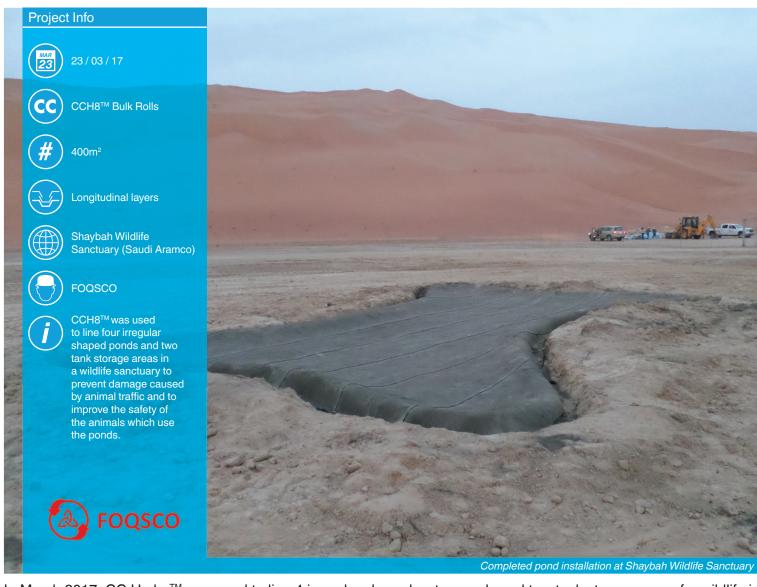
Each pond was approximately 11m in length by 6m wide and 20cm deep. PVC was being used to line the ponds prior to the project, for the two ponds that already existed, however, cleaning them was very difficult and the PVC was slippery and a hazard for the animals using them, as well as being easily damaged by their hooves. CC was chosen for the project as it would resist damage caused by animal hooves, and would be comparitively easier to clean.

In preparation for the installation, the two existing ponds were stripped of their PVC linings, while the two new ponds were marked out, excavated and compacted to the desired shape, with a depression in the centre to allow for adequate water storage in the ponds.

The CC was delivered to site in bulk rolls of CCH8<sup>™</sup>, which was mounted onto a spreader beam, held on two poles, then cut to the required lengths. The pieces were then moved to the site using wheelbarrows, unrolled across the ponds and the layers were the jointed using a hot air blower and rollers. On the outside edges, the CCH was pegged and anchored in pre-dug trenches, before being hydrated using a hose connected to a water tank. This was repeated for each pond, and the two tank storage areas.

400m² of CCH8™ were installed over three 8-hour days by a team of 6 people despite hot, dry weather conditions. The project will be scrutinized over a time period to determine if it sustains any damage from animals. However, the install was successfully, and the client was happy with the solution, particularly due to the speed and ease of installation.
