Project Info

CC8 Bulk

Outfall lining

Kingston, ON

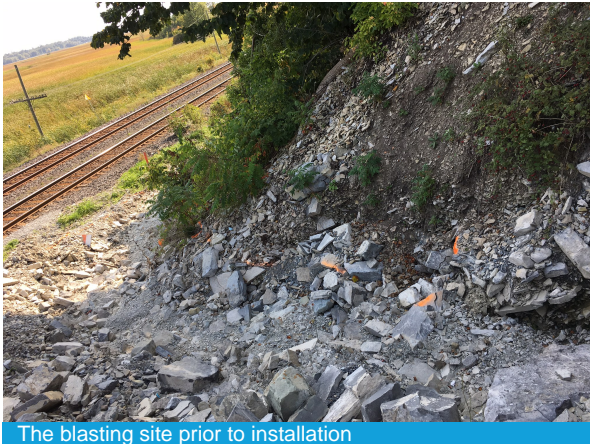
The blasting site prior to installation

The outfall for a hwy. 401 drainage system was an ongoing maintenance concern as water and debris would overtopped the normal drainage course banks and dump onto a CN railway line during significant rainfall events. Shattered rock that was previously placed to help slow and control the flow was found to be ineffective in channeling the water during periods of high volume flow. Due to these ongoing issues the ministry looked for ways to strengthen and enhance the outfall banks so that the water would stay within a predetermined path along the CN Rail line.

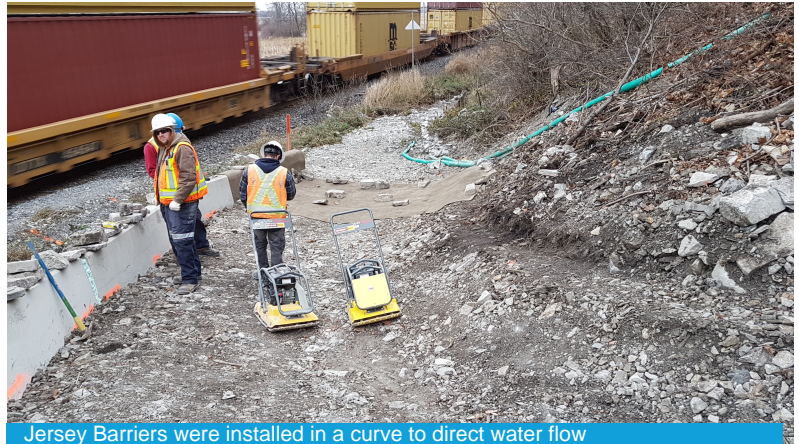
Jersey Barriers were installed in a curve to direct water flow

The installation took place in overcast conditions with temperatures around 6 degrees Celsius. Site preparations included compacting the ground and installing Jersey Barriers to create a curve, which would redirect water to flow beside the rail line.

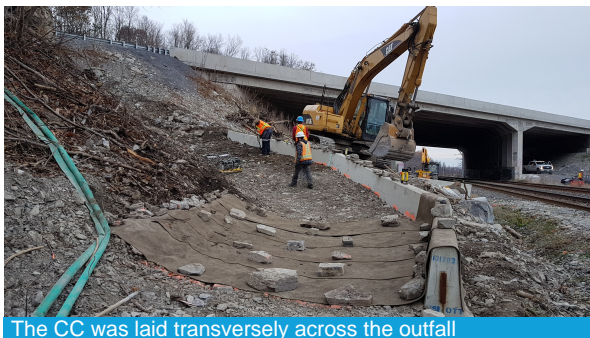
The CC was laid transversely across the outfall

An excavator was used to roll out the heavy CC bulk rolls. The CC was seated into the embankment on one side of the drainage course, laid transversely over the ground and over the jersey barriers on the other side of the drainage course. The CC was then sealed with 2 beads of sealant at the joints. Hydration was completed using runoff water from the existing drainage culvert and from a water tank that was brought into site. The installation was completed in only 5 hours with a crew of 5 workers and 1 excavator operator. Installation time could have been reduced if the excavator wouldn't have been required to stop during each train passage.

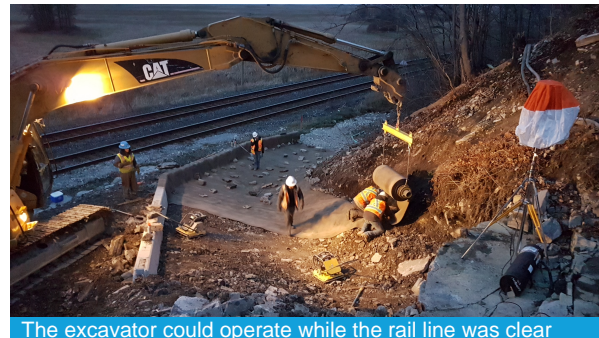
The excavator could operate while the rail line was clear

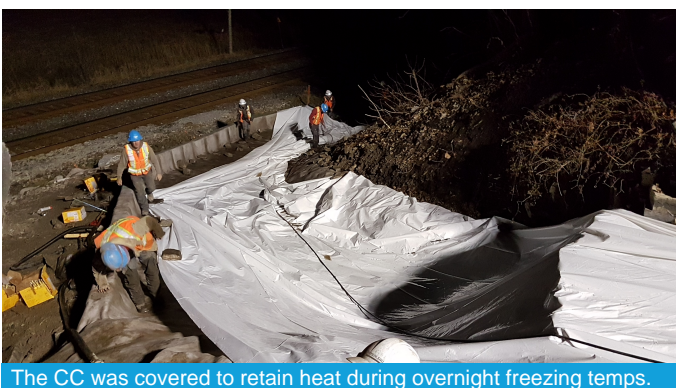
The CC was covered to retain heat during overnight freezing temps.

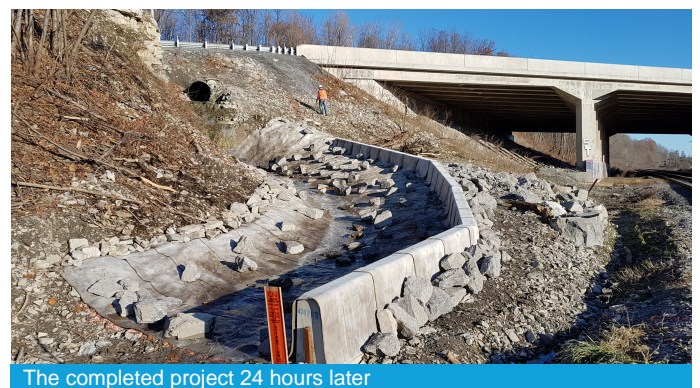
The completed project 24 hours later
