CASE STUDY

Channel Infrastructure Dam Improvement: Water Flow and Structural Stability

LOCATION: El Paso, Texas

PROJECT TYPE: Product Supply, and Installation

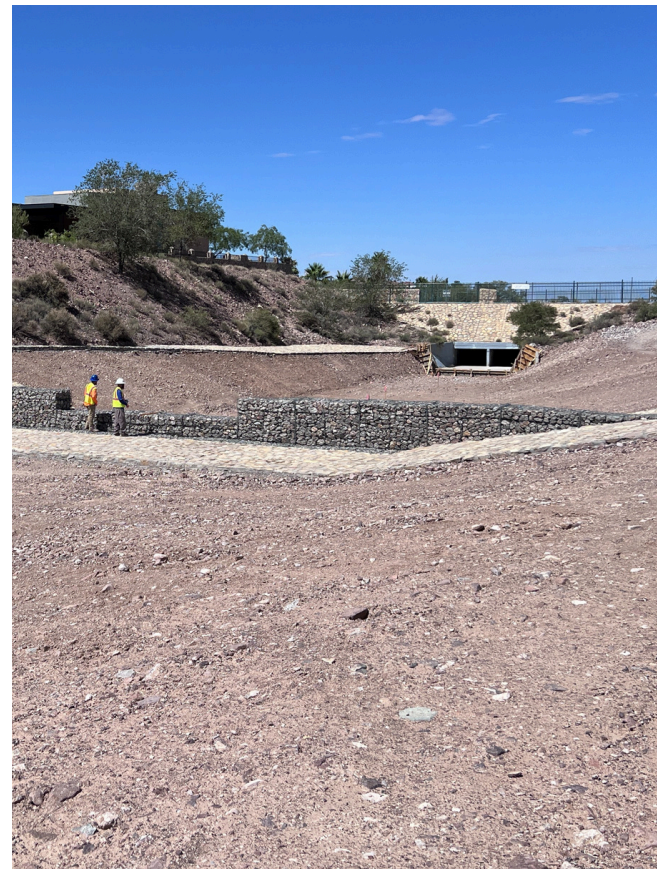
Before rehabilitation, the infrastructure consisted of concrete line channels that did not reduce the speed of water flow or catch the collected debris.

Channel Pre - Rehabilitation

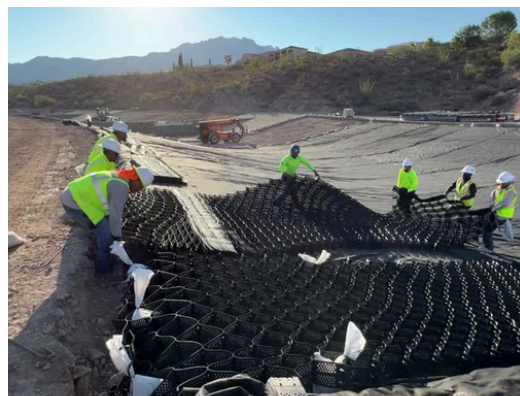
Geocell panels allowed for vertical drainage due to the perforations on the cell walls. TE Nonwoven geotextile was used to separate the rock infill from the natural subgrade while allowing water flow.

Given the challenges of navigating heavy equipment in the residential area, trucks were used to side-dump the rock directly onto the geocell, significantly reducing the need for material rehandling.

Geocell Installation

Titan’s operations Team created a panel layout based on the site drawings. With this on hand, custom-made panels were manufactured, which minimized waste on-site. Installation time was reduced by attaching adjacent panels prior to deployment.

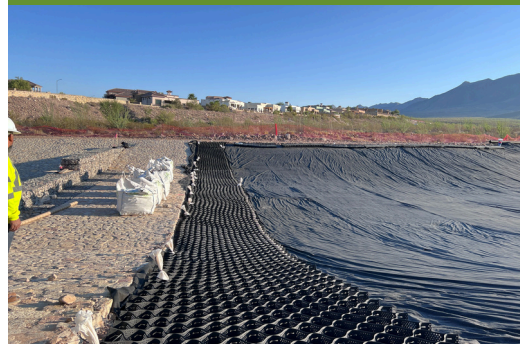
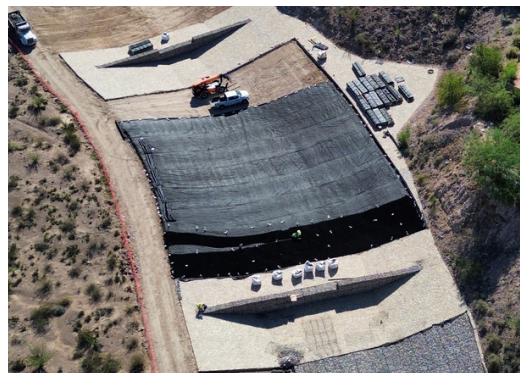
Arial shot of channel
