# CASE STUDY

## Secondary Containment Lining - HDPE Geomembrane

- ▼ **LOCATION:** Gimli, Manitoba
- ▼ **PROJECT TYPE:** Product Supply & Install
- ▼ **PRODUCT USED:** 60mil HDPE Smooth & TE-12 Nonwoven Geotextile

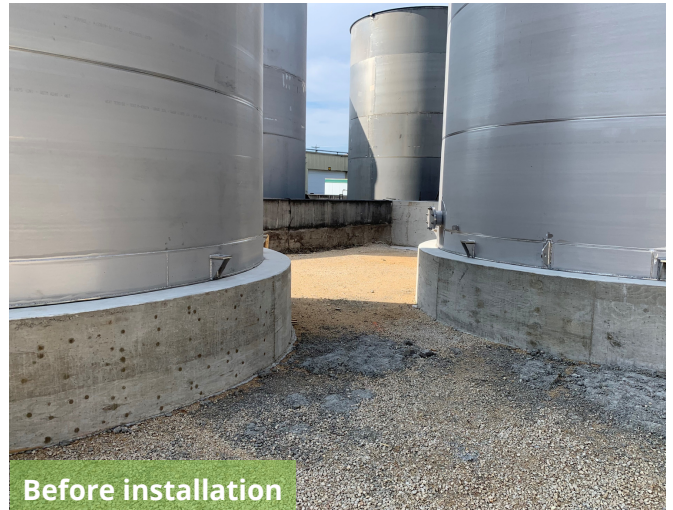
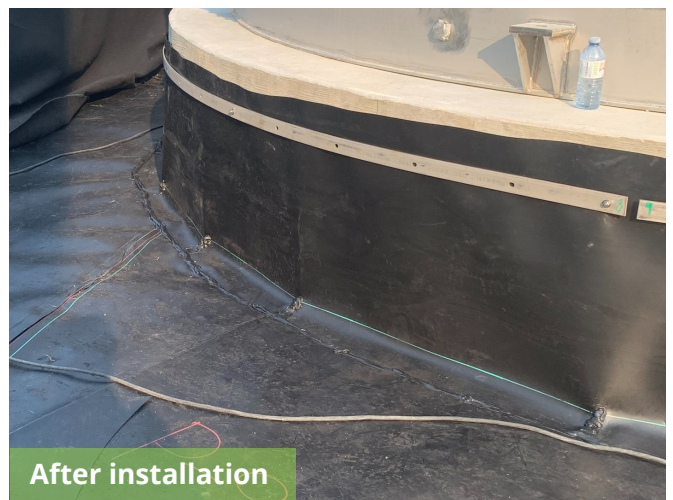
Titan installed 60mil smooth HDPE geomembrane inserted between 2 layers of TE-12 nonwoven geotextile which lined the secondary containment units. The geotextiles served as a protective layer, so the geomembrane remained undamaged from the environment. Both the geomembrane and the geotextile were secured to the concrete walls and tank foundations by using stainless-steel batten bar system.
