CASE STUDY

Storage Tank Floor - Ground Reinforcement

- ▼ **LOCATION:** Gillam, Manitoba
- ▼ **PROJECT TYPE:** Supply and installation
- ▼ **PRODUCT USED:** Titan Earth Grid™ & 8oz Non-Woven Geotextile

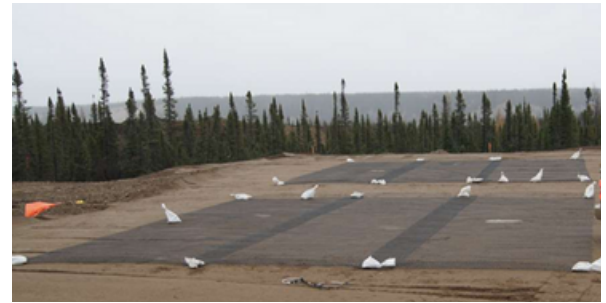
Titan worked with the project proponents on a geogrid horizontal foundation pre-design solution that included two layers of Titan Earth Grid™ and 8oz non-woven geotextile. The layers of Titan Earth Grid™ were separated by a 200mm layer of the base material. It was determined that the tensile properties, junction strength, flexural stiffness, and aperture stability of Titan Earth Grid™ provided adequate positive interlock with the soil and aggregate. The tensile properties allowed redistribution of stresses, which reduced the risk of localized weak spots by smoothing out uneven settlements.

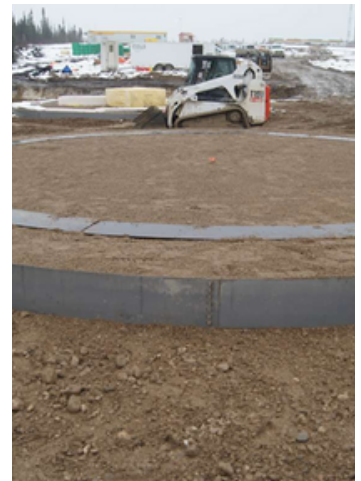
A gravel berm was contained within a Grade Band to support the weight of the tank walls. The gravel berm contained an 8oz non-woven geotextile TE-8 throughout the surface area of the gravel berm. Water runoff from the tank roof could potentially erode the gravel berm, therefore it was necessary to include the geotextile to help mitigate this risk.
