SLOPE PROTECTION (

In August of 2017, 125 sq. m of Concrete Canvas (CC) GCCM, 8mm bulk was installed by Aecon Construction, for the MTO, to seal behind a Retained soil System (RSS) wall. The was was located by an off ramp on the 401 highwayof Hero's in Cobourg, ON, where surface water had been penetrating through the ground behind the RSS wall, flowing out through the wall joints and onto the ramp road way surface causing extremely dangerous conditions for drivers in freezing temperatures.

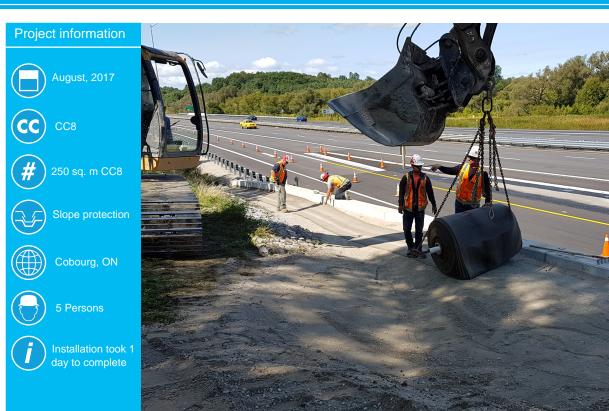
A previous constructed rip rap and geotextile intercept ditch had failed to stop water penetration, resulting in the continued dangerous driving conditions for motorists.

Due to these continuing safety issues, it was decided that CC would be installed to try and stop water penetration and direct water flow down to the highway ditch. CC was also chosen due to the limited site access and accessibility.

Prior to installation all rip rap and vegetation was removed from the area. The soil was then compacted to provide a solid and even substrate. Using 4 installers and 1 excavator operator the CC was laid longitudinally up the slope running behind the RSS wall.

It was joined on the seams using SikaFlex 1A sealant and a spike at every 30cm.

Rip Rap was then placed on top of the CC using the excavator prior to hydration. The total installation took 1 working day to complete.

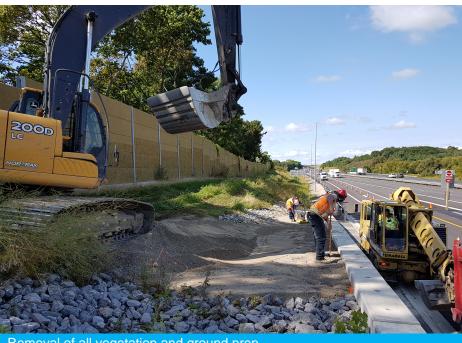
Removal of all vegetation and ground prep
