CC8™ and CC13™ Bulk Rolls

Eagle Gold Mine, Yukon, Canada

CC8™ and CC13™ were used to provide erosion control and channel lining to two spillways

Concrete Canvas® installation at Eagle Gold Mine in Canada

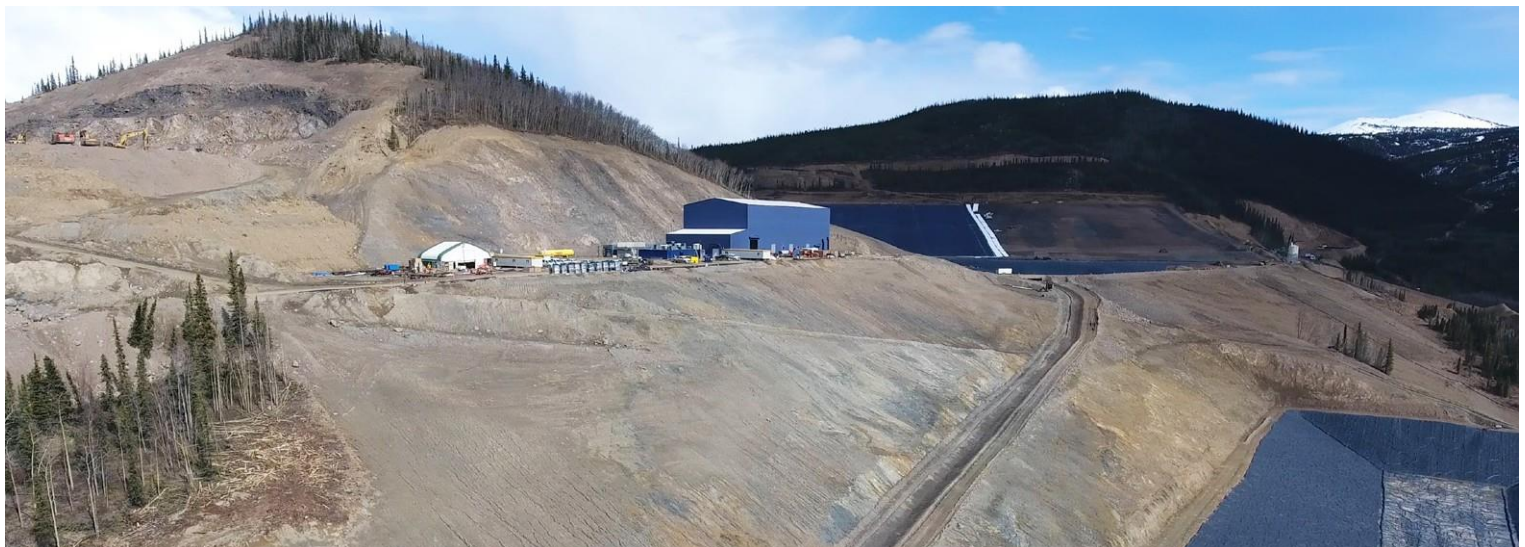
Main spillway

The main spillway is approximately 500m in length with profile sections of 5-8m at 7-15%. CC8™ was used for fall sections of 7.5% and CC13™ was used where the fall of the section increased to 15%.

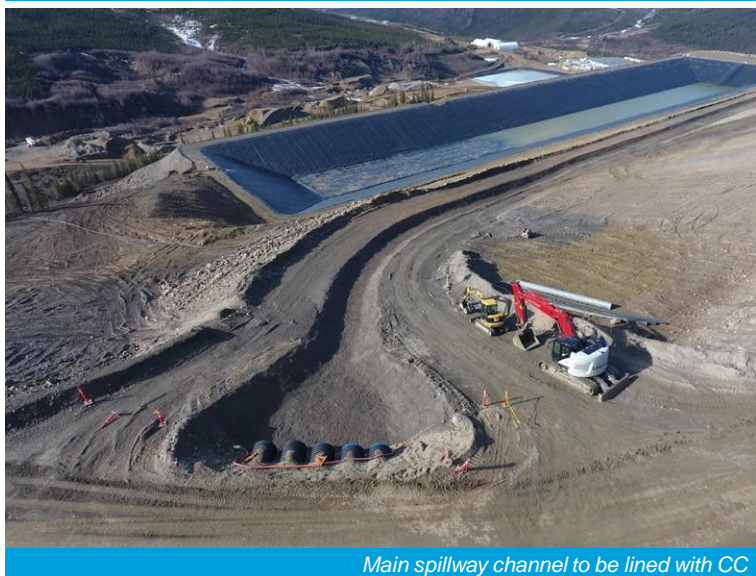
Main spillway channel to be lined with CC

The main spillway was installed as per standard CC channel lining detail; hydrated overlaps, Soudal 250XF bead, SS screws at 200mm centers, 100-150mm overlap with a 1.3m anchor trench (0.75 x 3) along either crest with ground pins. It was calculated that the main spillway did not require intermediate fixings.

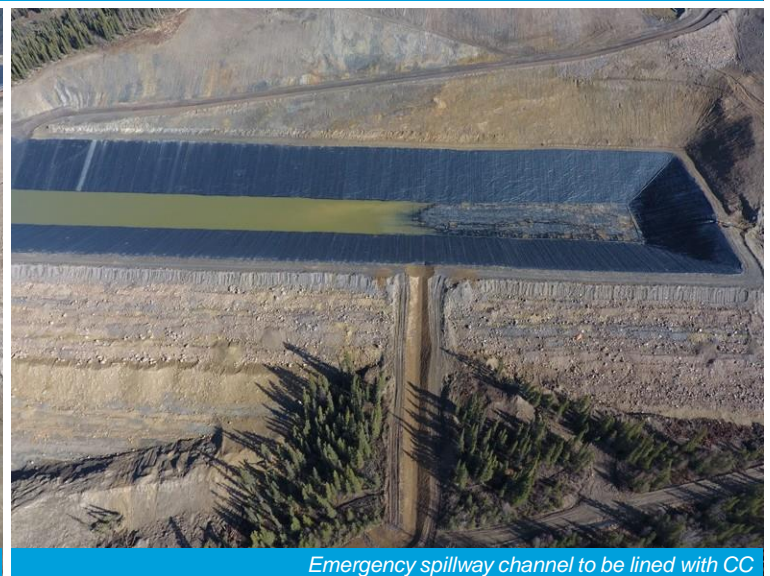
Emergency spillway channel to be lined with CC

The emergency spillway is approximately 140m in length of varying width at 50% gradient and lined exclusively with CC13™ as per the specification of the engineering consultant, BGC Engineering.

The emergency spillway had Gripple rock anchors at fixings of no less than 1.8m centers along its main section. At the 90° corner, anchor centers were no less than 0.5m apart.

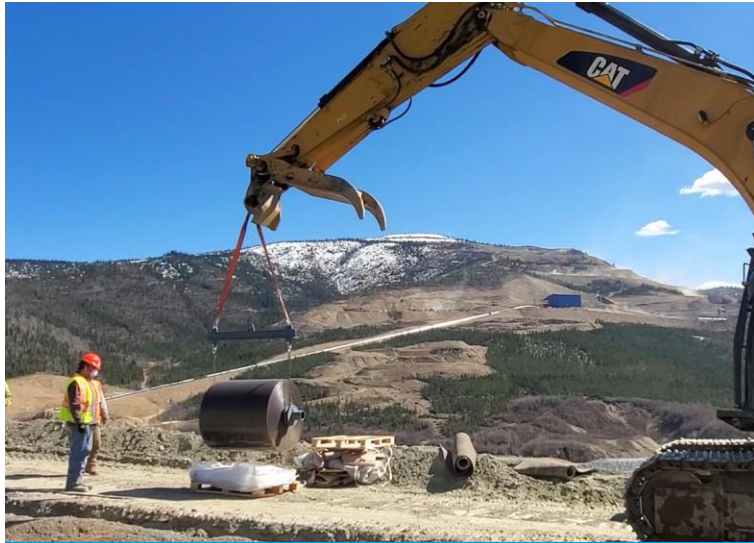
Bulk rolls of CC13 and CC8 deployed via spreader beam

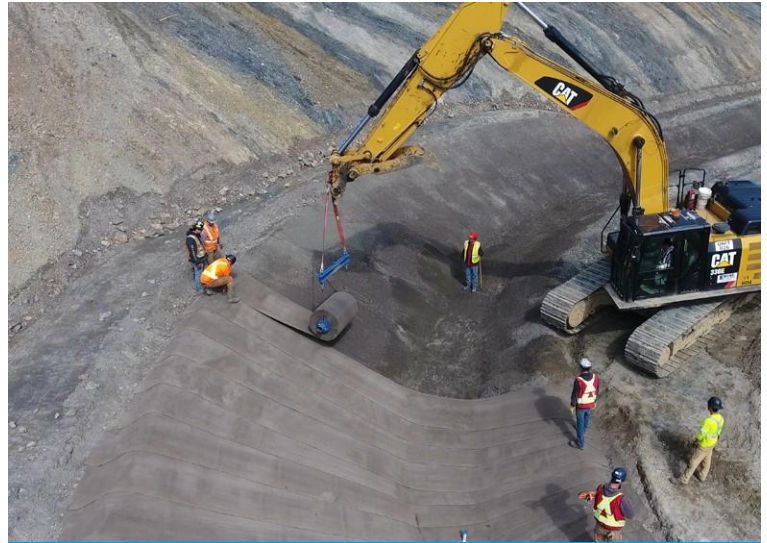
Installation starting downstream of main spillway.

The onsite contractor, JDS Energy and Mining Inc installed the material at a rate of 750 – 850m² per day in temperatures of 15°C. The area can reach lows of -30° in winter.

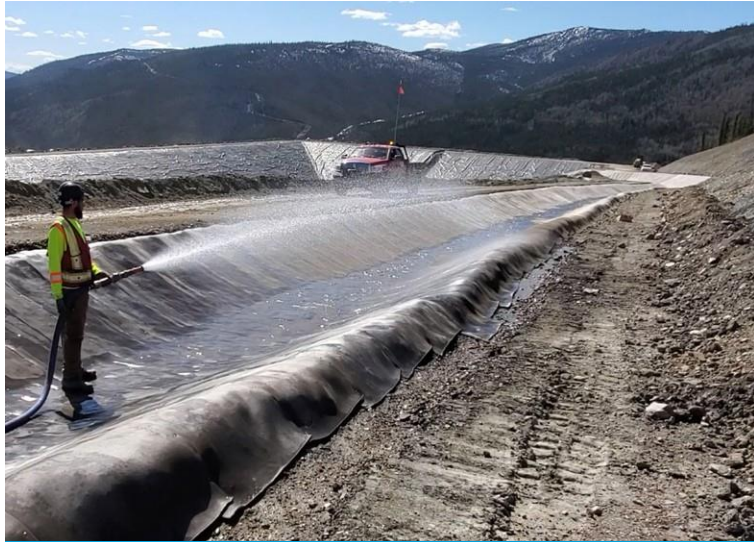
Hydration of the lined channel

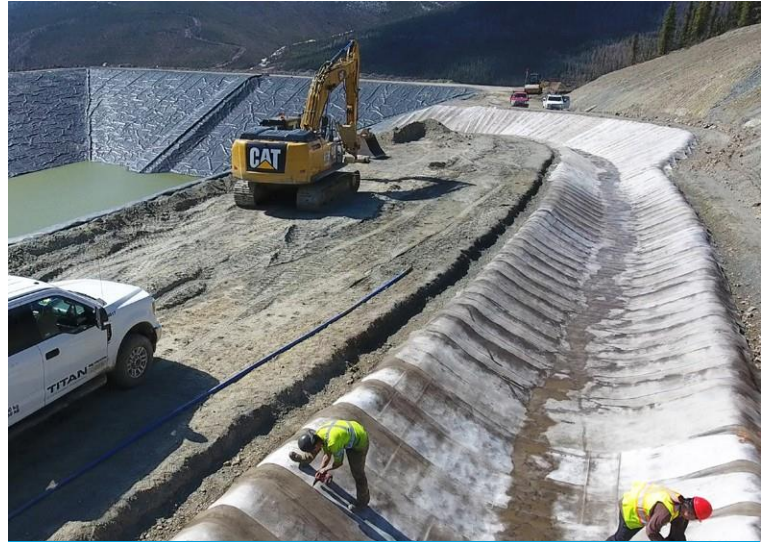
Joints were sealed and screwed for increased impermeability

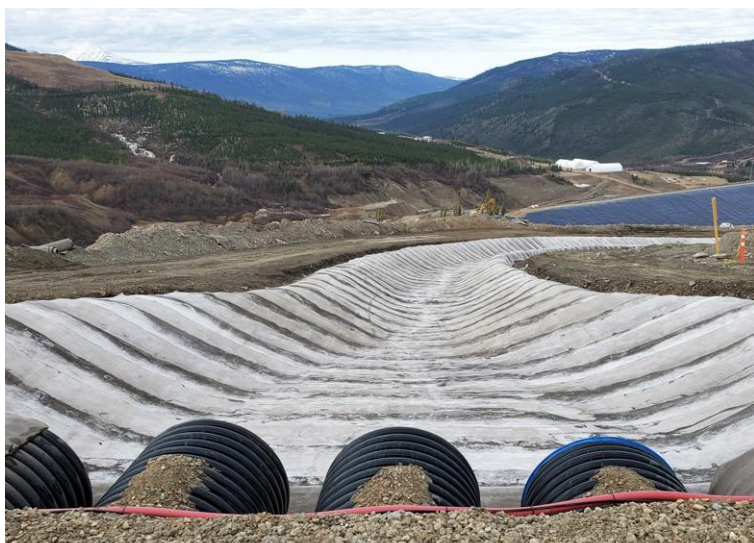
Upstream section of completed channel

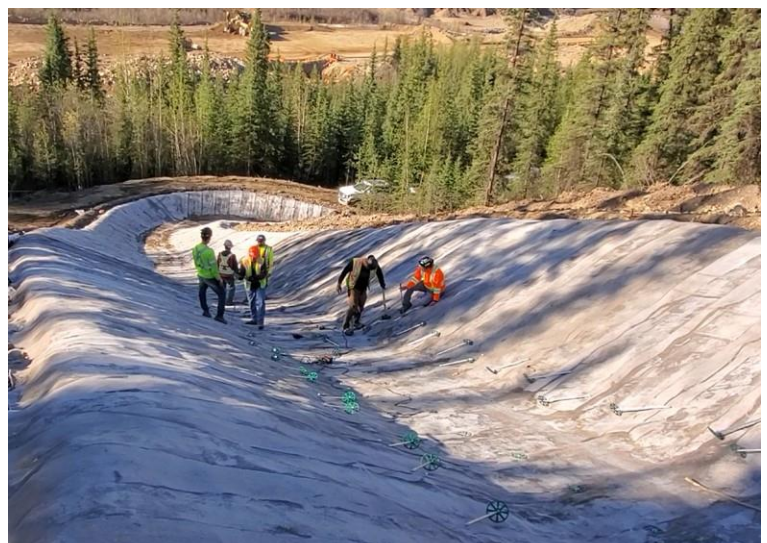
Installation of percussion anchors on emergency spillway section

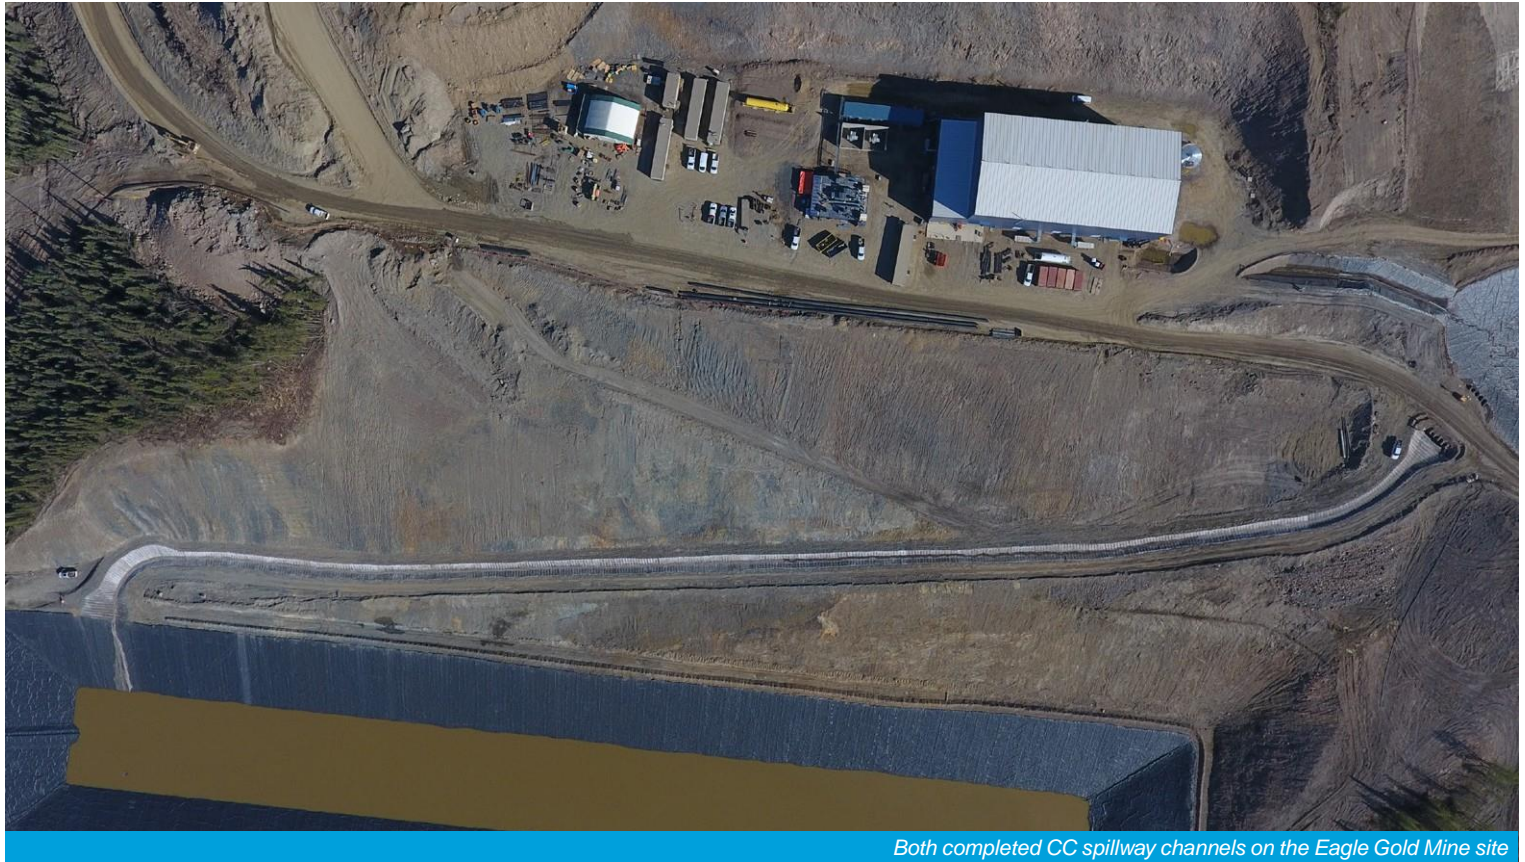
Both completed CC spillway channels on the Eagle Gold Mine site
