CONCRETE CANVAS®

CULVERT LINING CASE STUDIES

G Kirk Burn culvert, Laurencekirk, Scotland

i CC8™ was used to remediate a dilapidated culvert and prevent erosion caused by high water flow rates.

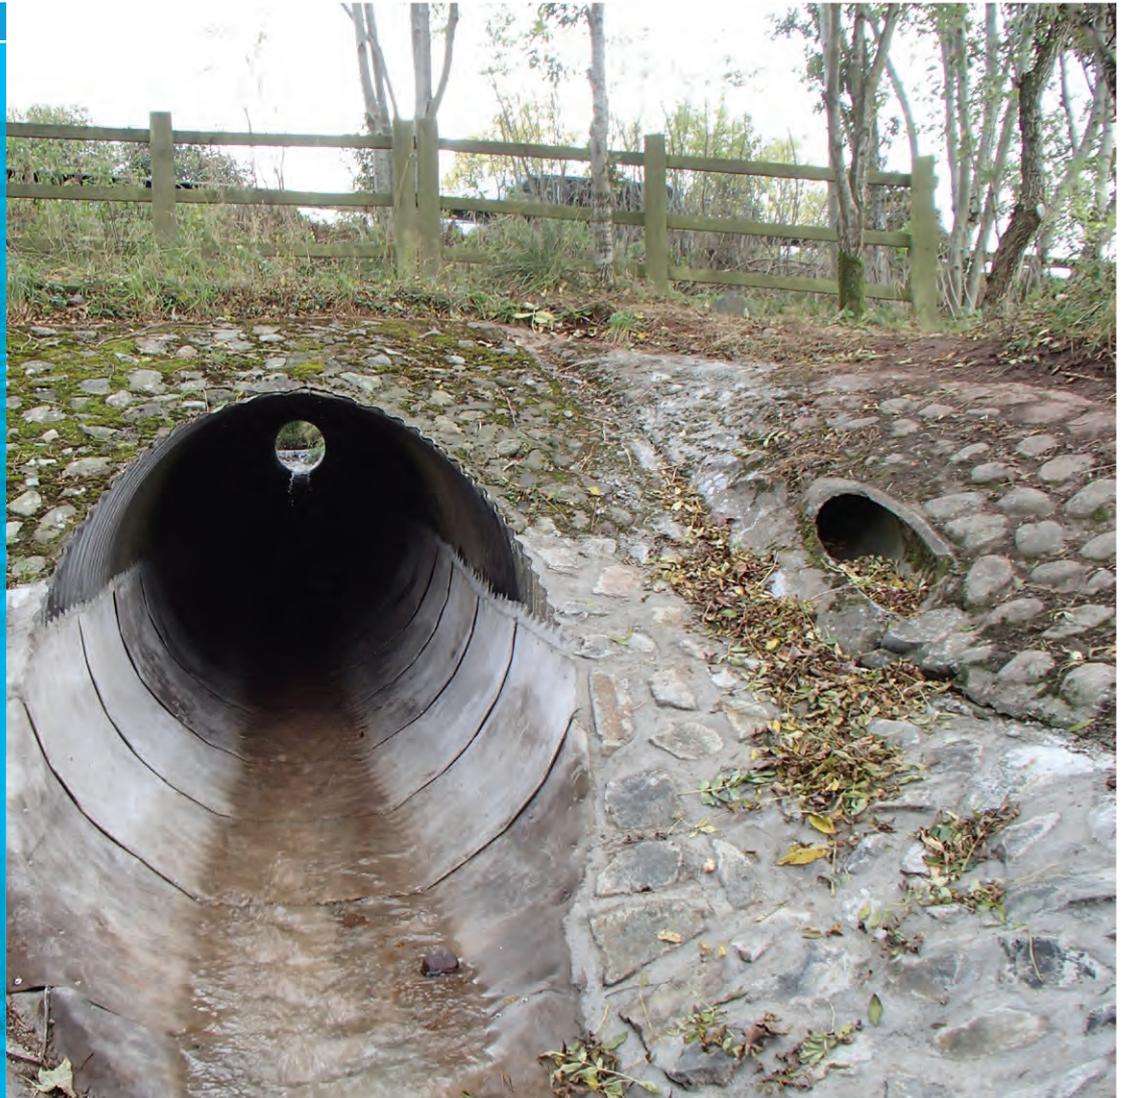
The completed culvert lining installation in Laurencekirk, Scotland.

In total, 170m² of CC8™ were installed in 5 days by a crew of 4 people. The client was impressed with the ease and speed with which CC was installed, along with its minimal environmental impact and increased lifespan compared to bitumen.

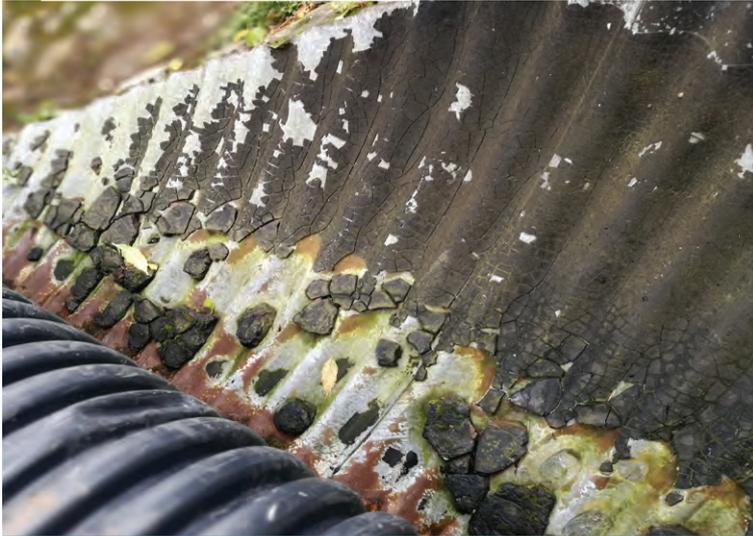
The original corrugated steel culvert, known as the Kirk Burn culvert, was 1.8m in diameter and had sustained significant degradation and erosion due to heavy water flows and abrasion. As a result, the existing 25mm bitumen coating inside the pipe had broken down through constant flow erosion and weathering.

Flow erosion had caused the existing bitumen lining to break down

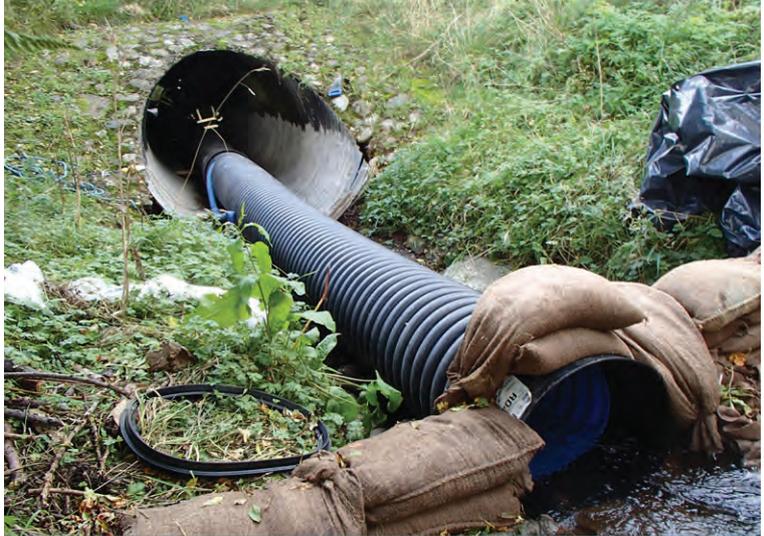
Water diverted into a 450mm HDPE Ridgidrain pipe

Prior to installation, the river was dammed using sandbags 10 meters upstream from the culvert and water was diverted into a 450mm HDPE Ridgidrain pipe which allowed fish to safely pass through the culvert for the project duration.

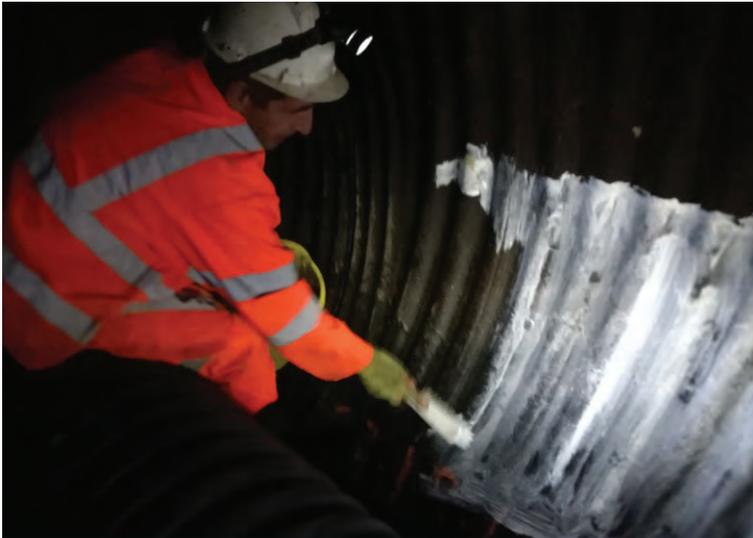
An Everbuild PVA adhesive & bonding agent was applied to crenulations

The contractor pressure washed the culvert to remove any sediment and debris, and removed any loose bitumen sections inside the culvert. An Everbuild Feb General Purpose PVA adhesive and bonding agent was then applied to the crenulations prior to filling them with a grout mix to provide a suitable fixing surface and to minimise void spaces underneath the CC.

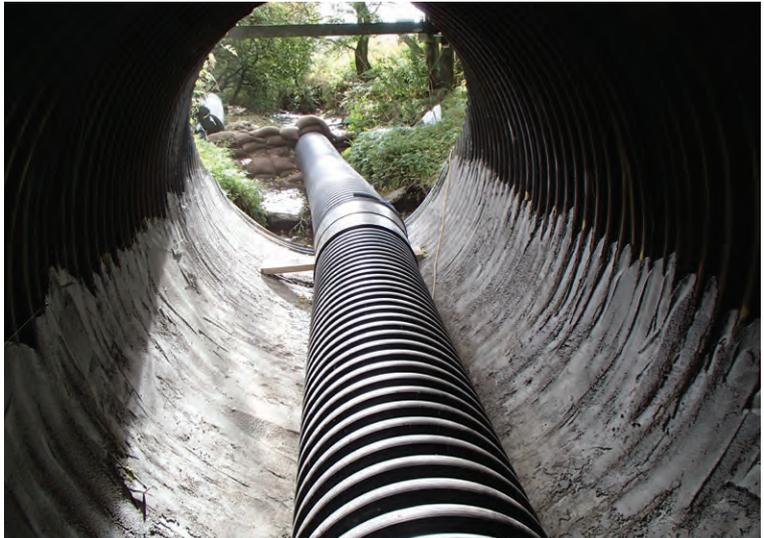
Semi-dry grout was applied to fill the corrugations

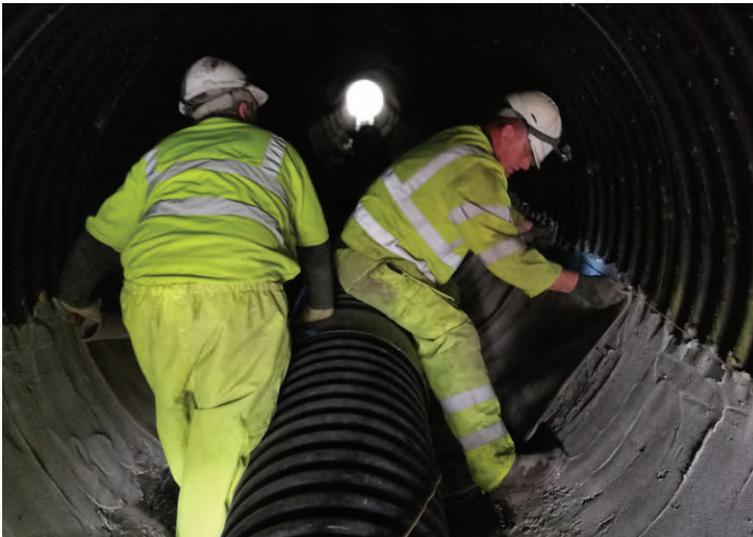
Batched rolls of CC8 were laid transversely across the width of the culvert

Due to restricted site access, batched rolls of CC8™ were delivered to site and unrolled by hand transversely across the width of the culvert. The adjacent CC layers were overlapped by 100mm and shingled in the direction of water flow. The CC overlaps were then screwed together and into the filled crenulations with 30mm stainless steel tech screws at 200mm centres and left unsealed, creating weep paths to prevent the build-up of any hydrostatic pressure behind the CC. The top edges of the CC were sealed with a line of grout to prevent water ingress behind the material. An anchor trench was dug on the upstream side to capture the CC edges and fixed with 300-500mm gabion stones before backfilling with material to prevent water ingress. The contractor used the water running in the HDPE pipe to hydrate the CC material with a hose pipe at the end of each day.

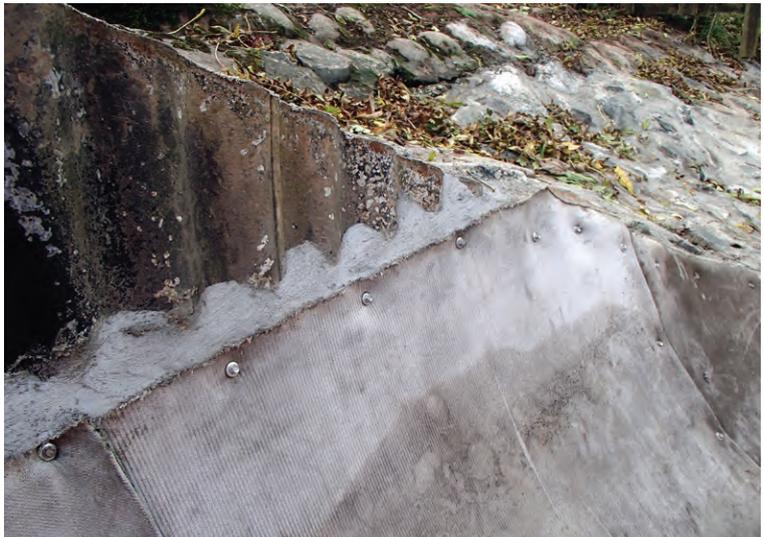
CC was fixed with tech screws & grout applied to prevent water ingress

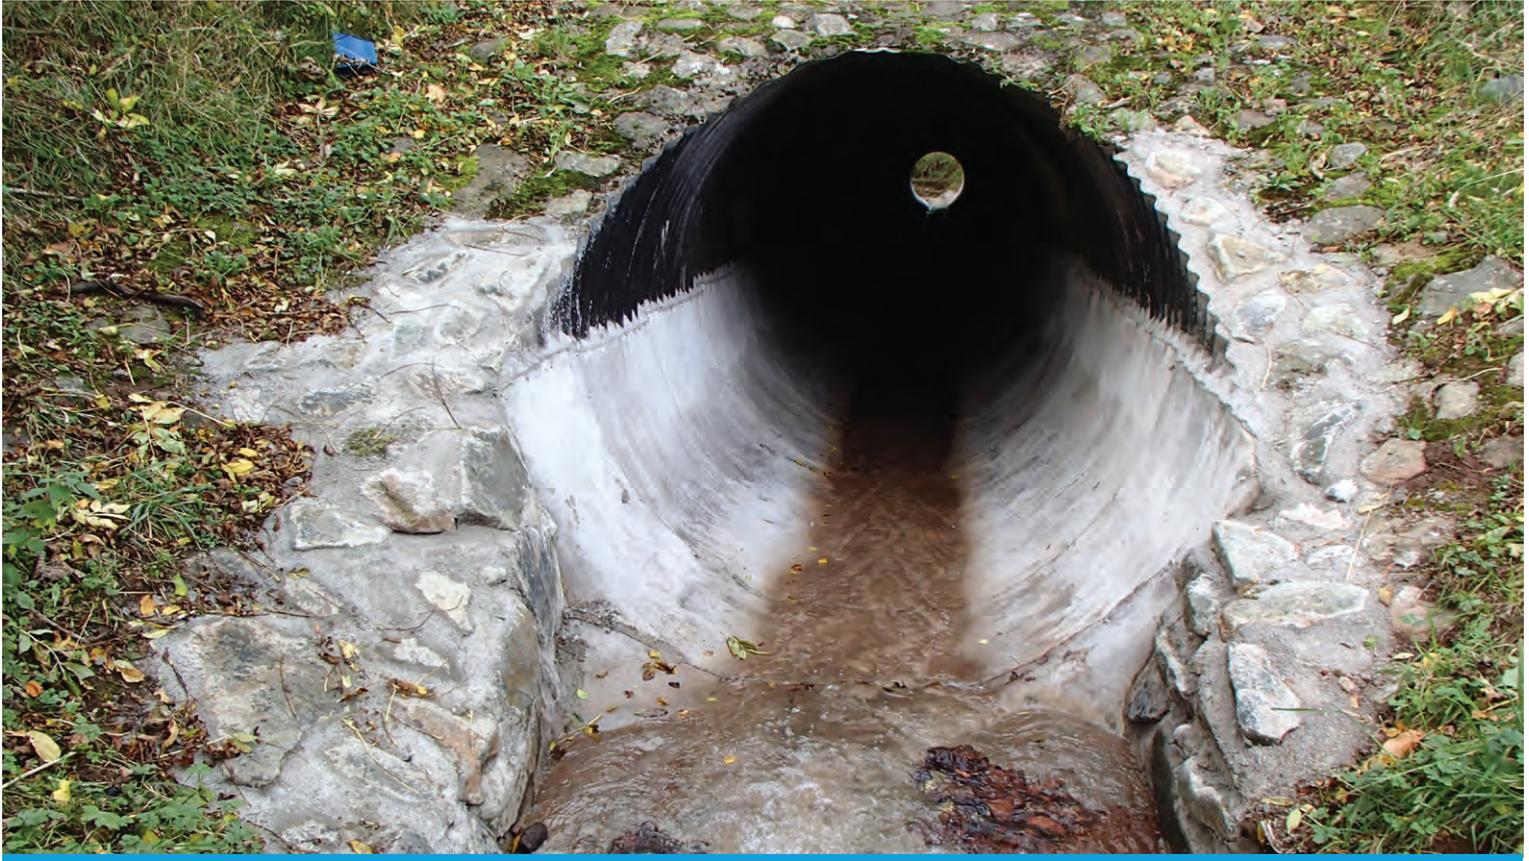
Completed relined culvert on upstream side

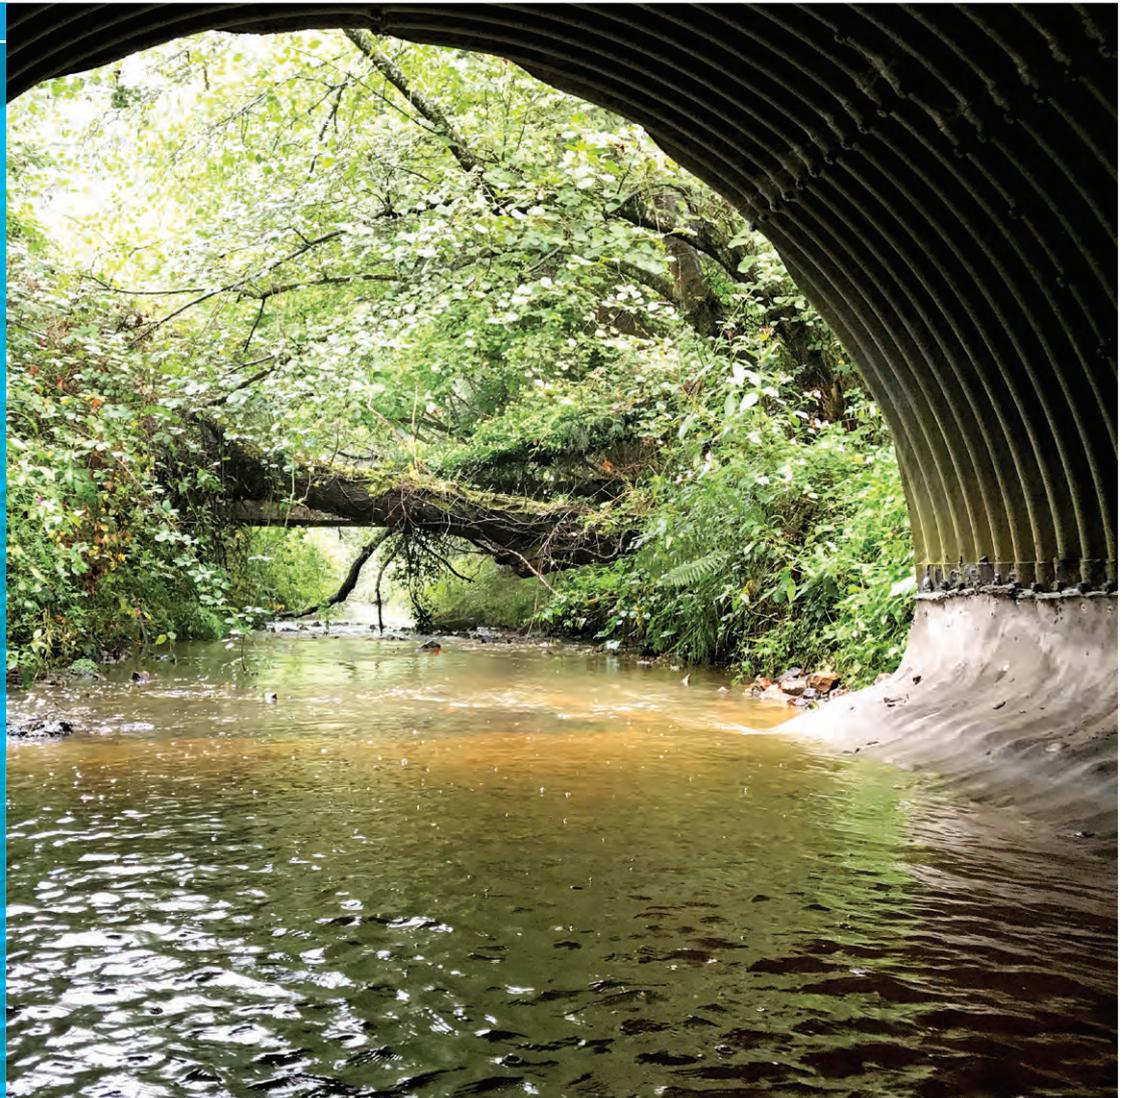
Completed culvert in use

The project as a whole took 11 days to complete, including mobilisation and preparation work. A total of 160m² of CC13™ were installed, fixed and hydrated in 3 days by a team of 4 people (with the majority of the installation time spent fixing the CC to the culvert with tech screws), on a site with limited access and material transported into position by hand.

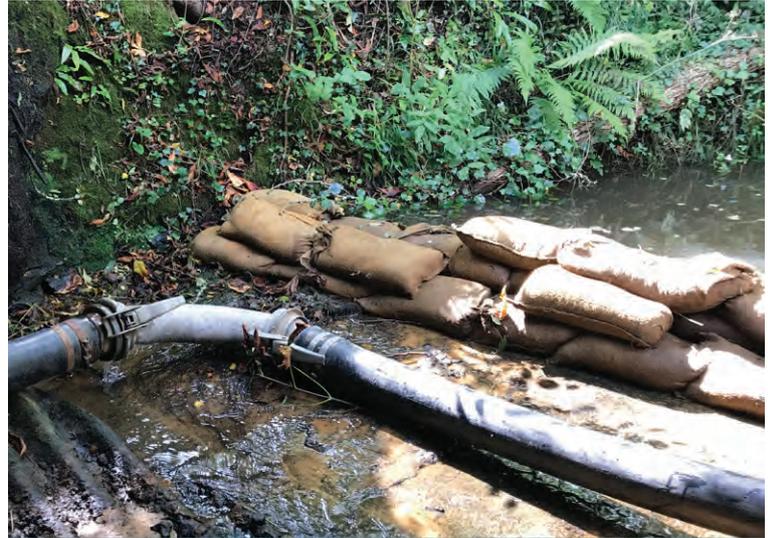
The waterflow was restricted for the works using sandbags

Bulk rolls of CC13™ were delivered to site ahead of installation and mounted on a spreader beam to lift the material for batching on the side of the highway above, before the batched lengths were lowered and transported by hand into the culvert. Water was diverted away from the culvert during works using sandbags and overpumping to avoid high water levels in the culvert and the CC being hydrated too quickly, allowing plenty of time to work with the material, as it has a 2-hour workable period following initial hydration before it begins to harden.

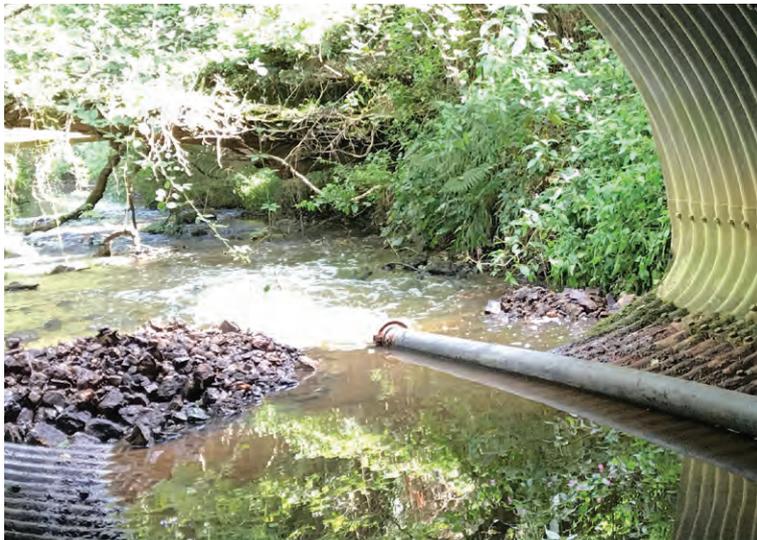
Water redirected using overpumping

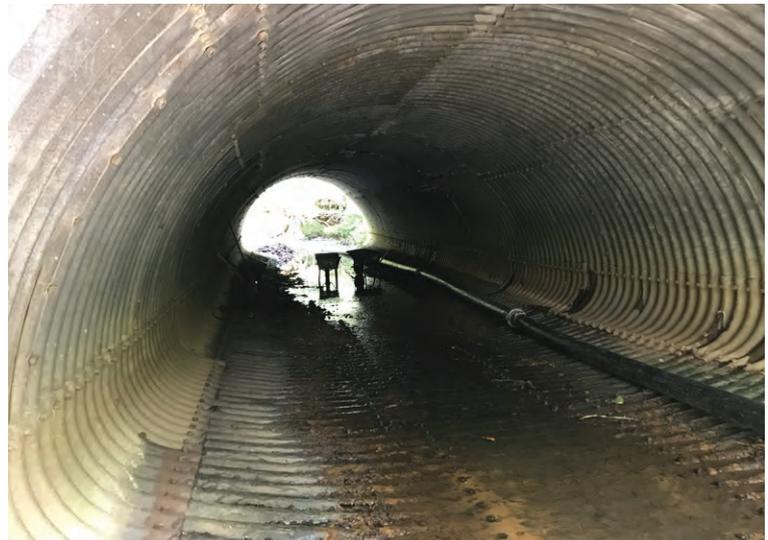
In September 2017, Concrete Canvas® GCCM* (CC) was used to line a culvert in Cooks Bridge, Midhurst, West Sussex. The culvert was situated under a highway, and provides the only passage under the road for the stream; however, the existing corrugated steel culvert had corroded over time, in part due to the abrasion from sediment and gravel transported along the channel in high flow conditions. The flow of water started to erode the soil beneath the structure, affecting the long-term performance of the culvert. CC was specified to provide scour protection to the culvert and increase the working life of the structure. The works were carried out by Suttle Projects for Igroup/Balfour Beatty Living Places/West Sussex County Council.

The culvert prior to prep and installation

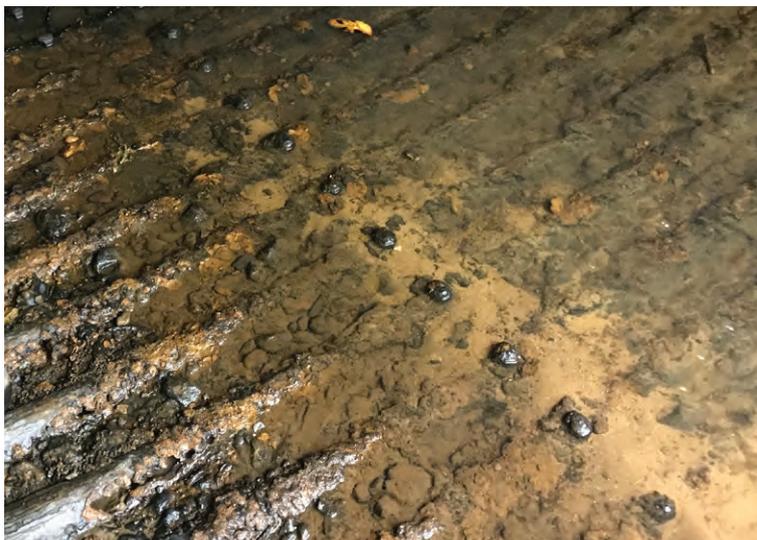
The culvert floor was corroded and heavily sedimented

To prepare the culvert, debris was removed from the corrugations and the culvert surface was cleaned to remove any sediment, some of which had solidified. The corrugation inverts were then filled with a rapid-set grout to ensure an even surface for the CC to be fixed to, as well as ensuring the material was flush to the culvert and to avoid any voids between the culvert and material. Grout was packed locally around protruding bolts and nuts to avoid potential puncture points.

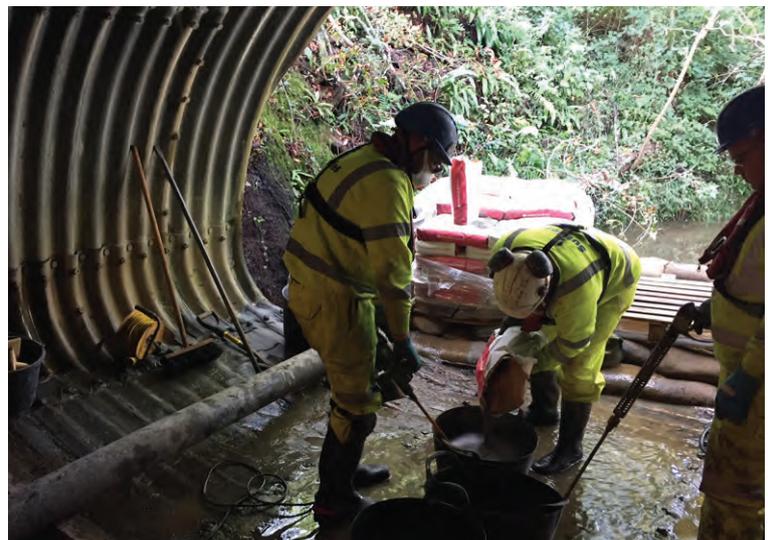
Quick-set grout was used to fill the voids in the corrugates

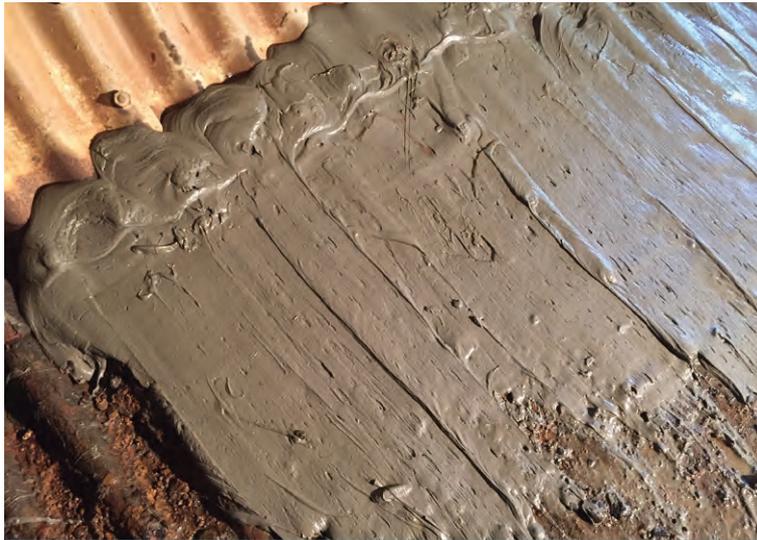
The grout provided a flat surface to lay the CC on top of

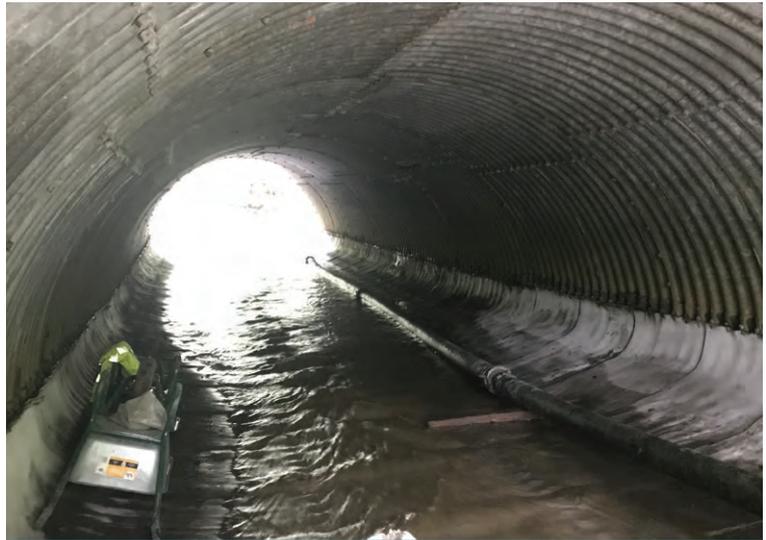
The CC was laid transversely across the culvert floor

The CC material was then laid by hand, transversely across the base of the 23m x 6m culvert. The material was fixed to the culvert by drilling holes through the steel and fixing in place using tech screws. The CC was fixed along its edge at roughly 150mm intervals. Additional fixings were then applied at 300-500mm intervals, to help the material fit to the curve of the culvert successfully. Each additional layer was laid in the direction of waterflow, with an overlap over 100mm, and jointed using Clearfix adhesive sealant for added impermeability. Sandbags were then placed on top of the joints to weigh them down while they dried. Once installation was completed, and the grout set, the CC was hydrated using water from the stream.

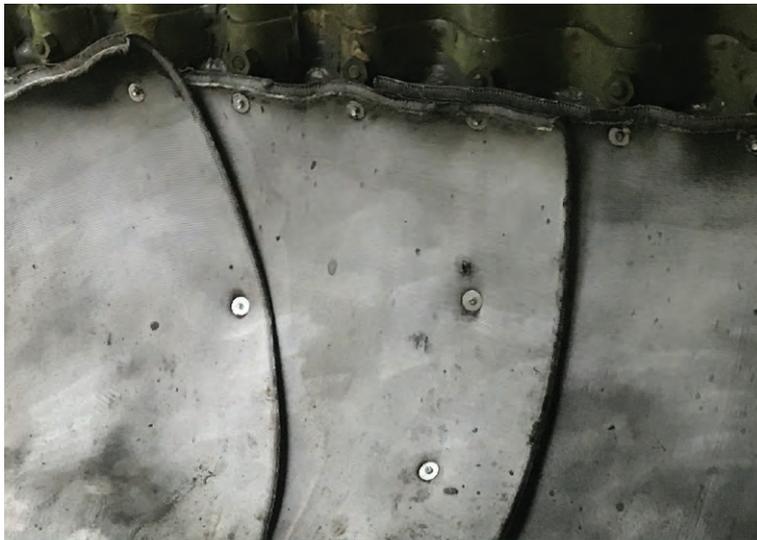
CC was fixed to the culvert using tech screws

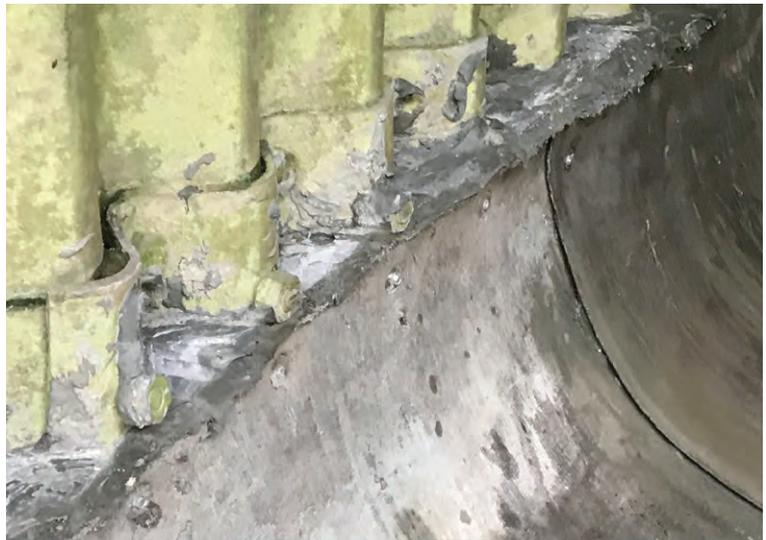
Voids behind the fixed CC were filled using more grout

Once set, the voids at the sides of the culvert and CC material were sealed by filling with poured grout to prevent ingress. At the start of the culvert, where there was a concrete apron, the CC was extended onto this and screwed in place, before a grout fillet was applied along the entire length to prevent water undermining. At the end, the CC was cut level with the headwall and another grout fillet applied and the edge buried with a larger stone.

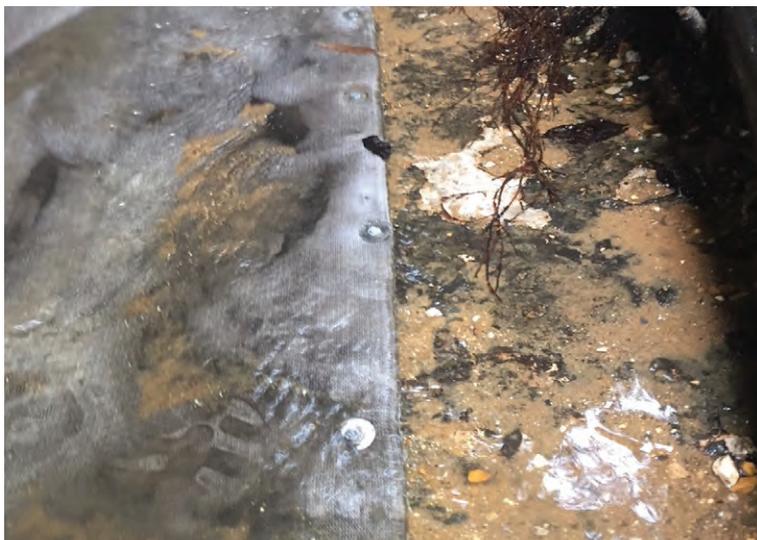
CC extending onto concrete apron, fixed using tech screws and grout

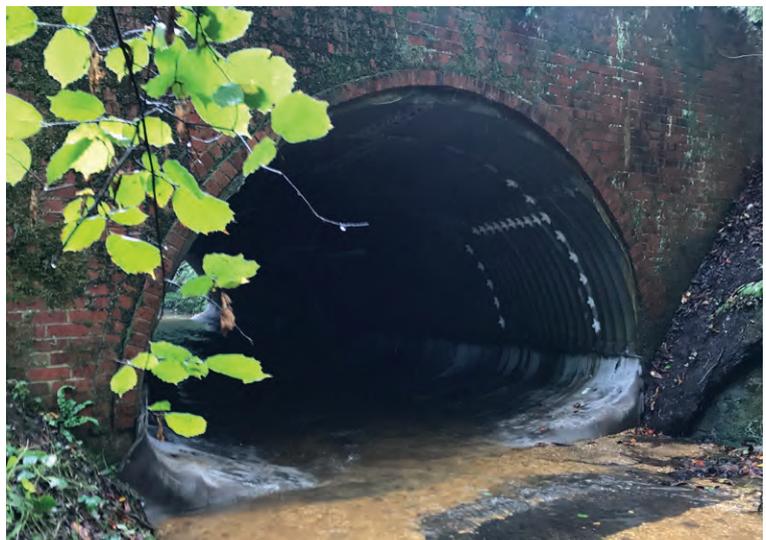
CC aprons at the start of the culvert

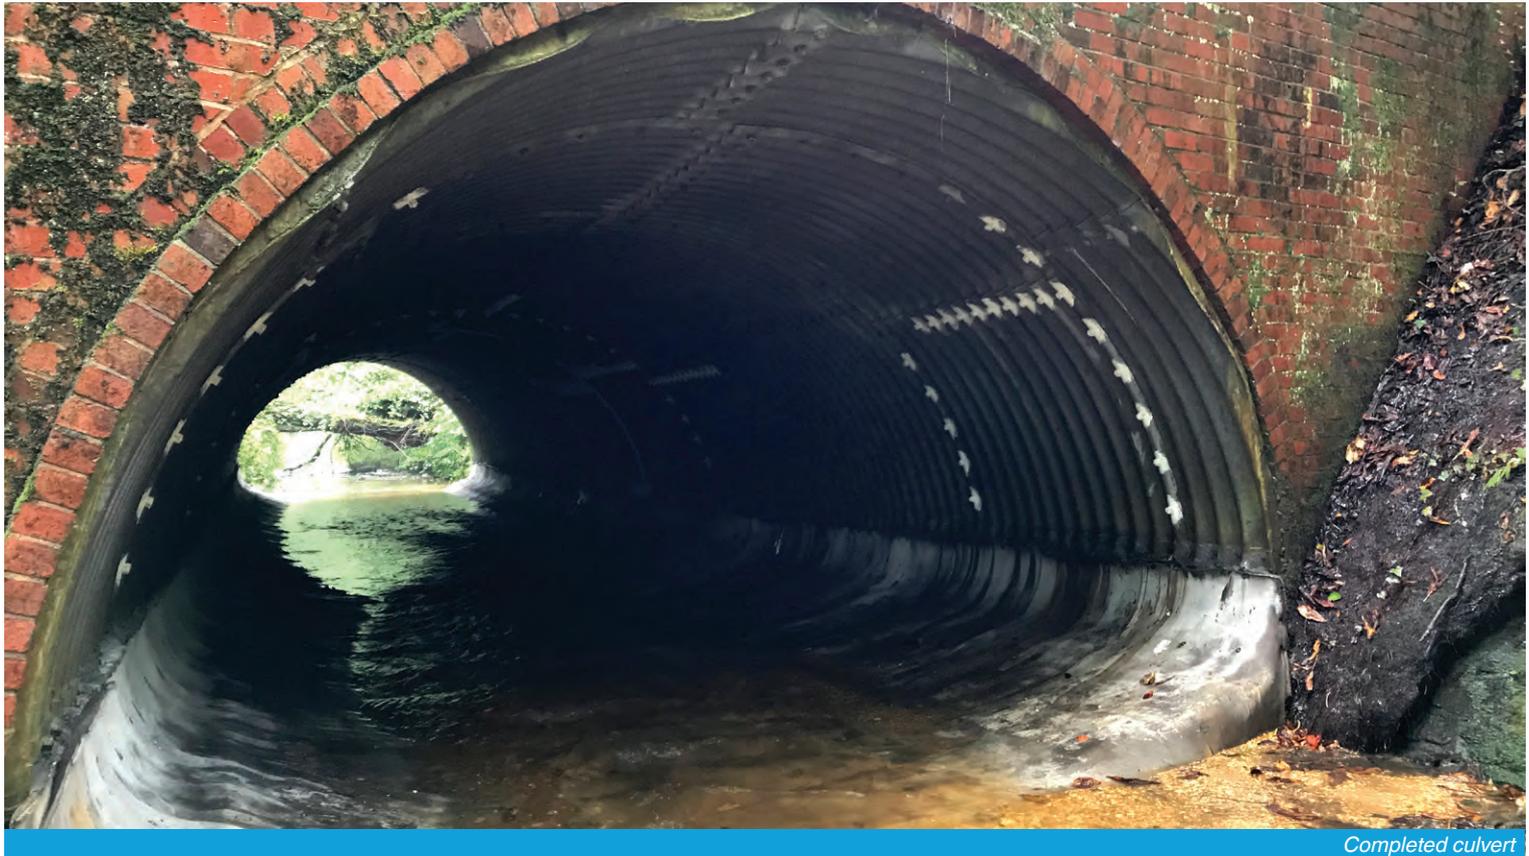
*Completed culvert*

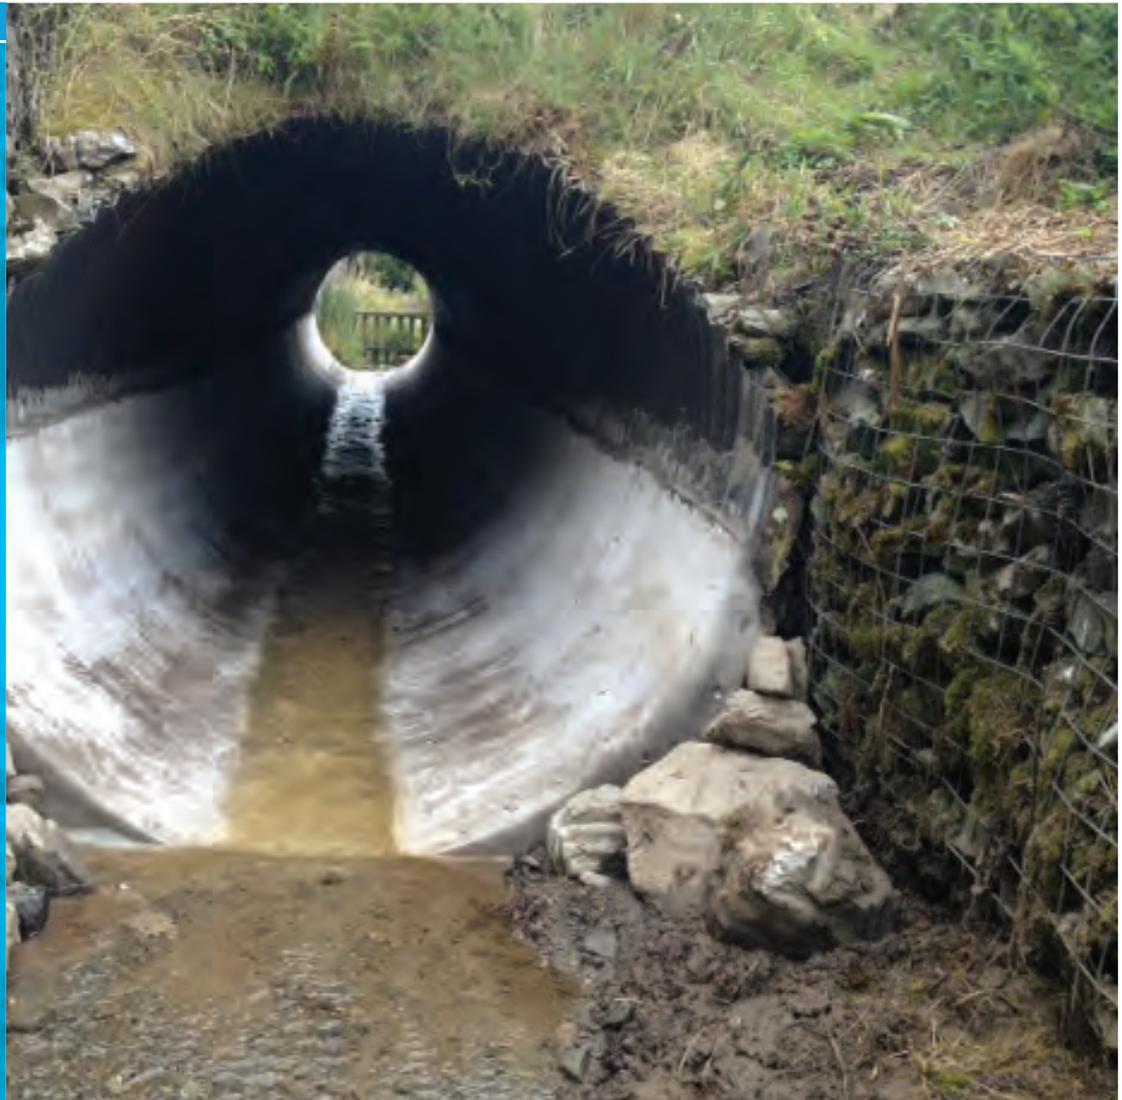
Completed relined culvert

190m² of CC5™ was installed in a week and a half, including diverting water flow and preparation work. Castle Group Scotland were impressed with the ease and speed of installation CC, as well as its minimal environmental impact.

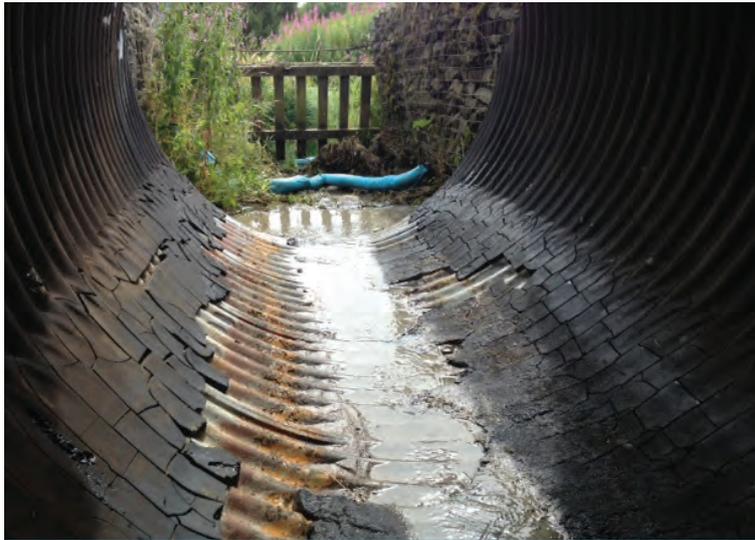
In August 2013, Concrete Canvas® GCCM (CC)* was used to reline an ARMCO steel corrugated pipe which formed part of a culvert in the Scottish borders. The existing 1-2mm bitumen coating inside the pipe had broken down through flow erosion and weathering, resulting in silt, debris and vegetation growth and build up which begun to compromise and degrade the culvert. Replacing the culvert would be cost prohibitive and involve temporary lane closures of the nearby A7 trunk road. Bitumen coating is now generally prohibited by the Scottish Environment Protection Agency (SEPA) due to potential environmental damage, and any remediation solution would need SEPA approval. Glass Reinforced Plastic (GRP) was also considered, but would have to be specially made to fit the culvert, leading to increased cost and lead time. CC was chosen due to its speed of installation, flexibility, and minimal environmental impact, having been authorised for use in live water courses by the UK Environment Agency on previous projects.

Flow erosion had caused the existing bitumen lining to break down

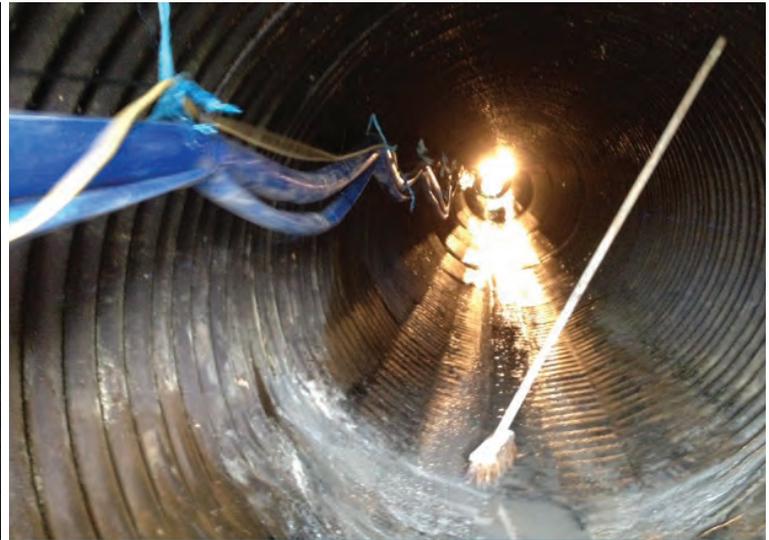
The culvert was pressure washed to remove the degraded bitumen

Prior to installation, the ARMCO pipe was cleared of silt and debris and the damaged bitumen lining removed with a pressure washer. The corrugations were then filled in using a semi-dry grout mix before bulk rolls of CC5™ were delivered and cut to length on site, ensuring minimal material wastage. The CC was then laid transversely, overlapped by 100mm in the direction of water flow and fixed to the pipe at 200mm centres using stainless steel tech screws before being hydrated.

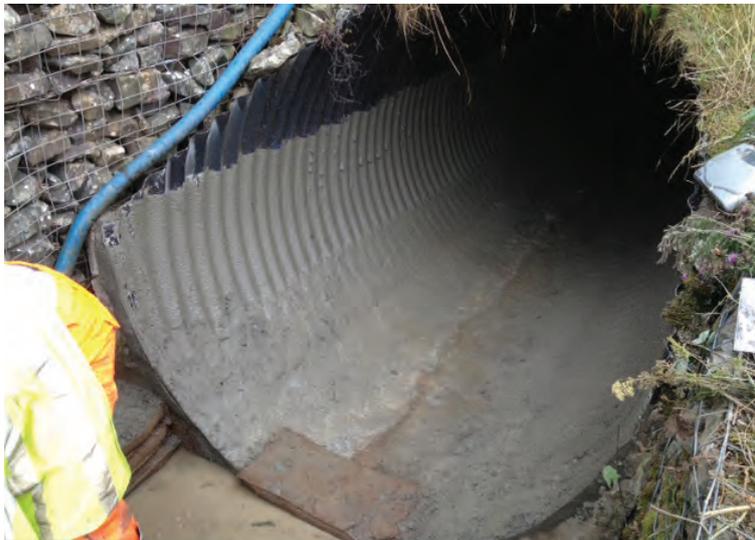
Semi-dry grout was applied to fill in the corrugations

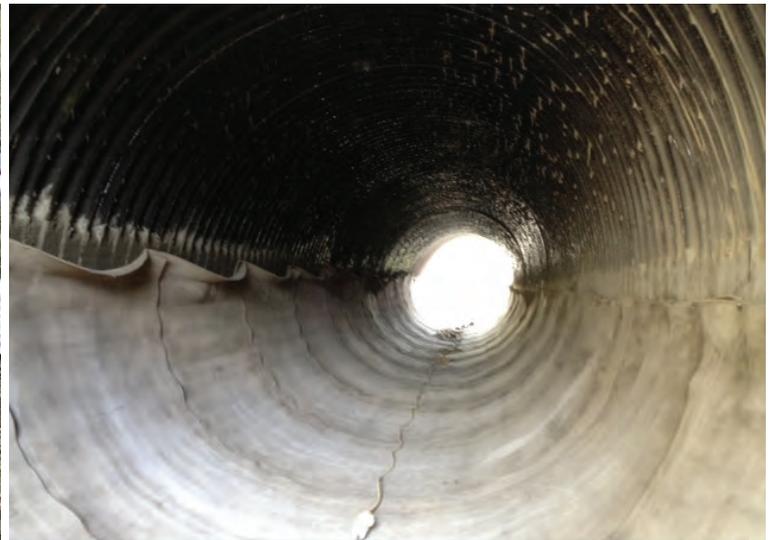
CC5 was applied in transverse layers inside the culvert

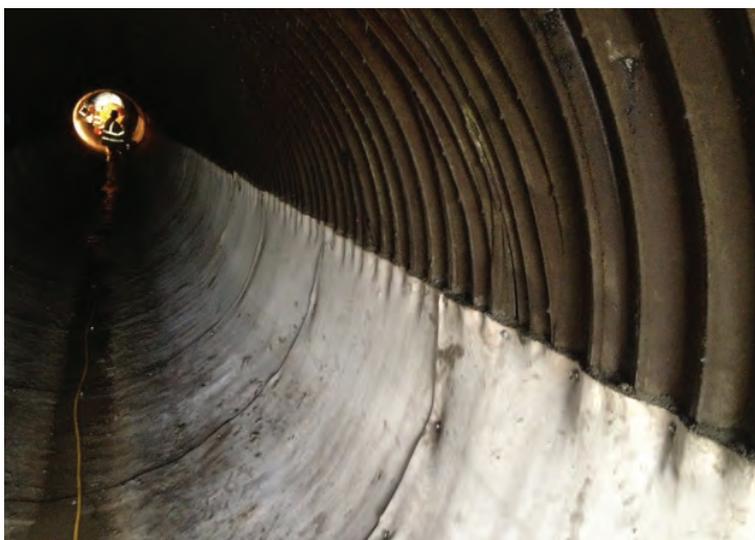
Stainless tech screws were used to fix the CC8 to the pipe

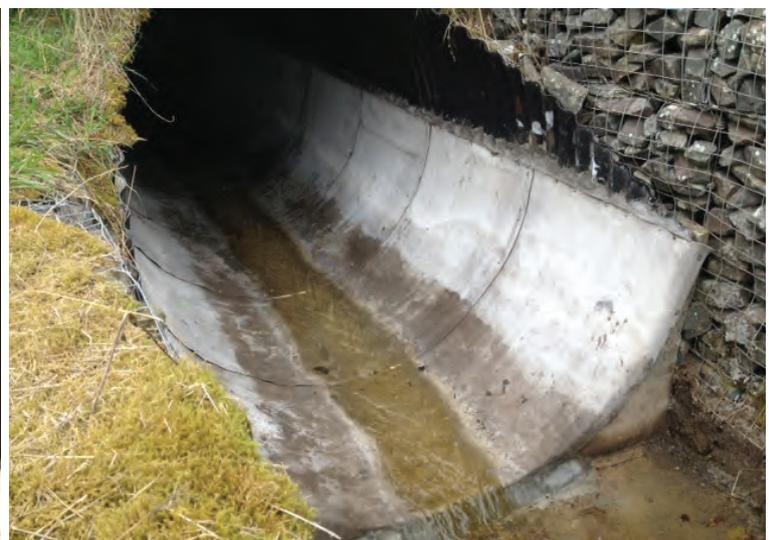
Relined culvert section

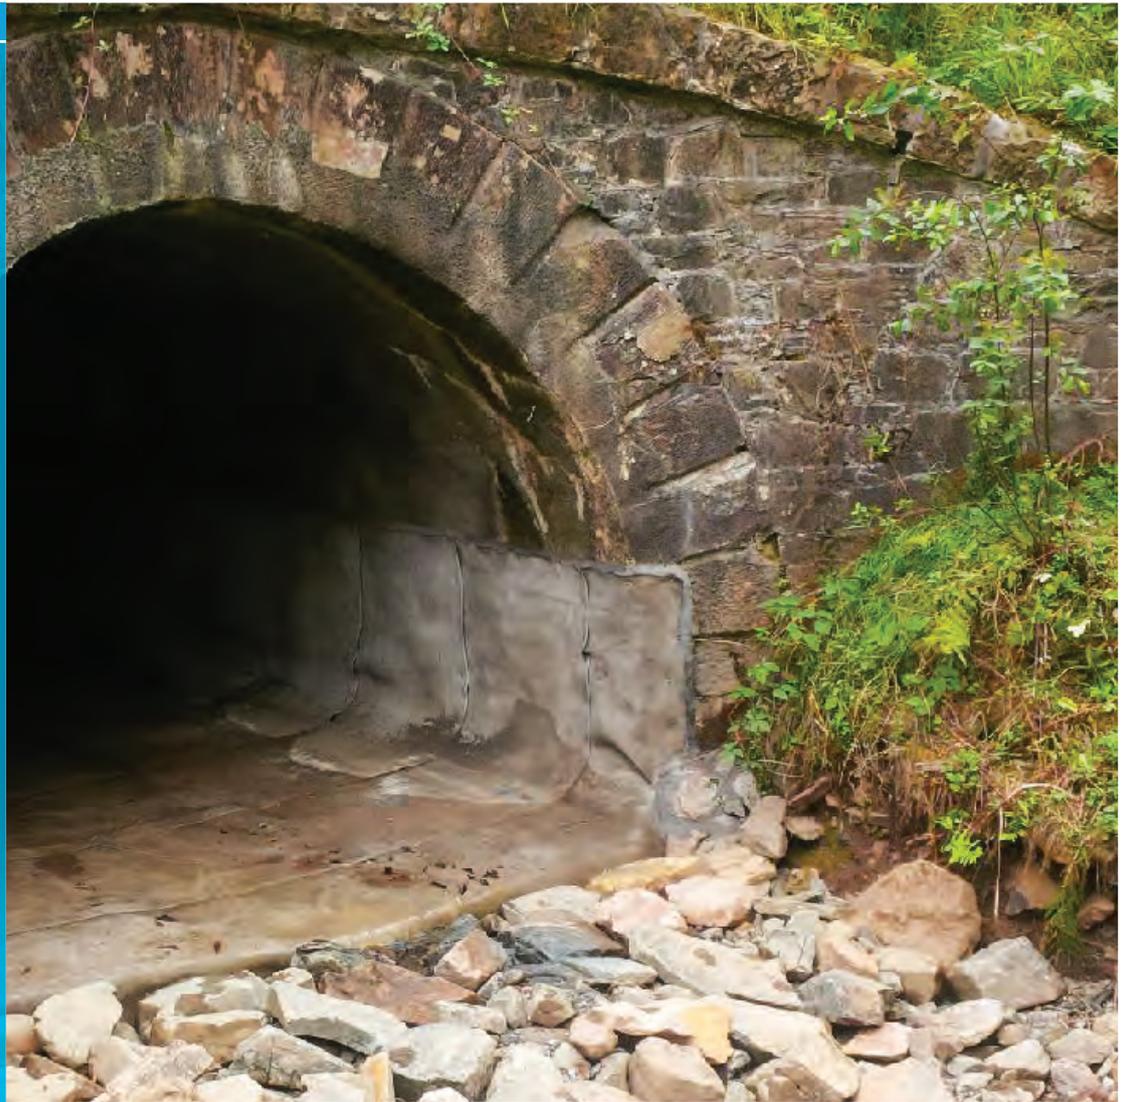
Completed installation in Earlston, Scotland

450sqm of CC5™ were installed by 4 people in 4 days in a live water course. The client was very impressed with the installation and CC is likely to be used on further culvert projects.

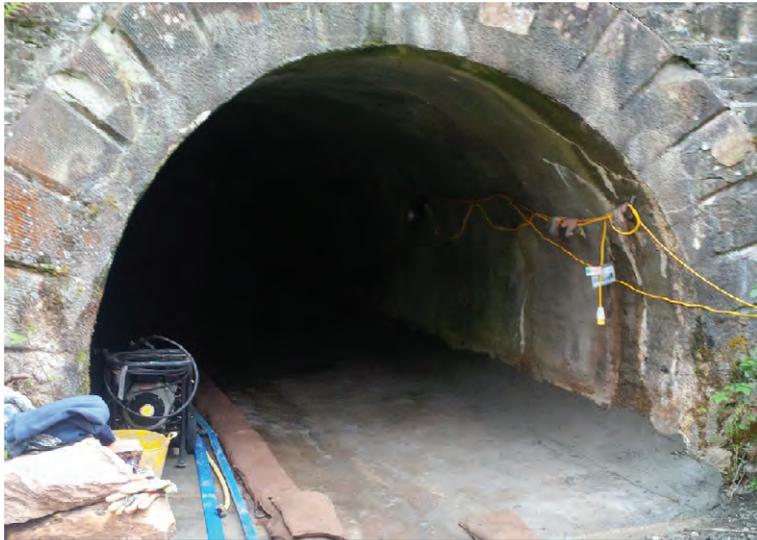
Masonry section before works began

Installation was carried out by Castle Group Scotland for Bear Scotland. To prepare the culvert the existing failed coatings were removed from the corrugated section and replaced with a semi dry mortar mix to provide a flat profile. Further down the culvert is of masonry construction, and the entirety of the culvert floor is poured concrete. Batched rolls of 5mm thick CC (CC5™) were delivered to site and unrolled by hand across the width of the culvert, with an overlap of 100mm created between adjacent layers. The overlaps were screwed with 30mm stainless steel screws at 200mm centres but were left unsealed, creating weep paths to prevent the build up of hydrostatic pressure behind the CC. The top edges of the CC were sealed with a line of grout to prevent water ingress behind the material. Water was pumped from the nearby water course for hydration.

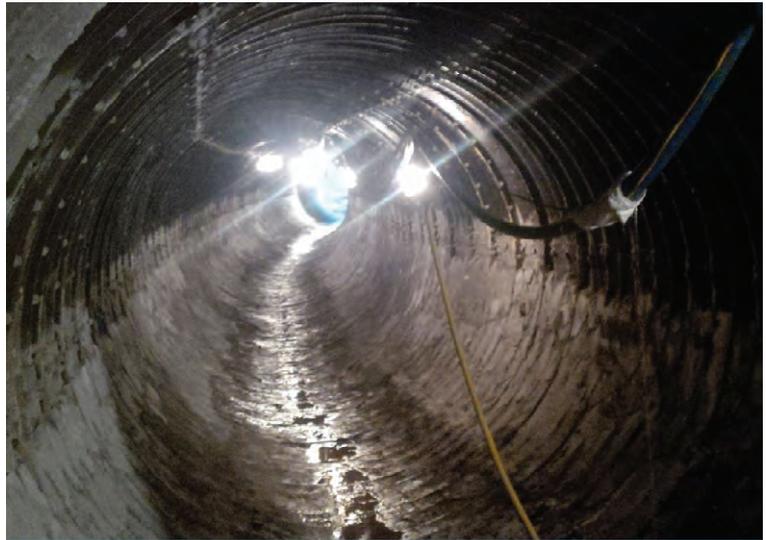
In September 2014, Concrete Canvas® GCCM* (CC) was used to line a culvert in Earlston, Scotland. The culvert was failing and previous lining/remediation attempts had been unsuccessful. Shotcrete was considered as an alternative, however this would have resulted in a much lengthier installation, as well as requiring much more complex logistics as access to the full length of the culvert was limited. Additionally there was concern over the environmental implications of installing shotcrete in this location.

Corrugated section before works began

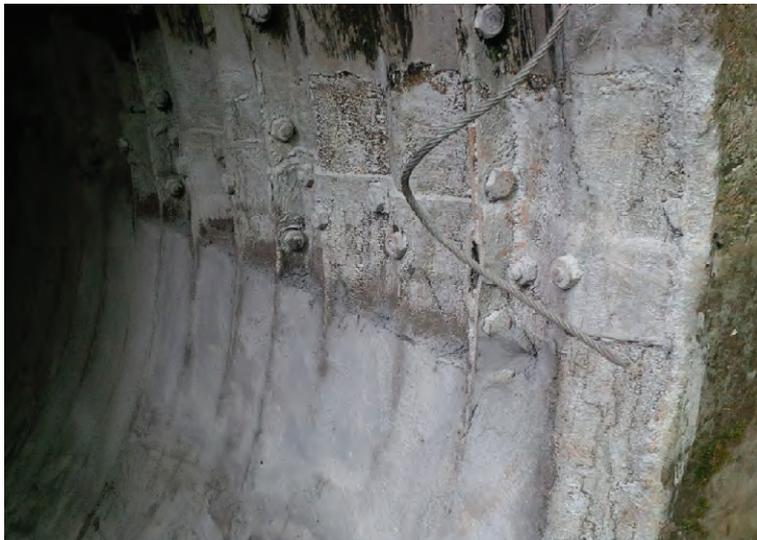
Grout applied to corrugated section

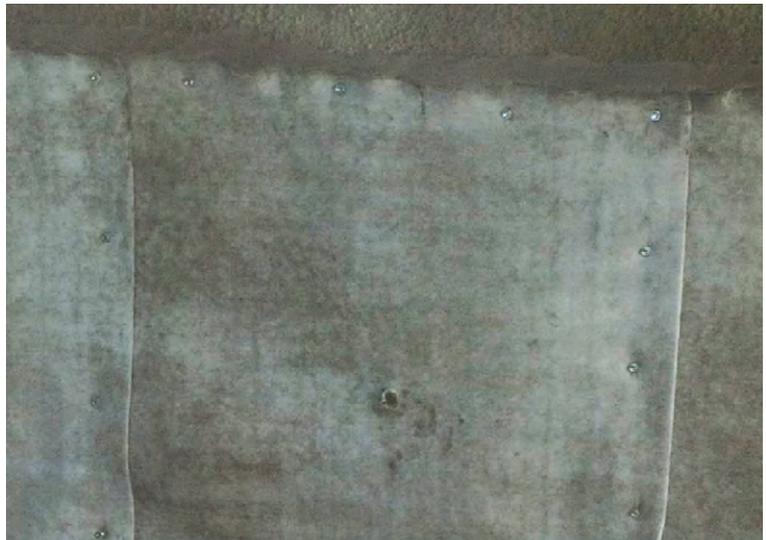
Overlaps screwed, and grout applied to prevent ingress

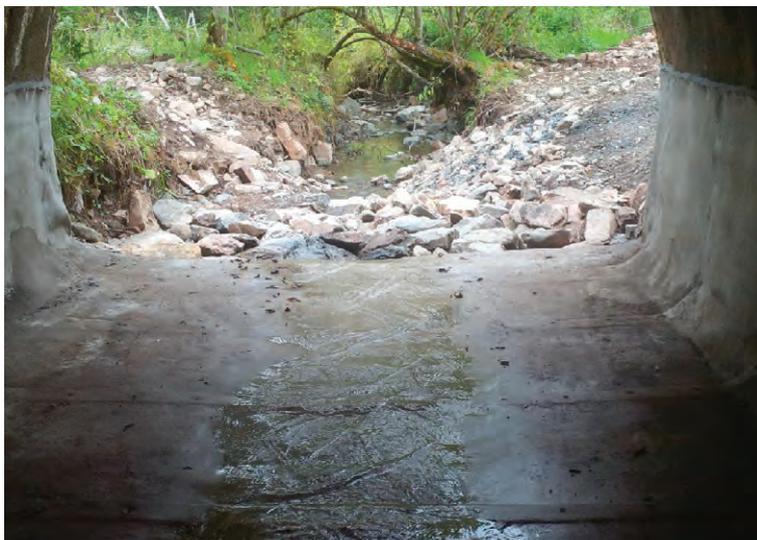
The finished install within the culvert

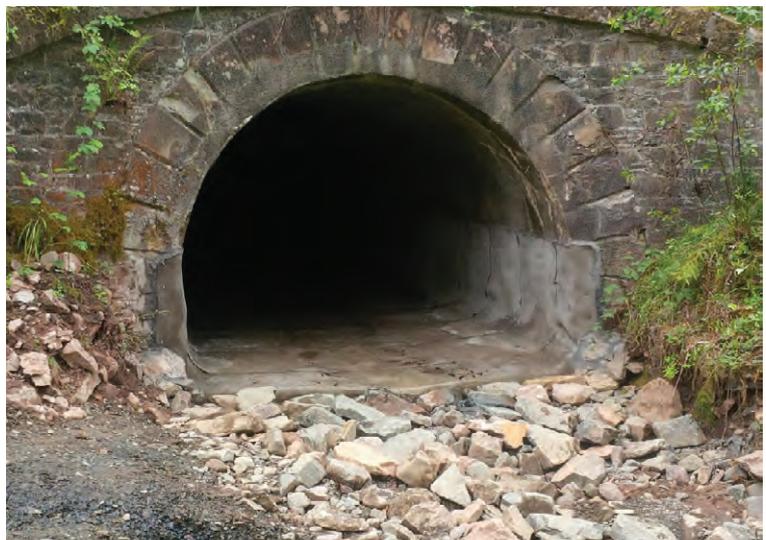
A view of the finished install from outside the culvert
