CONCRETE CANVAS®

CULVERT LINING CASE STUDIES

G Kirk Burn culvert, Laurencekirk, Scotland

i CC8™ was used to remediate a dilapidated culvert and prevent erosion caused by high water flow rates.

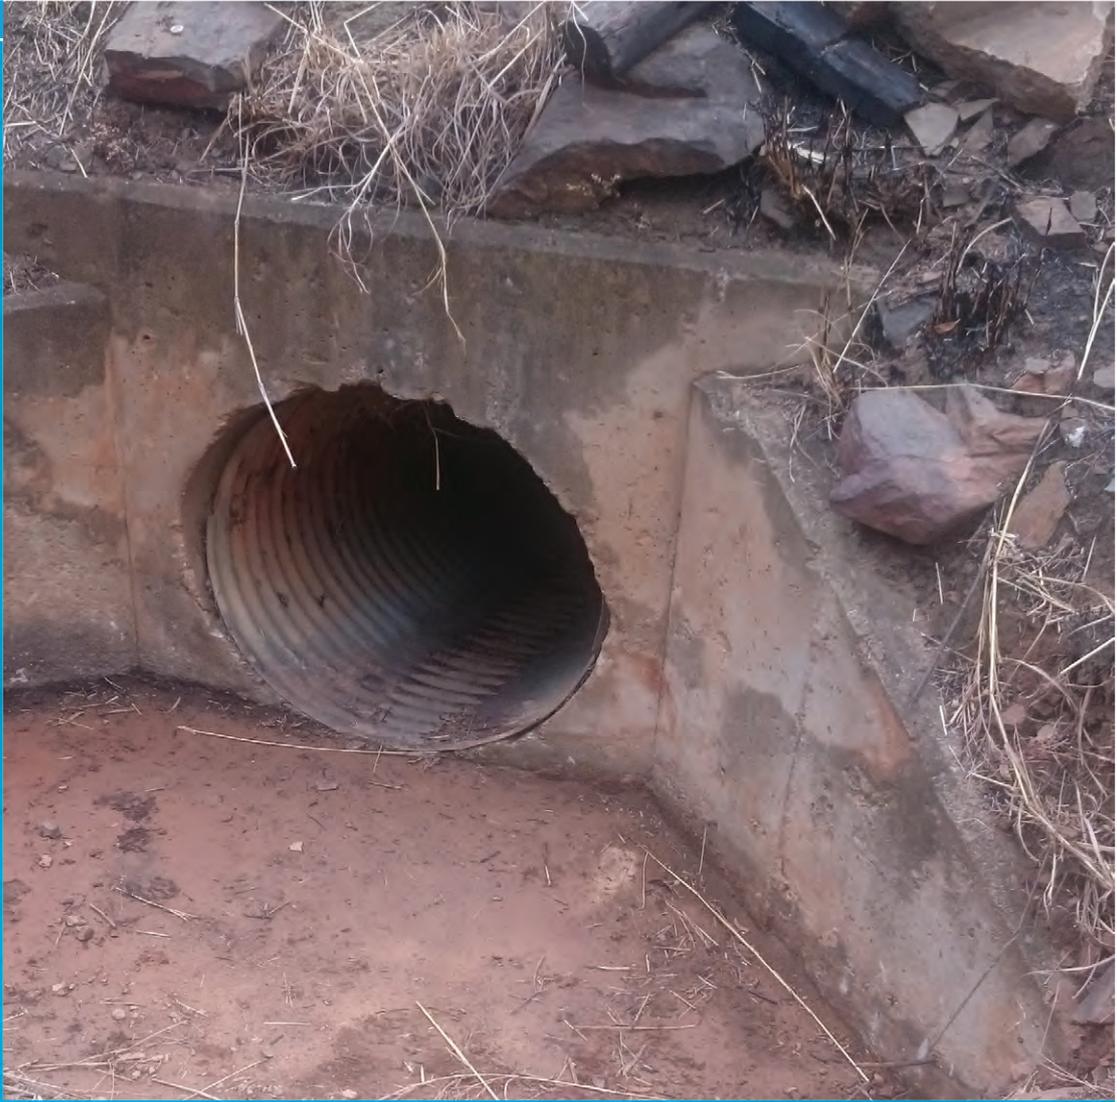
The culvert prior to installation

The culvert had previously been lined with corrugated steel, however abrasion had damaged the galvanised layer of the material, which had led to the rapid deterioration of the steel itself, particularly where water was trapped in the corrugations.

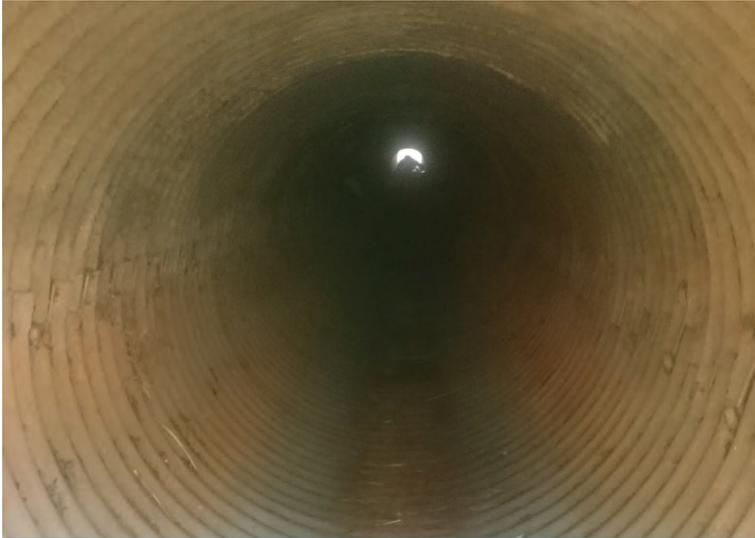
Existing corrugated steel culvert

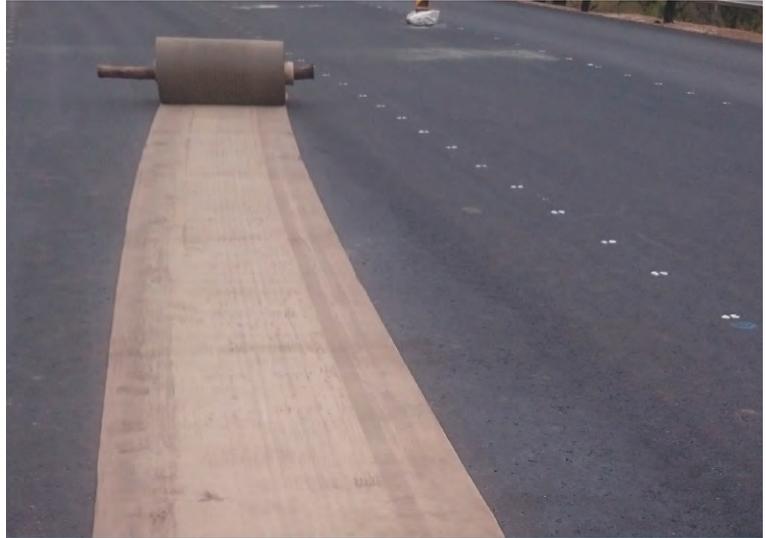
Bulk rolls were used, then cut to specific lengths on site

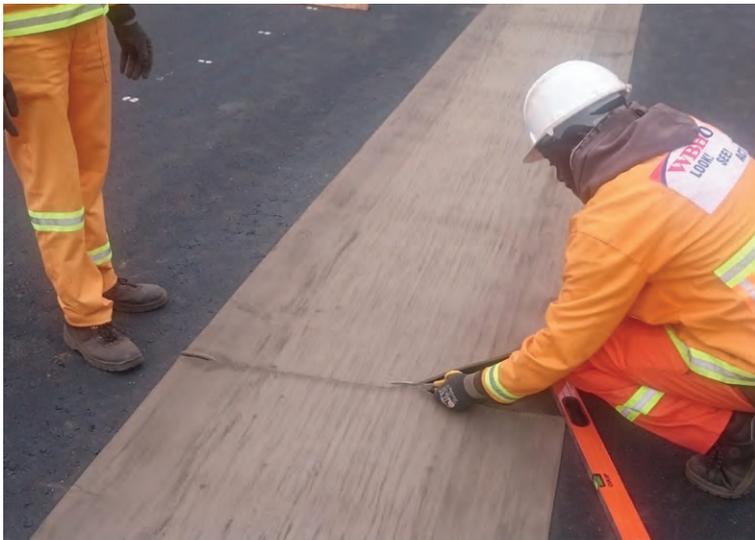
CC5™ was cut to 8m lengths for easy transportation on site

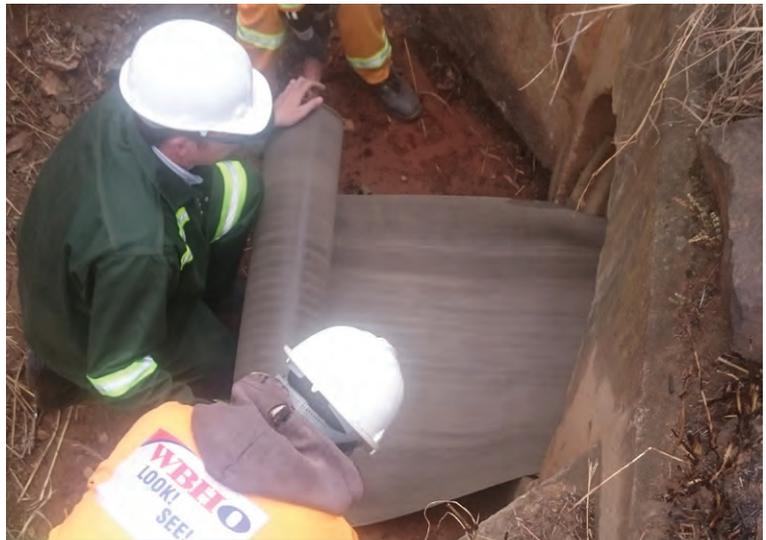
Laying CC5™ lengths in culvert

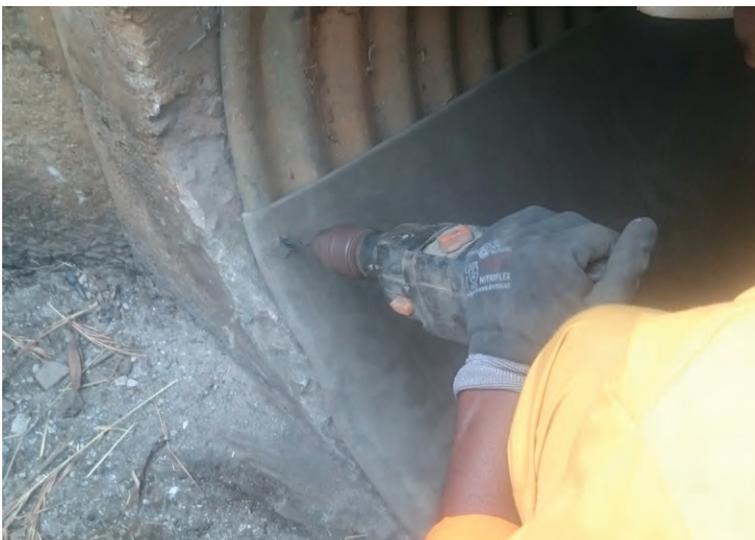
Fixing with pop rivets

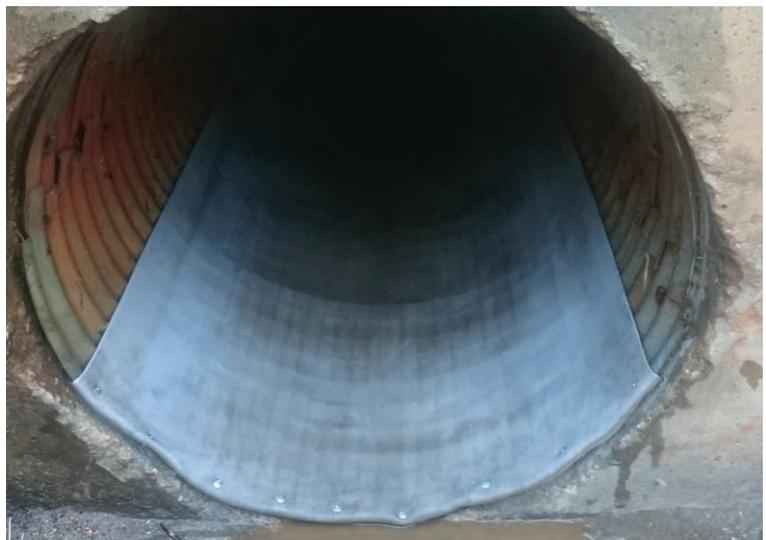
Completed installation

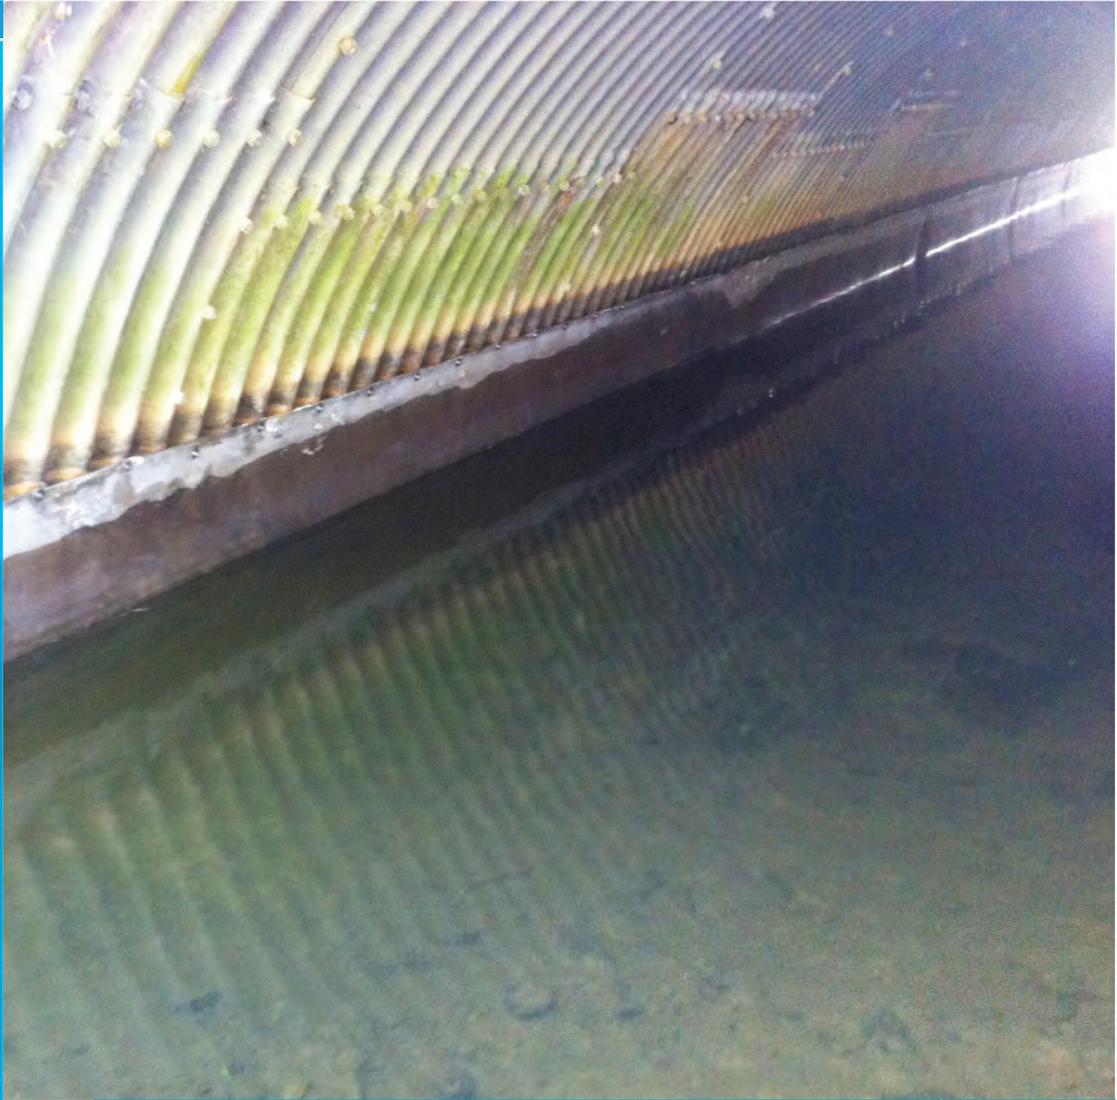
The completed project

A total of 80m² of CC8™ were installed by 3 people in just 6 hours, following 8 hours of site preparation, when the client had allowed for 2 days. Furthermore, CC's low alkalinity and low washout rate meant the works did not negatively impact the local ecology.

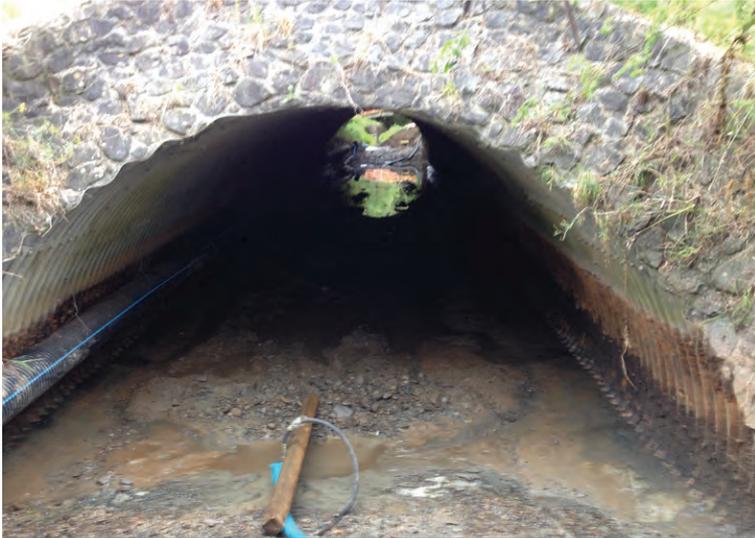
The culvert before work began

To prepare the site, the drain was cleared, the area dammed and the water flow diverted. A bespoke length was cut from a bulk roll of CC8™ and delivered to site. This was then unrolled on the flat and cut to length, before being carried into the culvert. The CC8 was fixed to the existing corrugated metal using 32mm hex self-drilling screws at 200mm intervals. Where joints were needed, overlaps of 100mm were created and mechanically jointed with more hex screws. To hydrate the material, the water flow was redirected through the culvert, allowing the CC to be submerged in water.

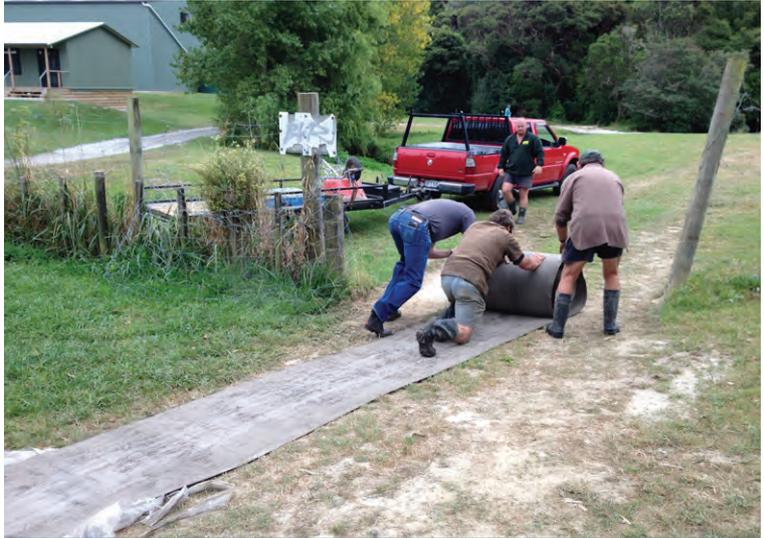
Unrolling the CC8 in order to cut it to length

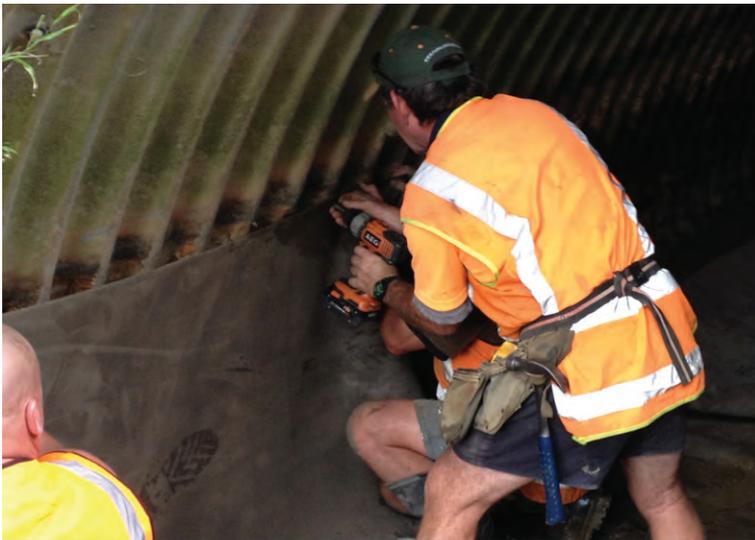
Fixing the CC to the culvert

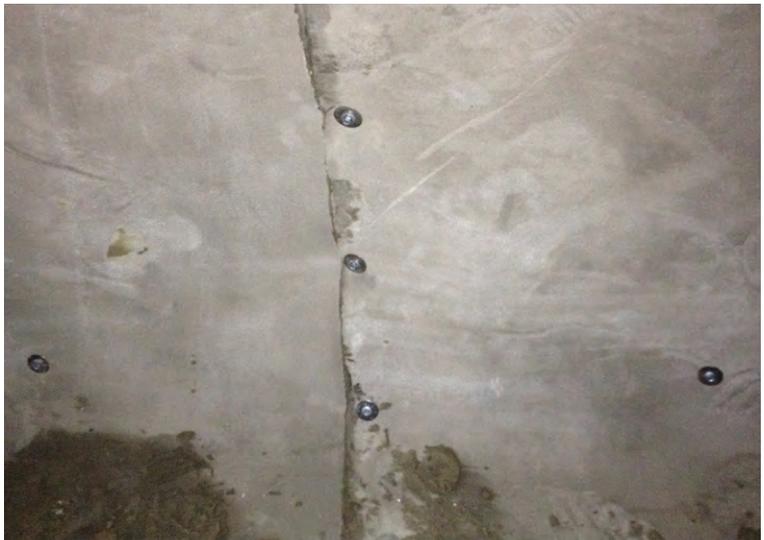
32mm hex screws

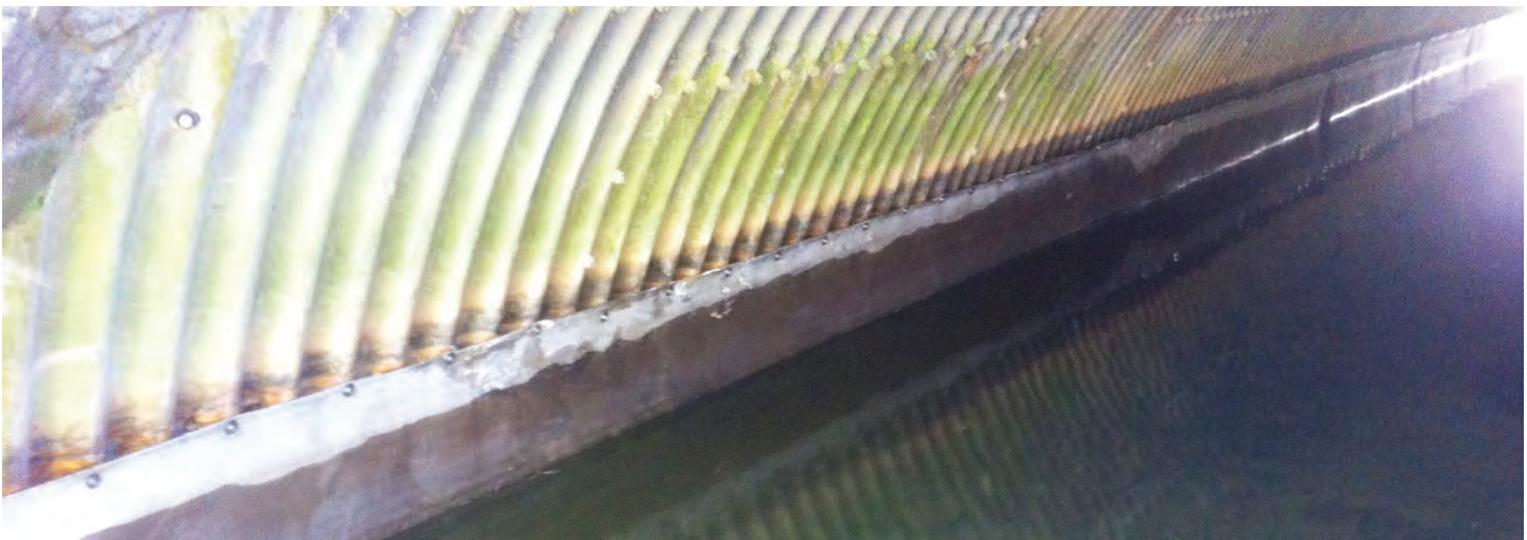
The finished project
