CCH8™ Bulk Rolls

Lulu 92, Royal Commission Jubail, Saudi Arabia

CCH5™ and CCH8™ were installed as a fully impermeable channel lining solution

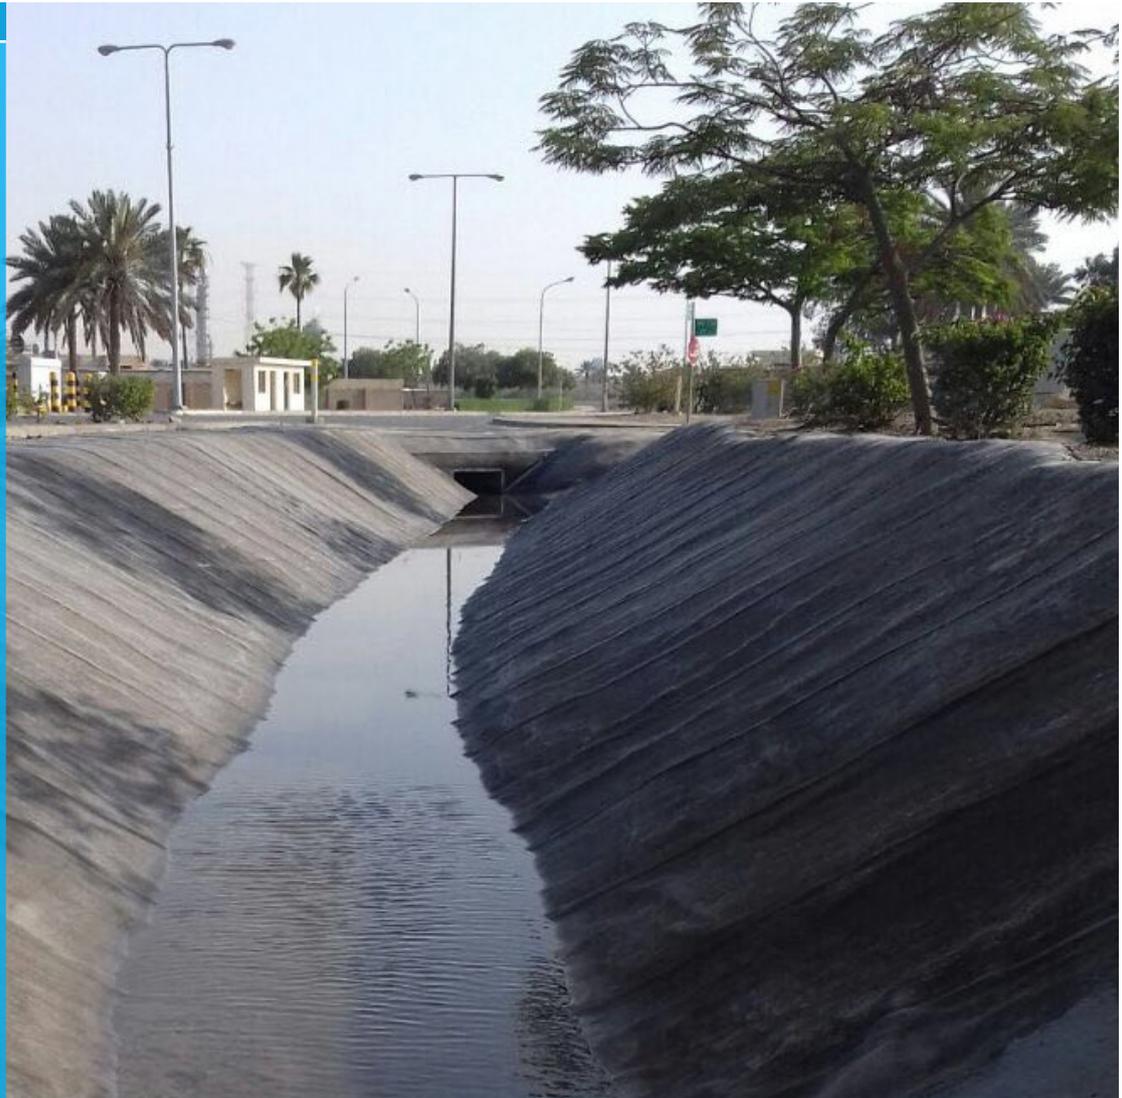
Completed channel following installation

A total of 430m² of CCH8™ was installed in just two days, across approximately 20 hours. The project was deemed a major success and the CCH lined structure is still performing as designed over two years after installation.

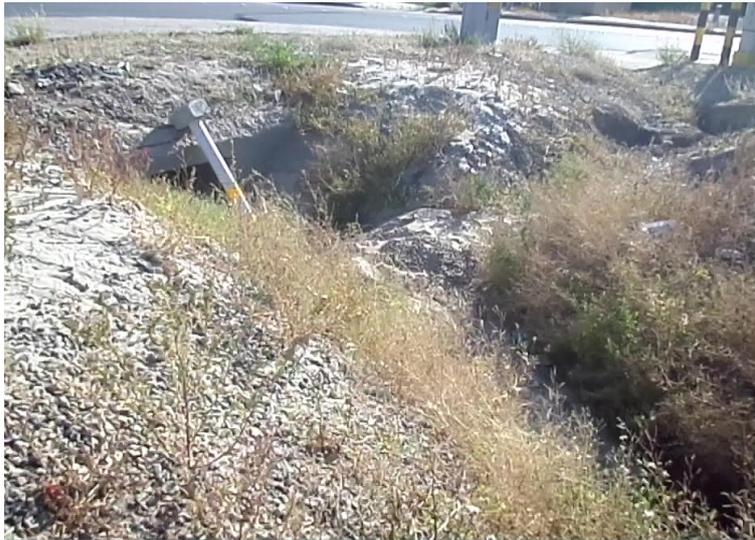
Channel prior to works

In preparation for the installation, loose soil and vegetation were removed by the client prior to handing over to the contractor, FOQSCO. The channel had crumbled over time due to erosion of the soil and gravel-based substrate. To prepare it for installation, the channel was profiled, graded and then compacted using plate compactors. Anchor trenches were then prepared on both shoulders and a layer of geotextile was laid across the channel profile to provide an additional layer of protection to the CCH geomembrane backing, preventing puncture from the gravel below.

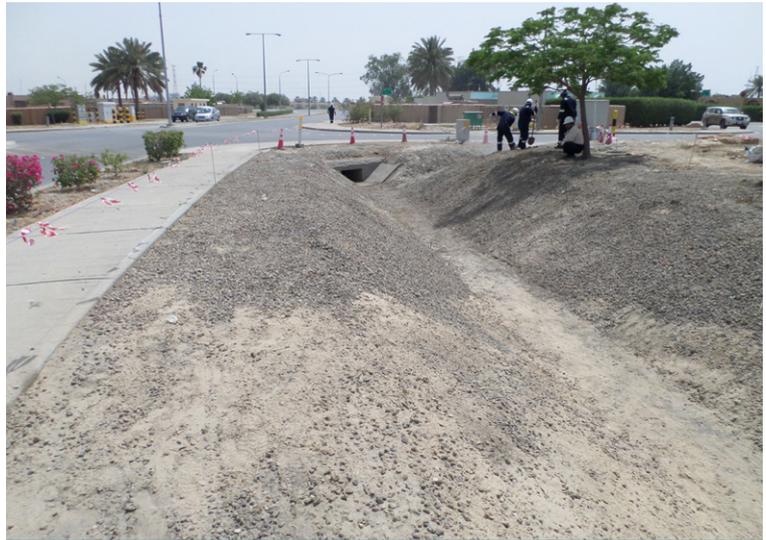
Following profiling and grading of the channel

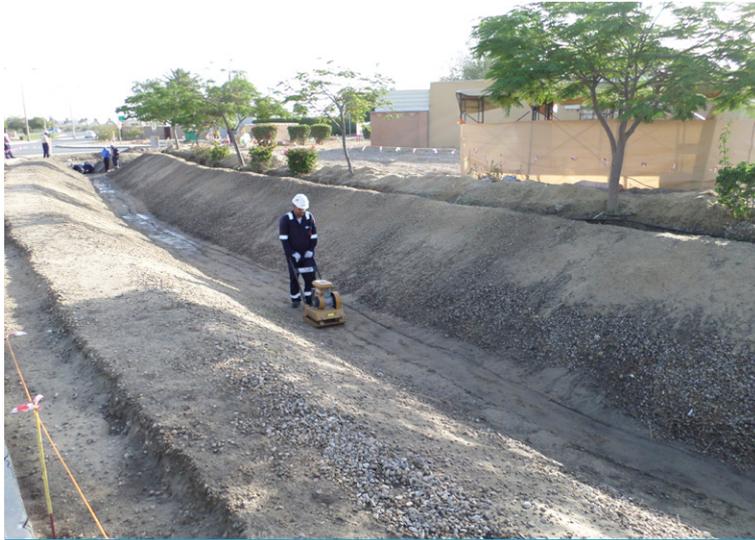
Compacting the substrate

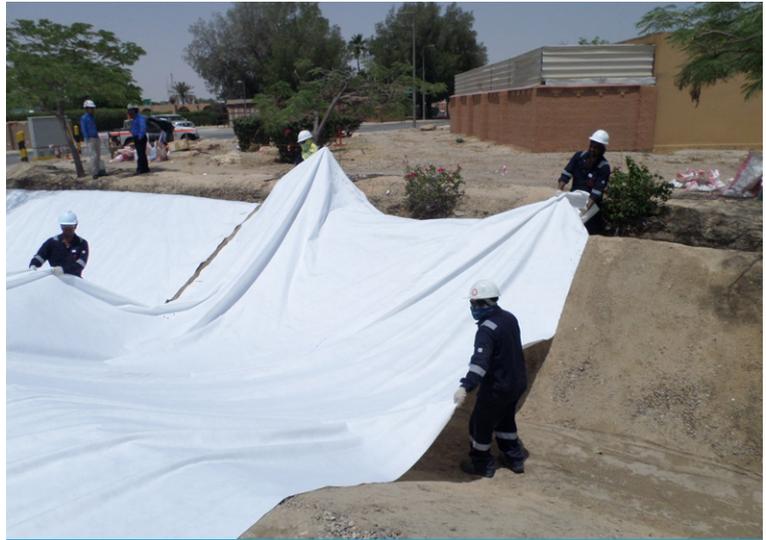
Installation of geotextile

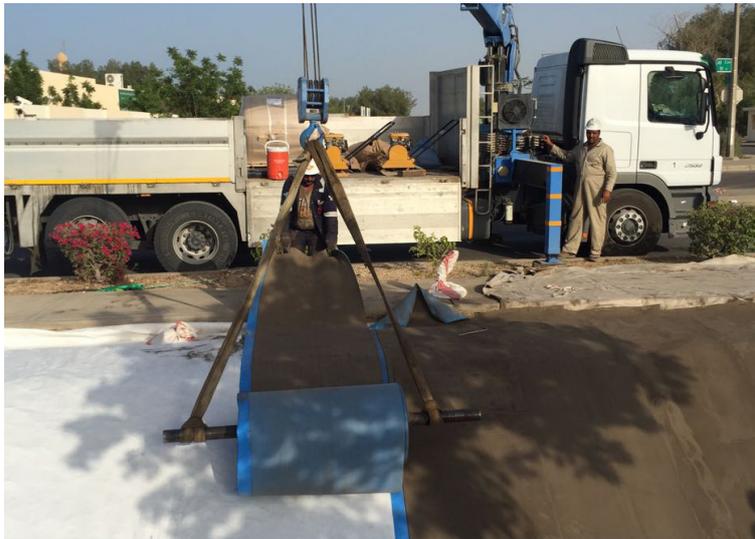
Deploying CC from spreader beam and boom truck

Bulk rolls of CCH8™ were delivered to the site and mounted onto a spreader beam which was suspended from a boom truck. The CCH was then deployed transversely across the channel and cut to length in situ, with the leading and trailing ends captured within the anchor trenches and secured to the substrate using steel ground pegs. In areas that were difficult to access with the boom truck, the CCH was instead dispensed from a steel stand, cut to required length and moved into position by hand.

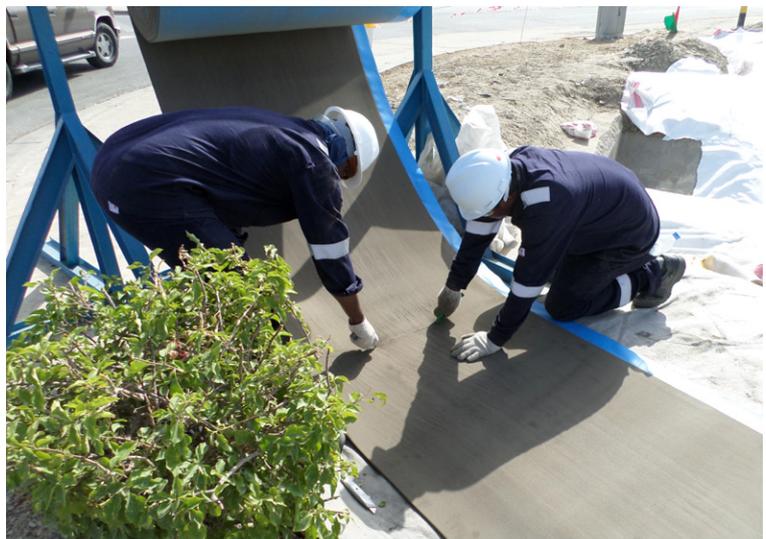
CC deployed from spreader beam and steel stand

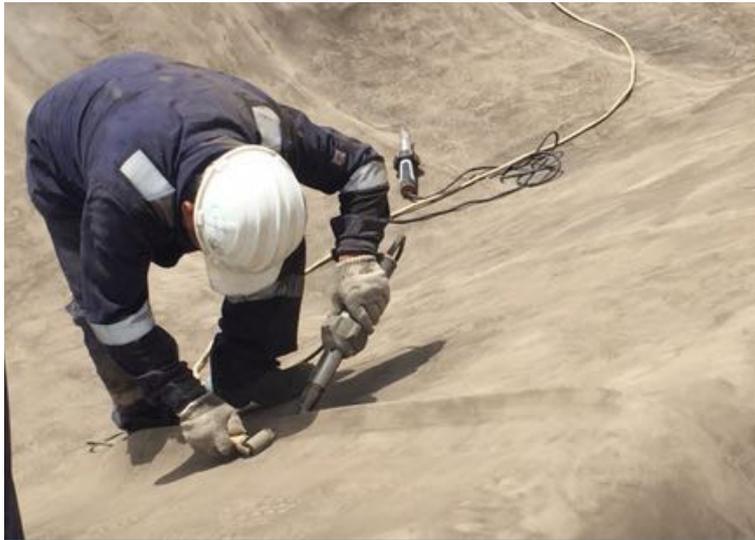
Thermal welding of CCH overlaps

The CCH was laid with the edge of subsequent layers overlapping the welding strip of the last. The lengths of material were later jointed by thermally welding the PVC layers together. Stainless steel strips and anchor bolts were used to fix the material to existing concrete infrastructure.

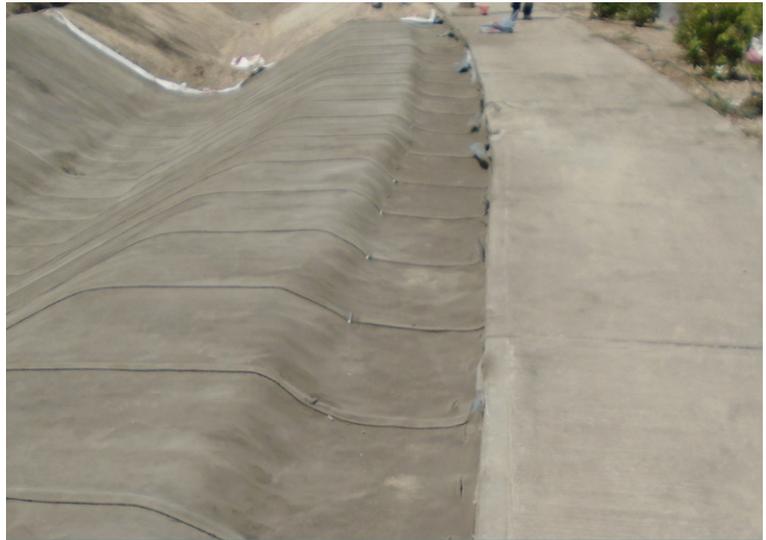
CCH pegged within anchor trenches

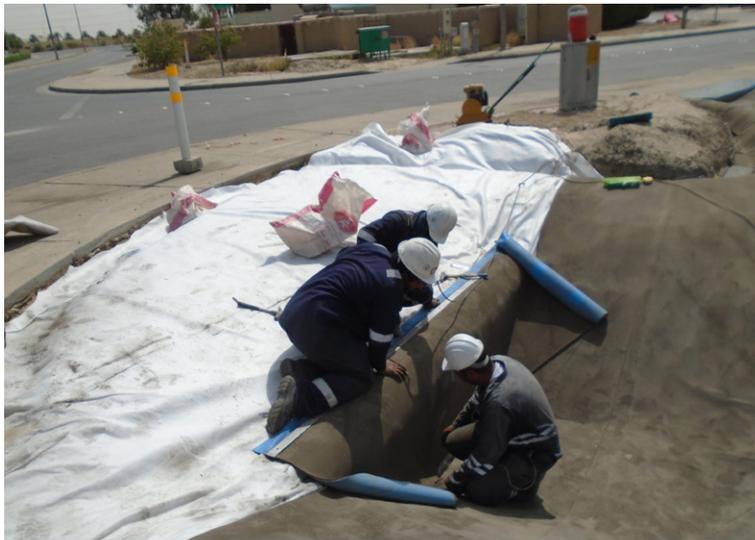
Fixing CCH to existing concrete infrastructure

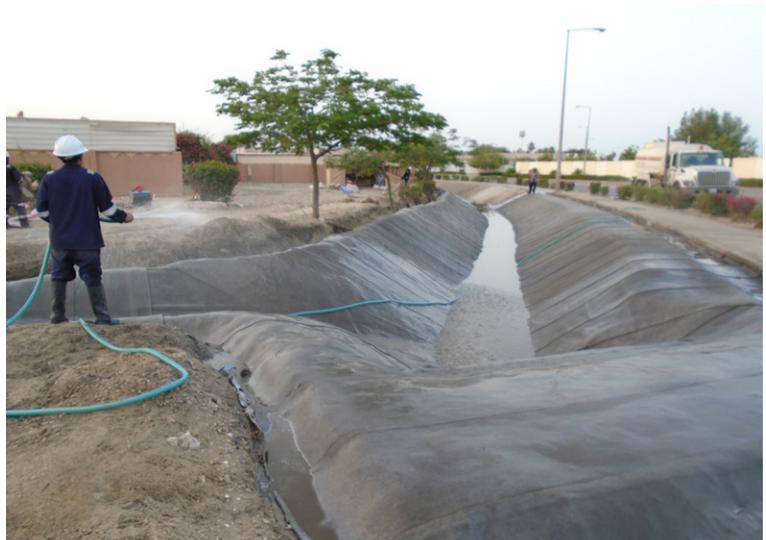
Hydration of CCH was carried out in the evenings

Following installation, the CCH material was hydrated; this was carried out in the evenings when temperatures were lower to prevent evaporation of the water used to saturate the material. Rehydration was also carried out one hour later. The anchor trenches backfilled with poured concrete; the anchor trench which runs adjacent to the side walk was also covered with gravel for a neater and more aesthetically pleasing termination detail.

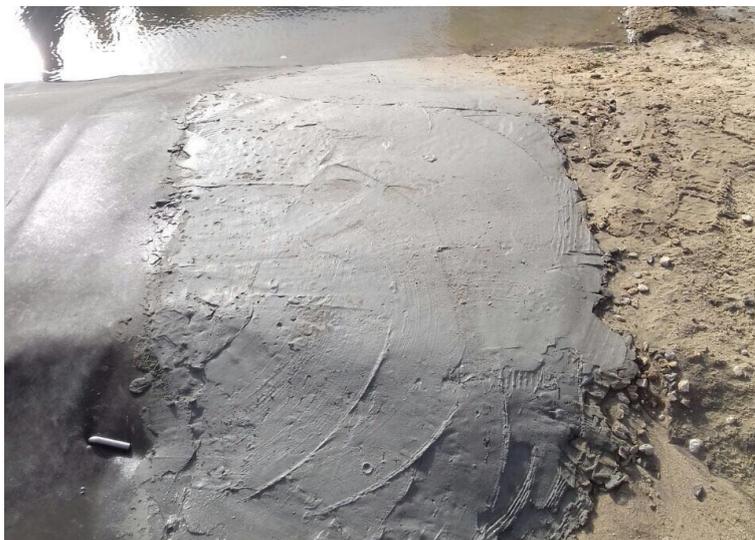
Anchor trenches filled with poured concrete

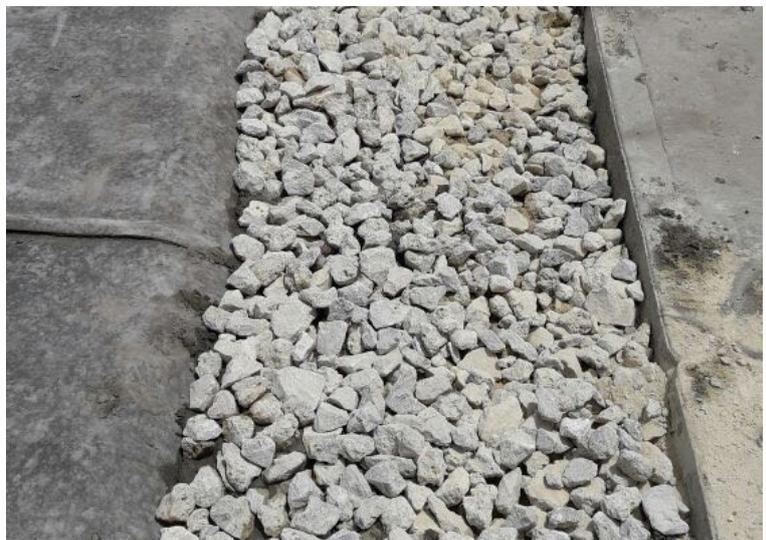
Gravel placed over poured concrete anchor trench for neater termination

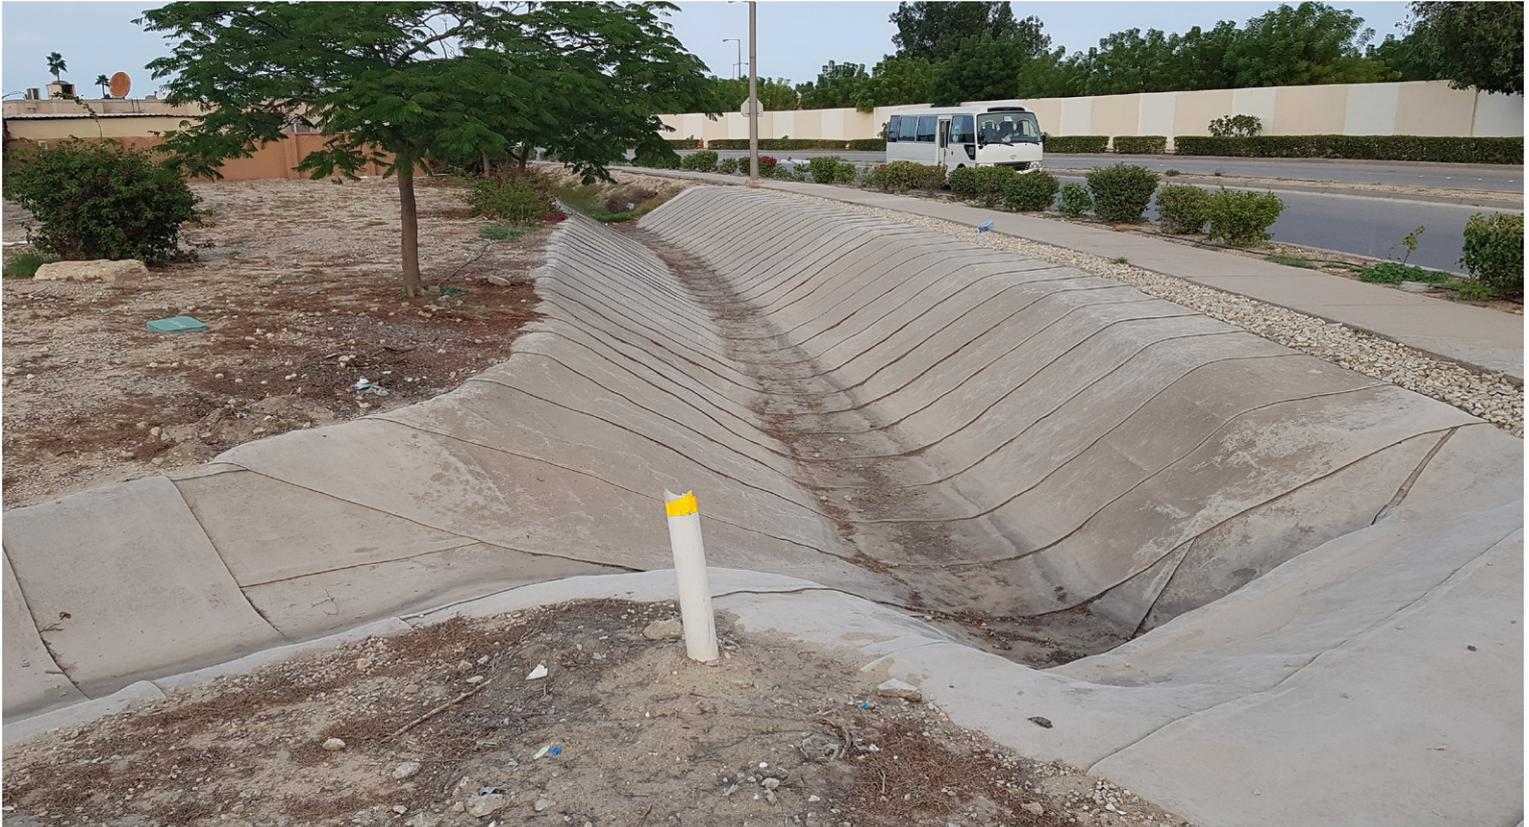
On a return visit to site in January 2020, the channel was found to be performing well

The contractor re-visited the site in January 2020, and found that the CC lined channel was still performing as expected and in good condition.
