Use of polymer Geogrid reinforcement in the foundations of ground supported tanks for control of differential settlement

Sam Bhat, Jimmy Thomas and Ron Skrobutan
Titan Environmental Containment Ltd., Ile des Chenes, Manitoba, Canada

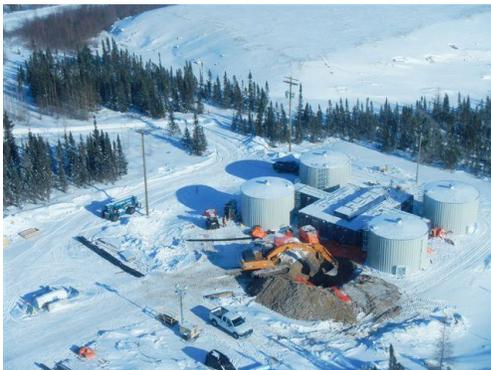
Figure 1. Aerial view of the completed facility

The Keewatinow start-up camp, which is located approximately 75 km north of Gillam, Manitoba, required two domestic water storage tanks and two fire water storage tanks. All four tanks were pre-fabricated tanks with a diameter of 7244 and height of 5126 mm and were to be directly supported on the ground (see figure 1).

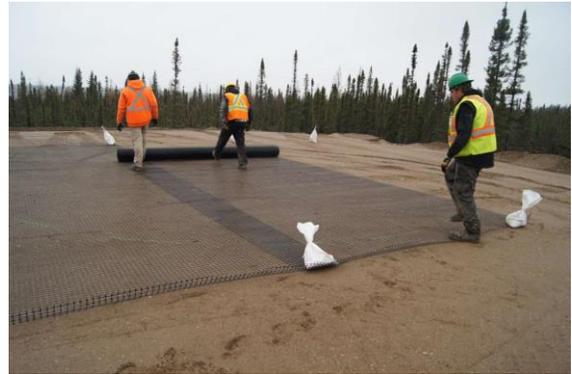
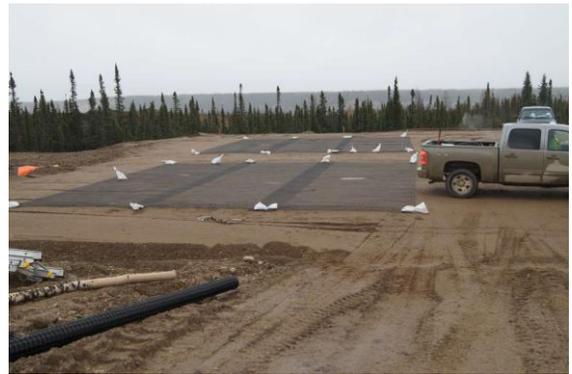
of standard Proctor maximum dry density. The first layer of HFM-BL2PP was laid without wrinkles and folds. Adjacent rolls were overlapped by 450 mm. Sand-filled bags were placed along the edges of the mat to hold it in position (figure 4). Granular fill was spread over the mats and compacted to a thickness of 200 mm. The second layer of HFM-BL2PP was laid and 150 mm thick layer of fill was compacted over it. No, special equipment or expertise was required for the installation of mats. The installation was easy and not affected by the extreme weather conditions.

Figure 4. Laying of Horizontal Foundation Mat HFM-BL2PP

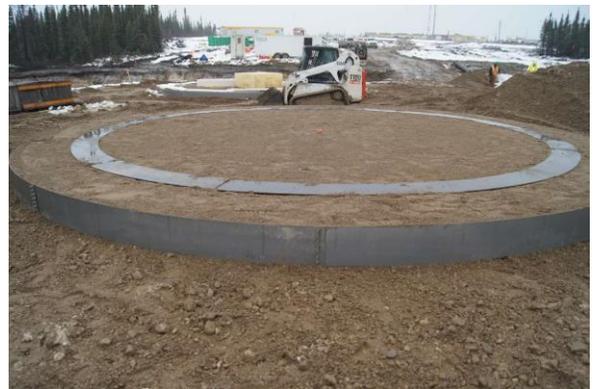
The grade band, gravel pad, non-woven geotextile and fibre board were installed over the reinforced granular raft (figure 5).

Figure 5. Construction of grade band completed and steel bearing plate installed.

The tanks would be placed on a compacted gravel berm contained in a retainer ring called a Grade Band, which is fixed to bolt channels embedded into ground. A ¼" thick by 18" wide laser cut and perfectly fitted steel bearing plate would be positioned on the level gravel pad so that the tank walls will sit directly in the middle of the plate. This would help to distribute the weight of the tank walls and roof to the granular foundation below. An 8oz non-woven geotextile TE-8(supplied by Titan Environmental Containment Ltd) would be placed above the bearing plate to cover the entire surface of the gravel berm. A layer of fiber board is placed over the geotextile to serve as cushion and protection for the coated steel floor plates.
