CC8 Bulk

Tazin Lake,
Saskatchewan

CC used to
armour and
waterproof weir
for SaskPower

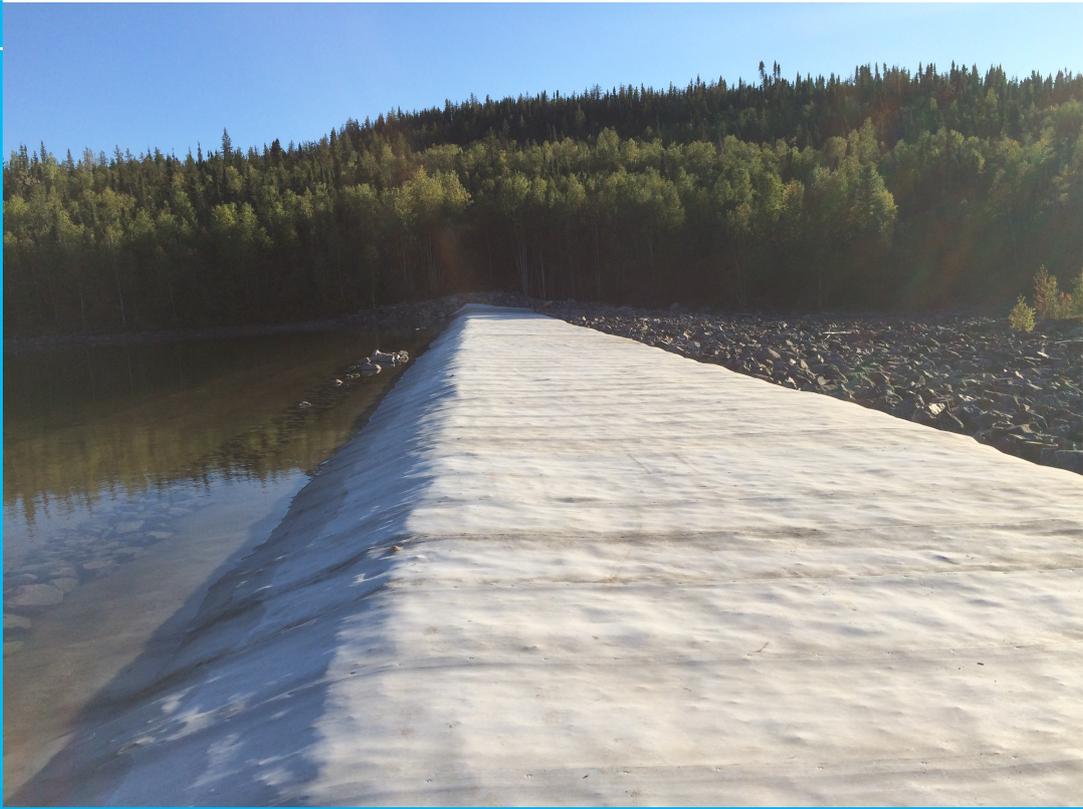
In August and September of 2015, Concrete Canvas GCCM (CC) was used to create a new weir for SaskPower. CC was used as the armouring and water resistance layer of the weir, placed over a dam structure that was built from sand and gravel.

The CC was laid perpendicular to the weir crest in full length sheets (11m) and anchored on both sides in a 0.5m deep trench which was subsequently filled with rip rap. Overlap seems were sealed with SikaFlex 1A sealant and screwed together at 0.3m intervals.

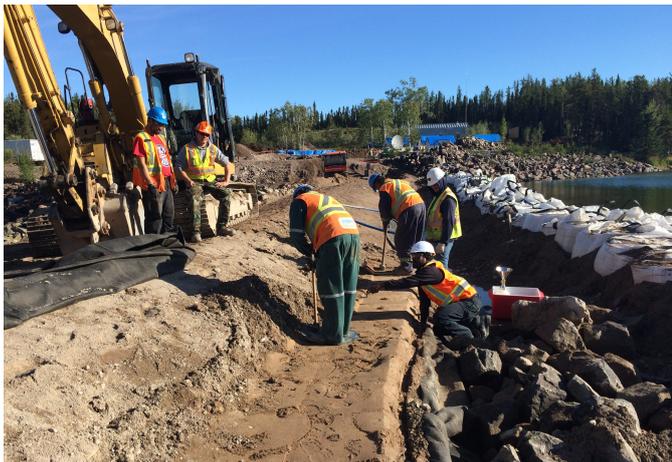
Limited working area on site

Access to the installation area was very limited by the location of the coffer dam on one side and limited by reach of the excavator. Installation happened in stages. The geotextile was laid out first, then panels were placed within short reach of a CAT 314 that positioned rip rap in the anchor trench. The crew would complete a section and then move along the weir and repeat.

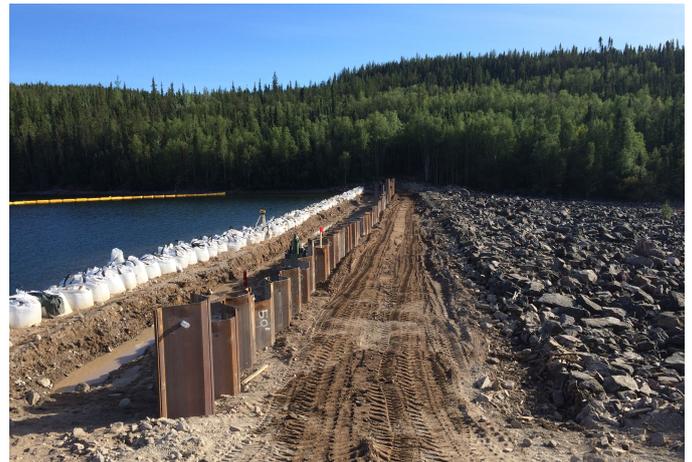
Site preparation

Installation occurred in variable weather including light rain. Estimated temperature ranged from 15-22 degrees Celsius over a period of 8 days. Before CC was installed, a sheet pile wall was driven along the length of the weir. Excavation and replacement of existing lake bed for a depth of 300mm was completed, then the dam structure was built with local sand and gravel that was built up and compacted in layers.

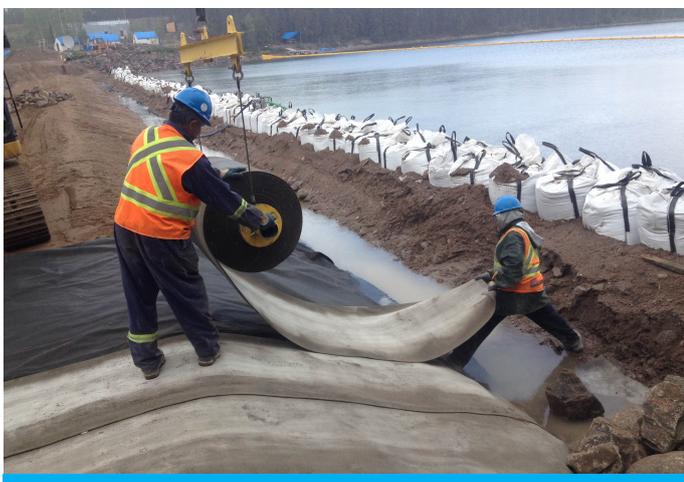
Unrolling Concrete Canvas

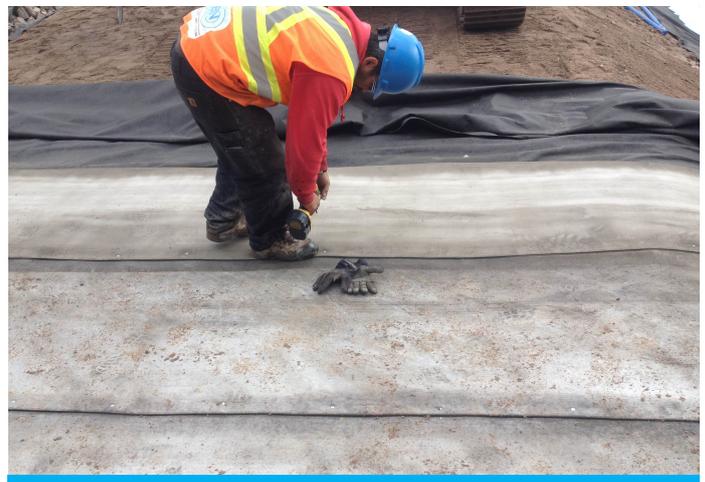
Securing overlapped CC joints

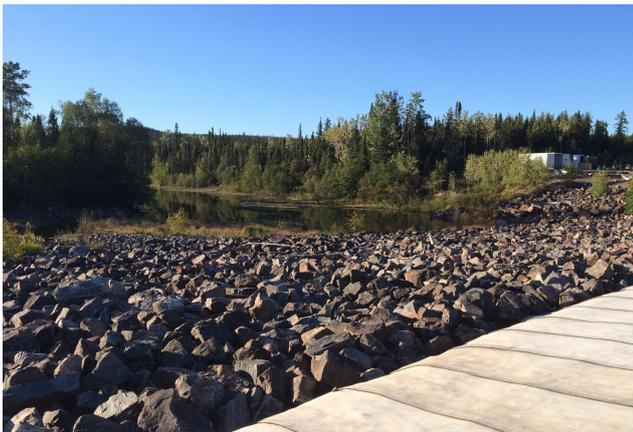
Rip rap placed to dissipate water flowing over weir

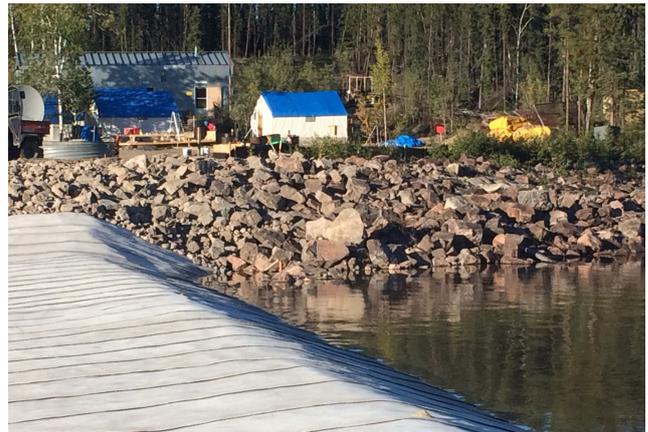
Completed weir -looking towards the lake side

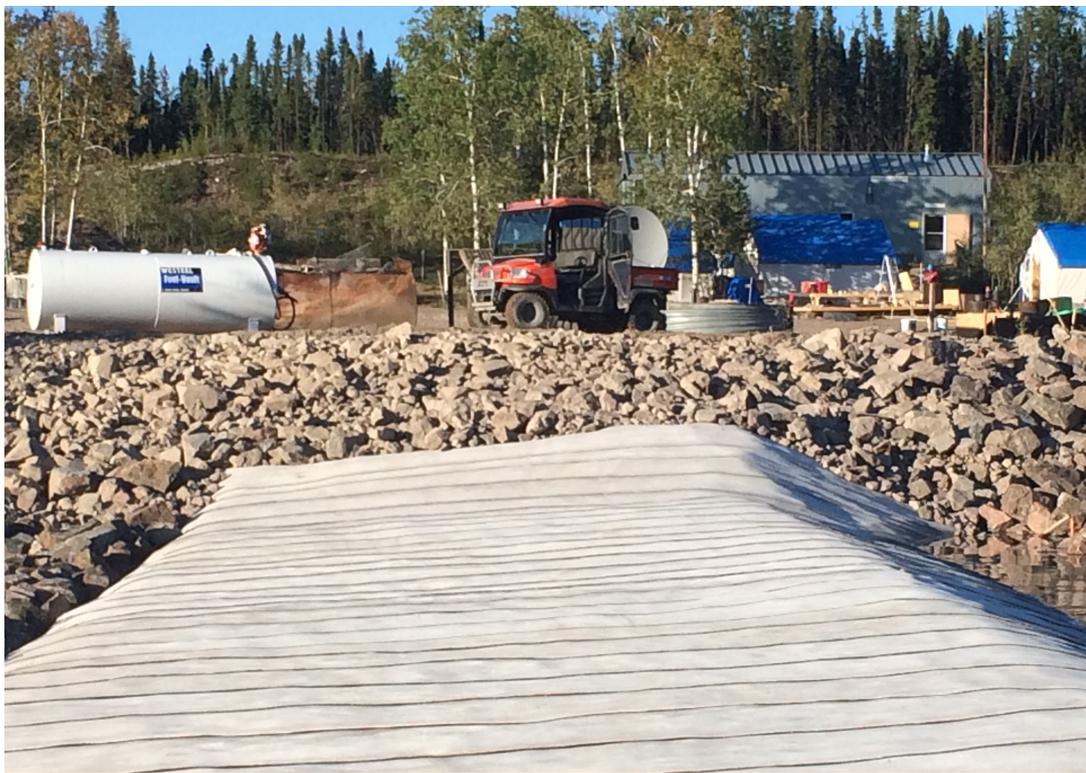
Full view of completed weir
