CC5™ Batched

North West
Alberta, Canada

CNRL

Remediation

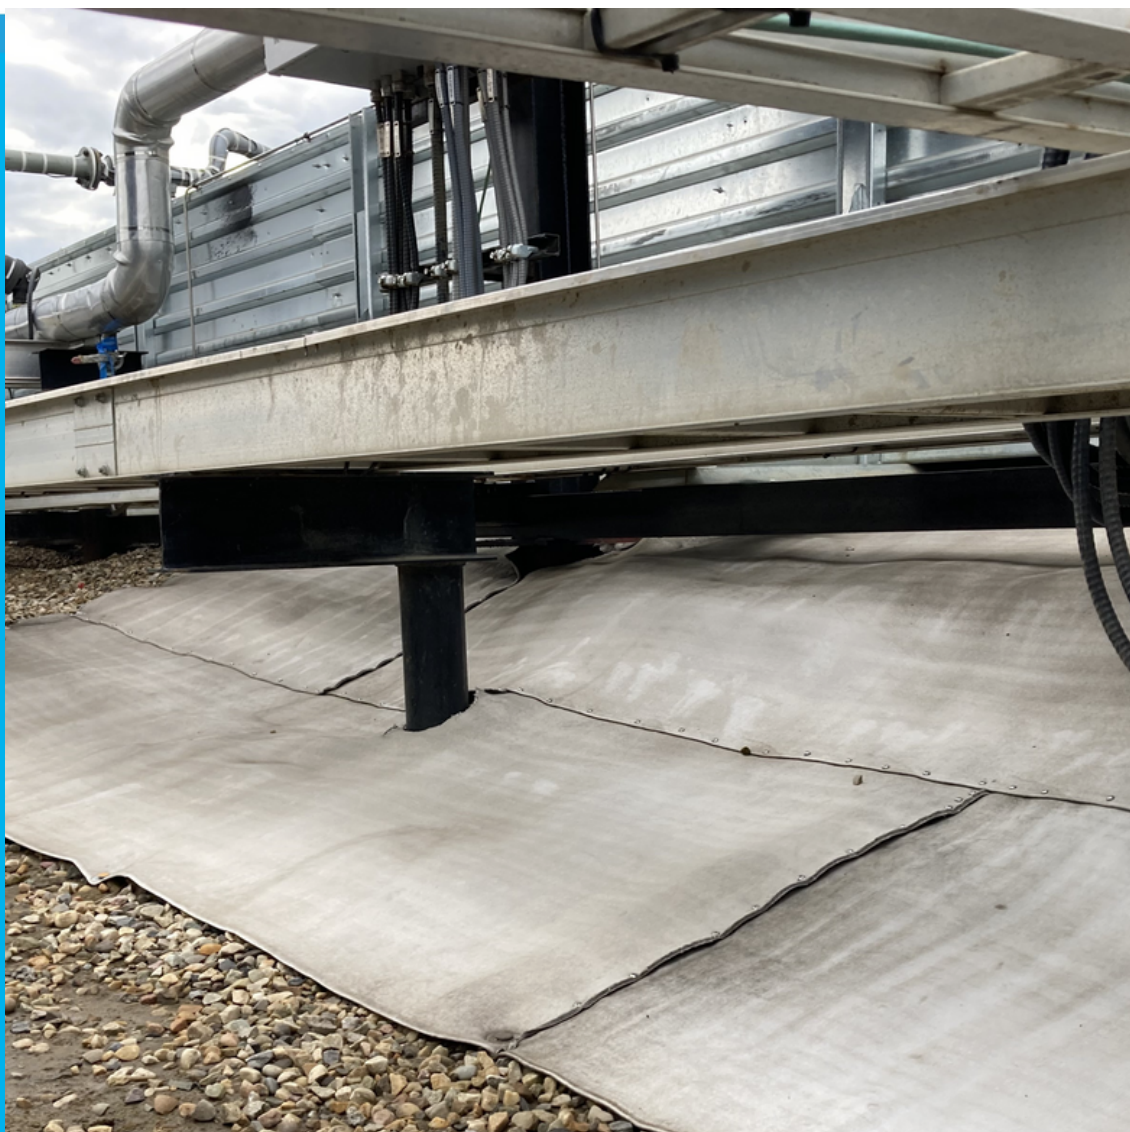
In August 2021, local contractors installed 91m² of Concrete Canvas® (CC5) to rehabilitate an existing tank farm on a concrete pad. The soil surrounding the tank farm was eroding and starting to undermine the concrete pad so CC5™ was chosen as a hard armor erosion protection solution

Before laying the CC rolls, the installation team walked around the pad and filled in all the areas where the soils had eroded, then packed the fill down. CC rolls were then laid under all the piping and existing equipment, and attached to the concrete pad.

The tight working area and the need to work around existing infrastructure made this a detailed task, however, CC's portable batched rolls and the fact that this product can be installed without the use of heavy machinery made for a seamless installation.

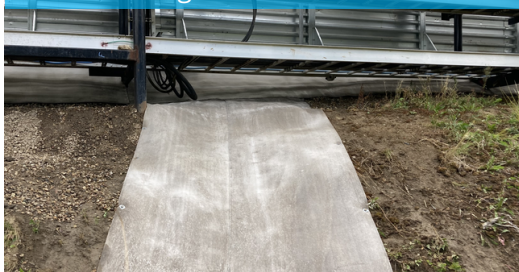
CC5™ laid longitudinal

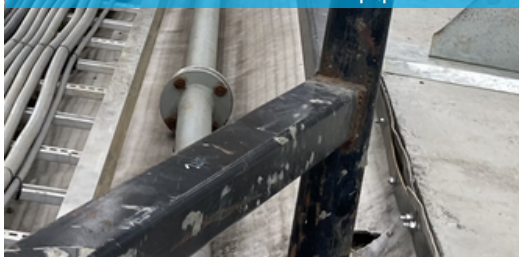
CC5™ laid transverse under pipe sections
