## Project Info

Caltrans District Three Maintenance Dept.

CC used to remediate an existing concrete channel required to control road surface water runoff

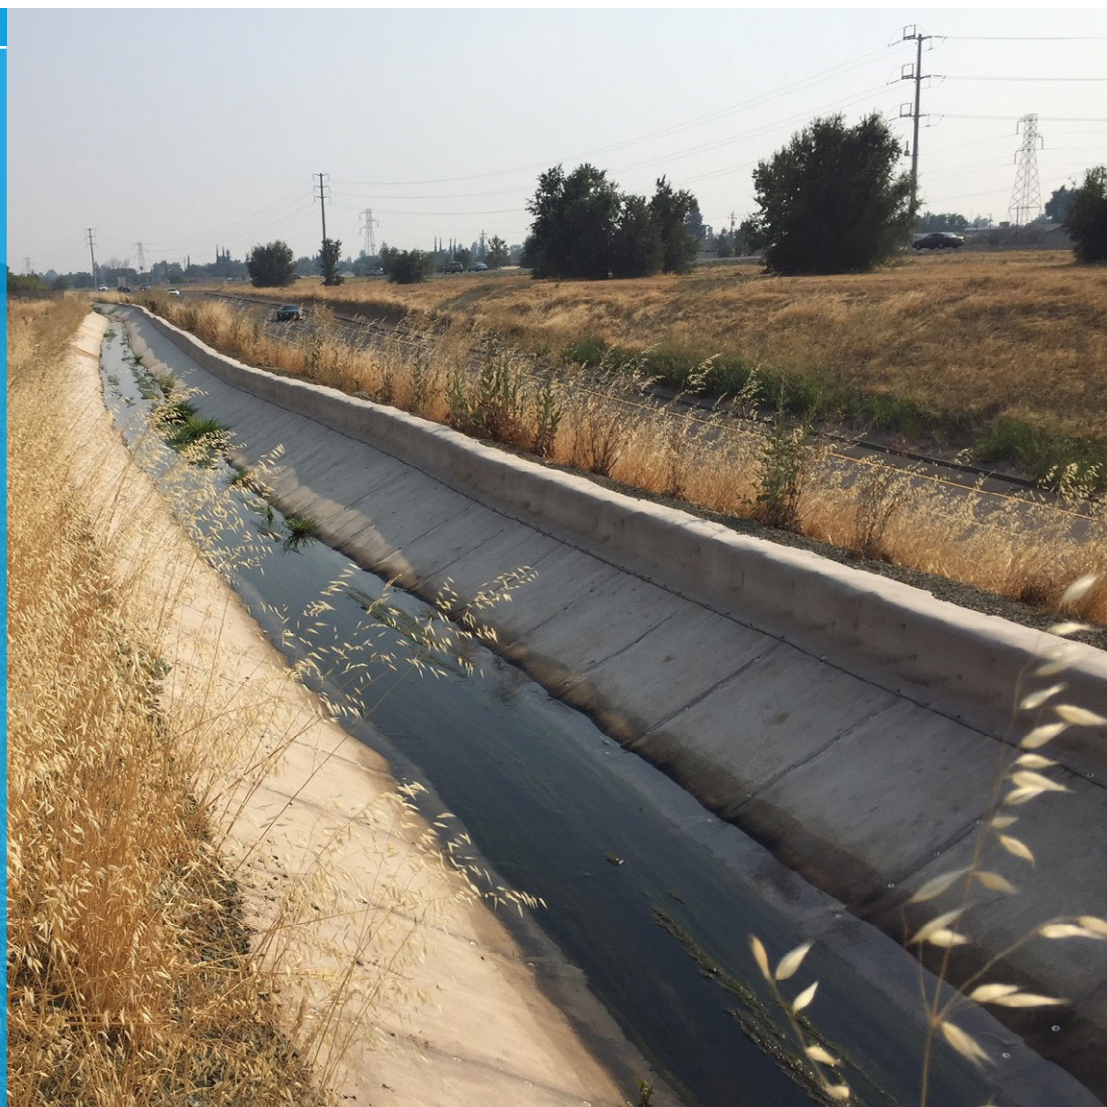
Completed channel revisited

The transportation engineer for Caltrans District Three revisited the site two months after the completion of the project and was pleased with how the CC looks and was satisfied by its performance. The department is also looking at using CC for other applications, including culvert lining, swale and channel protection, weed suppression below guardrails, and slope protection.

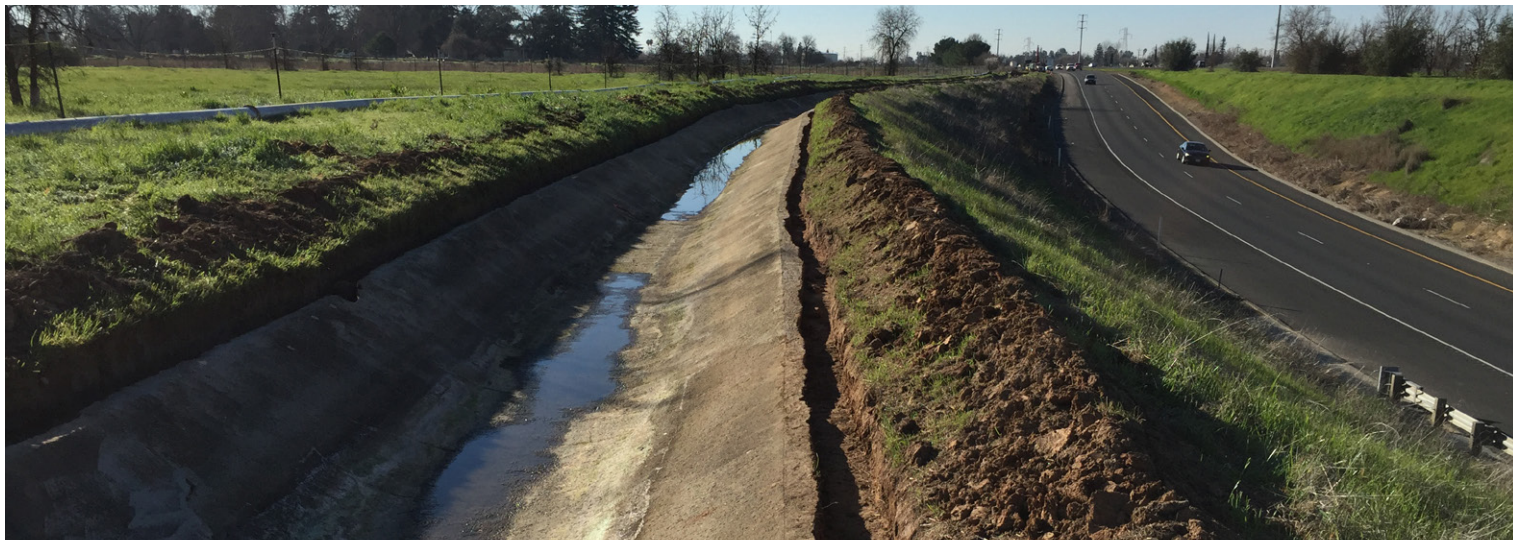
*Channel prior to installation*

The existing channel was de-vegetated, anchor trenches created at the shoulders of the channel and major cracks and damaged sections were filled with a quick-set concrete fill material to avoid voids below the CC material.

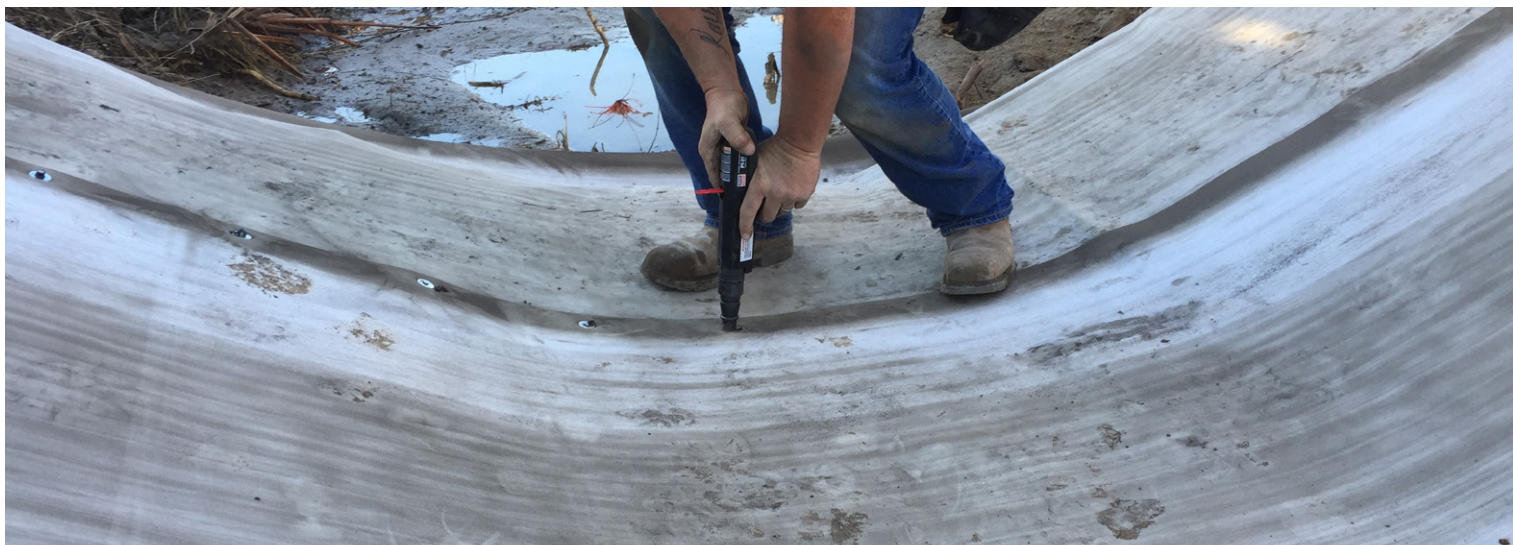
*Joining of overlaps*

The CC was then deployed from crest to crest, with overlaps facing the direction of waterflow to prevent ingress. The edges of the material were captured within the anchor trenches while overlaps were sealed using caulk and fixed to the existing concrete swale using masonry nails.

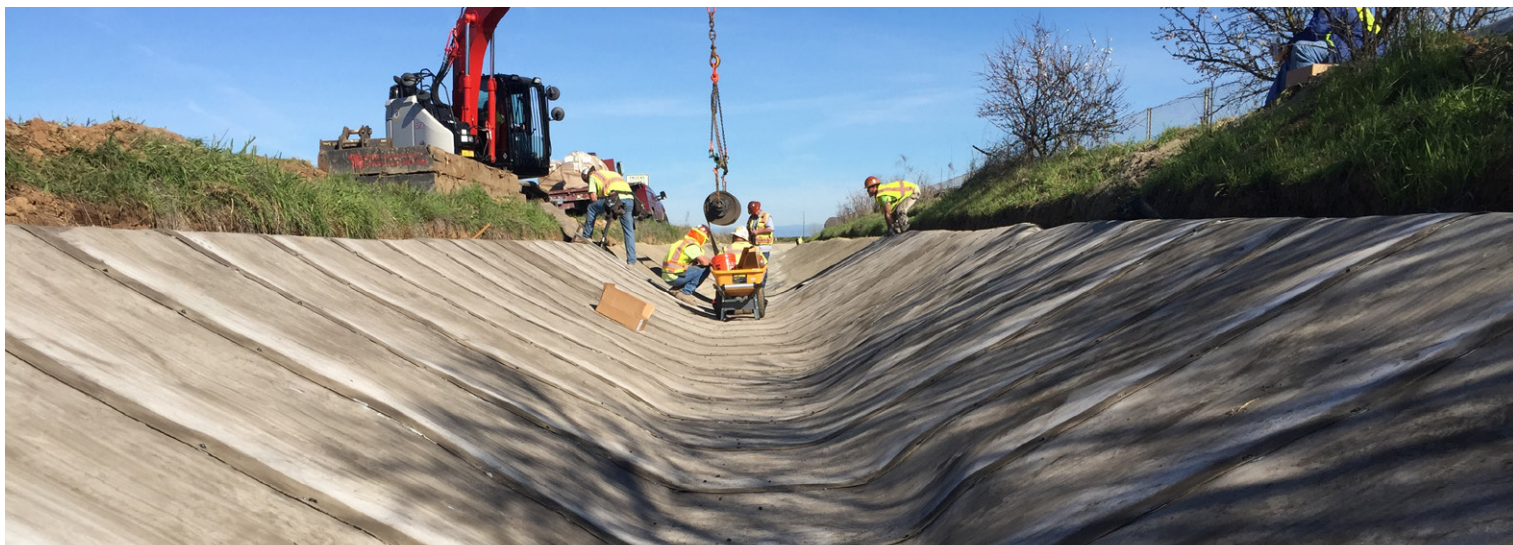
*Deployment of CC bulk roll*

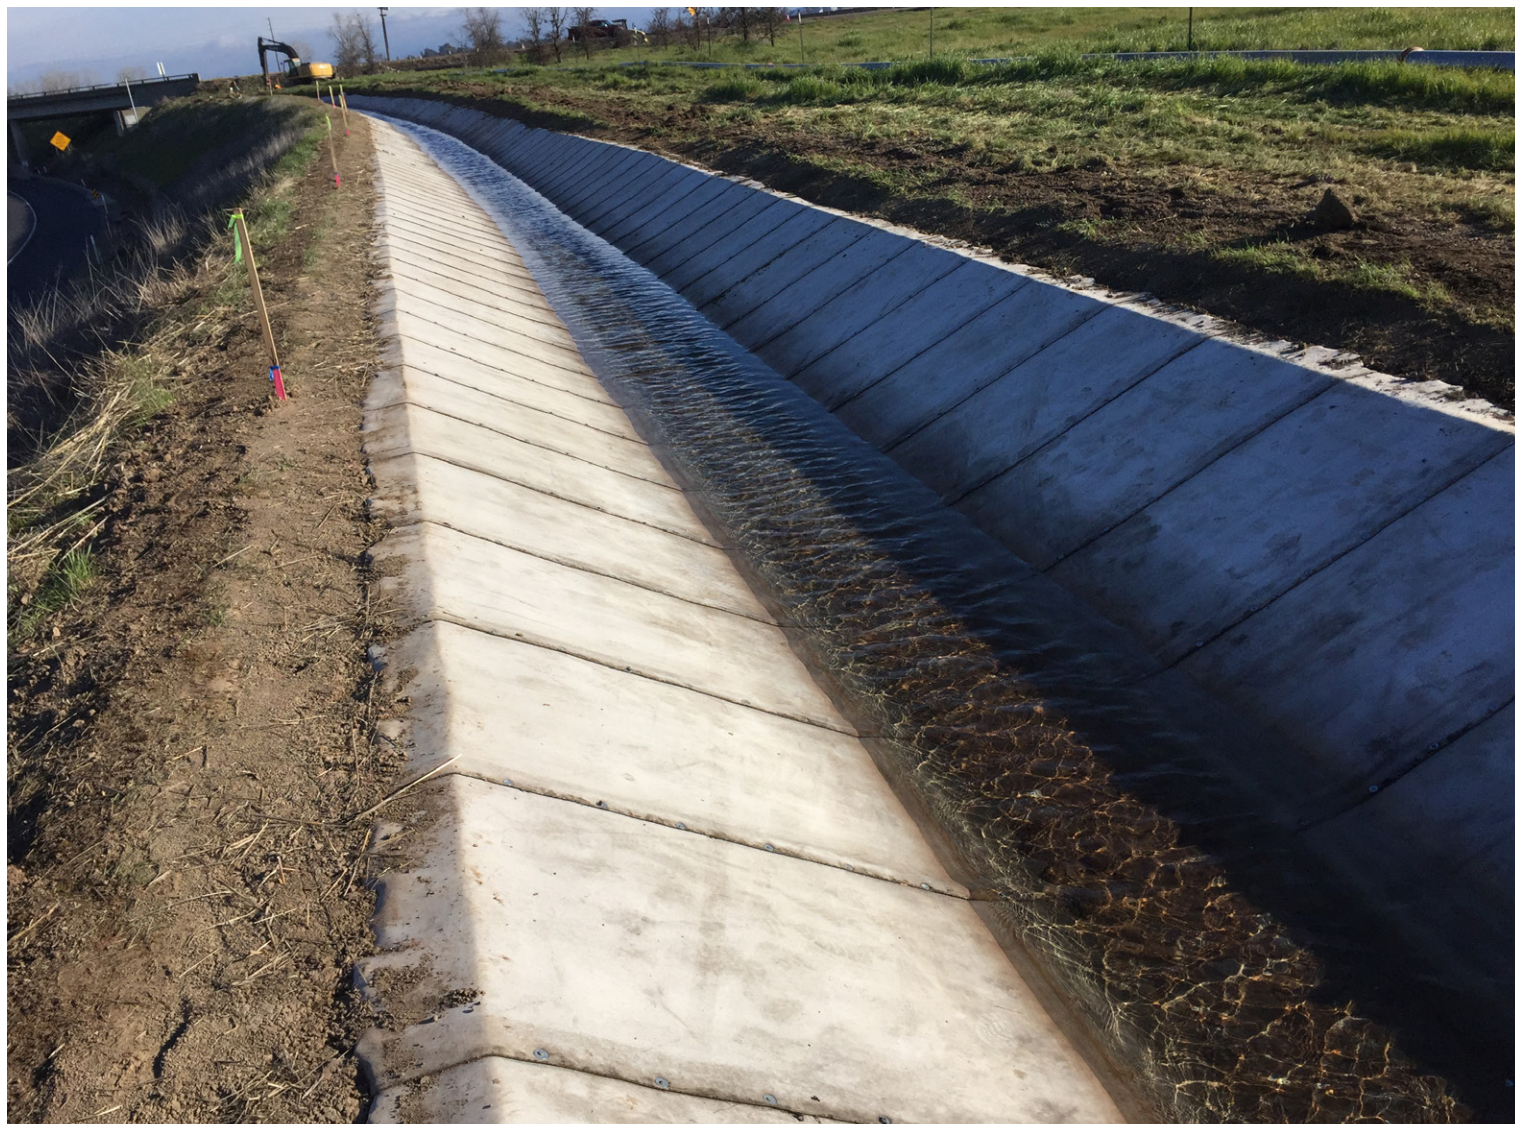
Completed channel

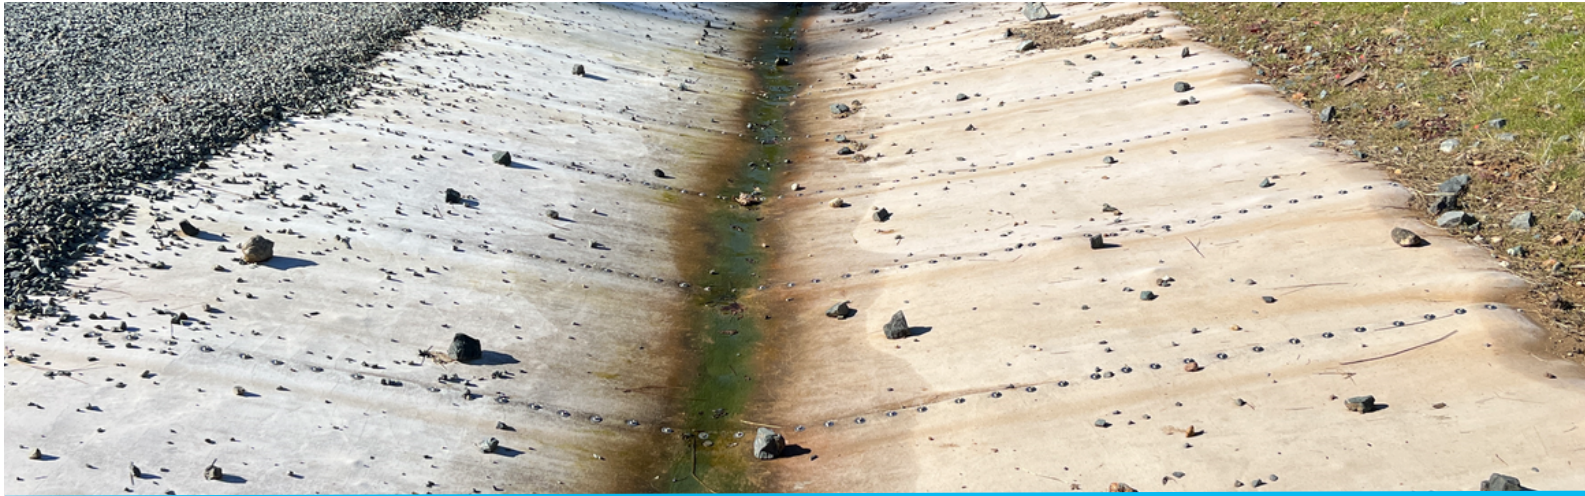
*Five years after installation*

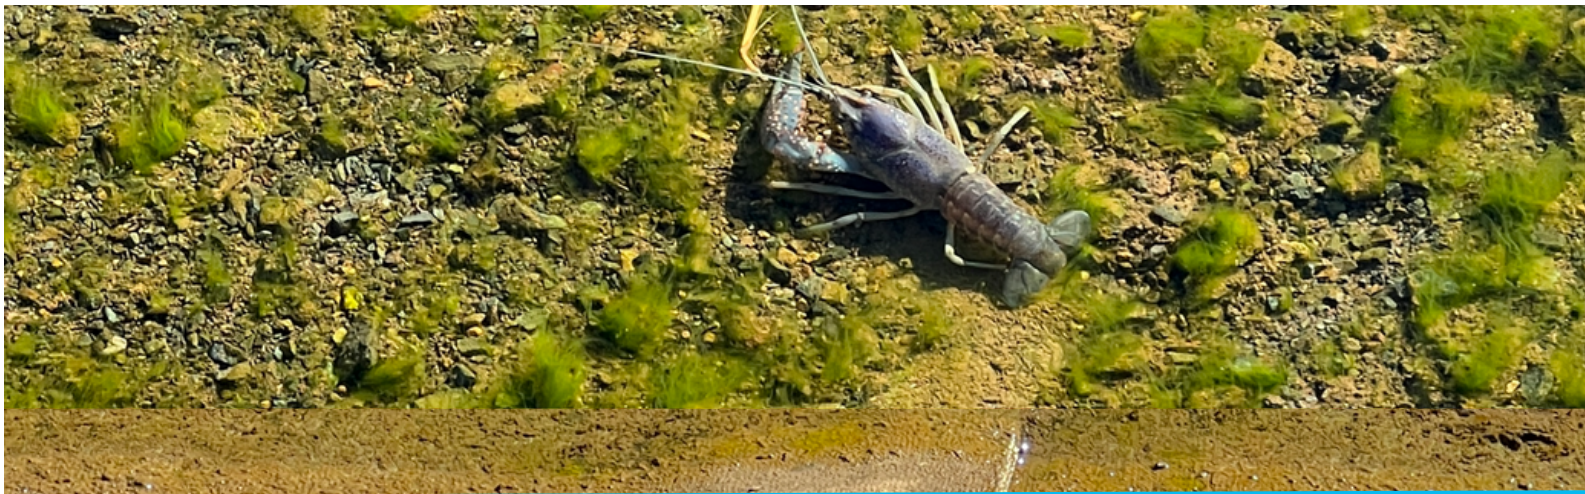
*After five years of operation with vegetation*

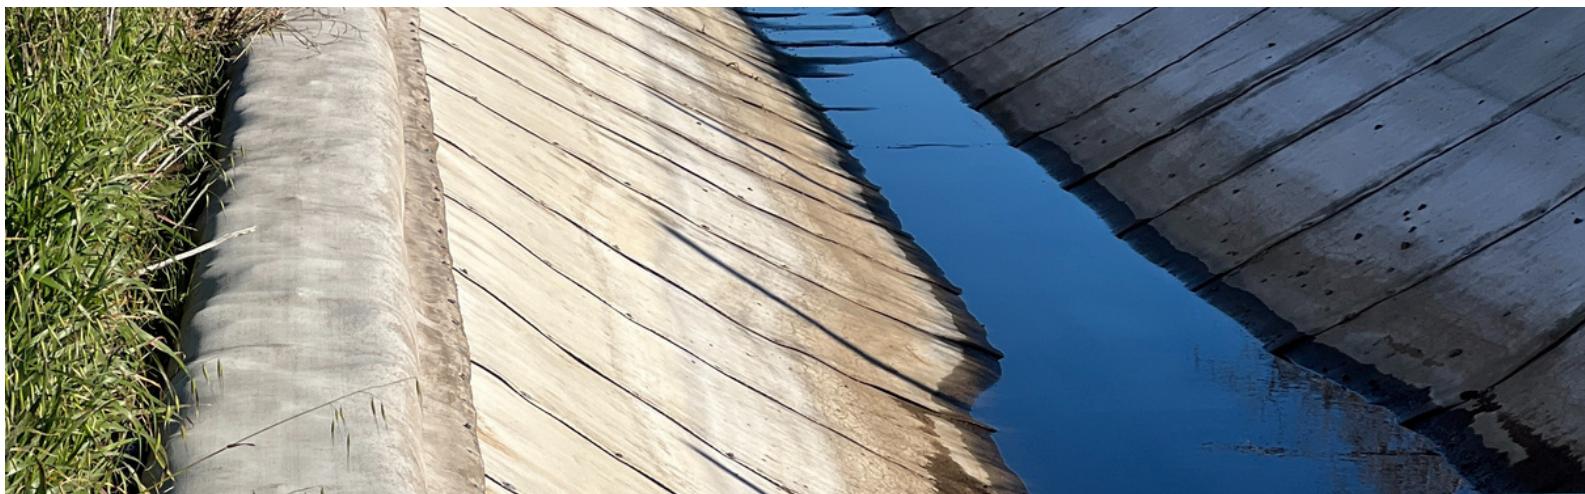
*After five years of operation with waterflow*
