CC8

Slope protection

Cobourg, ON

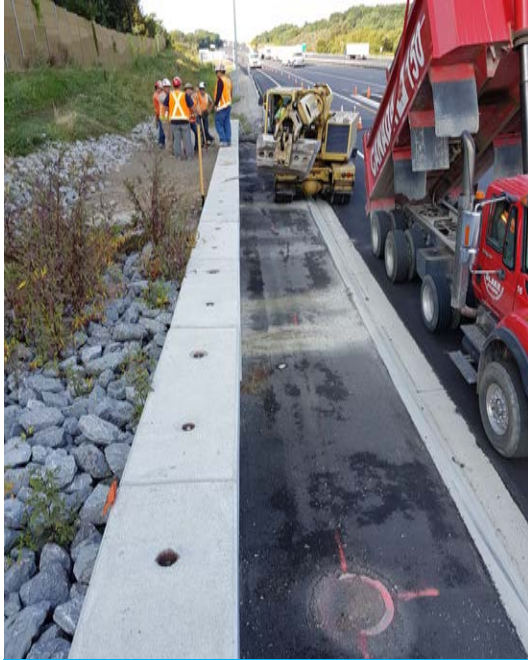
Site prior to installation

In August of 2017, 125 sq.m of 8mm bulk roll Concrete Canvas (CC) GCCM, was installed by Aecon Construction, for an MTO project, to seal behind a Retaining Soil System (RSS) Wall located by an off ramp on the 401 highway in Cobourg, ONT. Here, surface water had been penetrating the RSS wall, flowing out onto the road surface. The existing rip rap and geotextile intercept ditch was failing to hold water back, causing extremely dangerous conditions for drivers in freezing temperatures. To address this serious safety concern, CC was installed as a ditch lining solution to help redirect water flow from the road to the adjacent ditch. It was chosen for its ease of use considering site access, and ability to be installed with little impact on traffic.

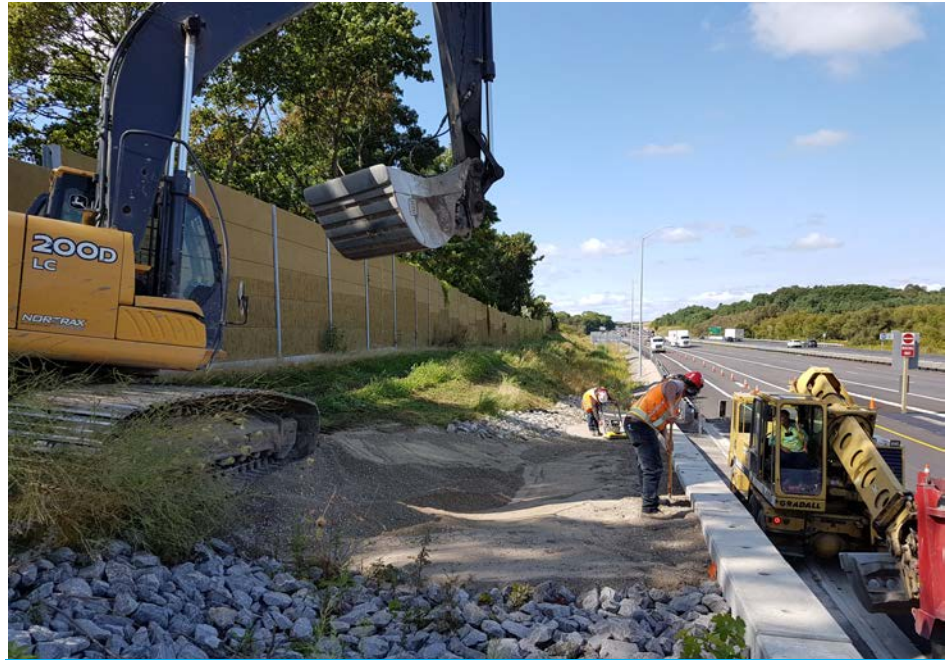
Removal of all vegetation and ground prep

Prior to installation all rip rap and vegetation was removed from the area. The soil was then compacted to provide a solid and even substrate. Using 4 installers and 1 excavator operator the CC was laid longitudinally up the slope running behind the RSS wall. It was joined on the seams using SikaFlex 1A sealant and a spike at every 30cm.

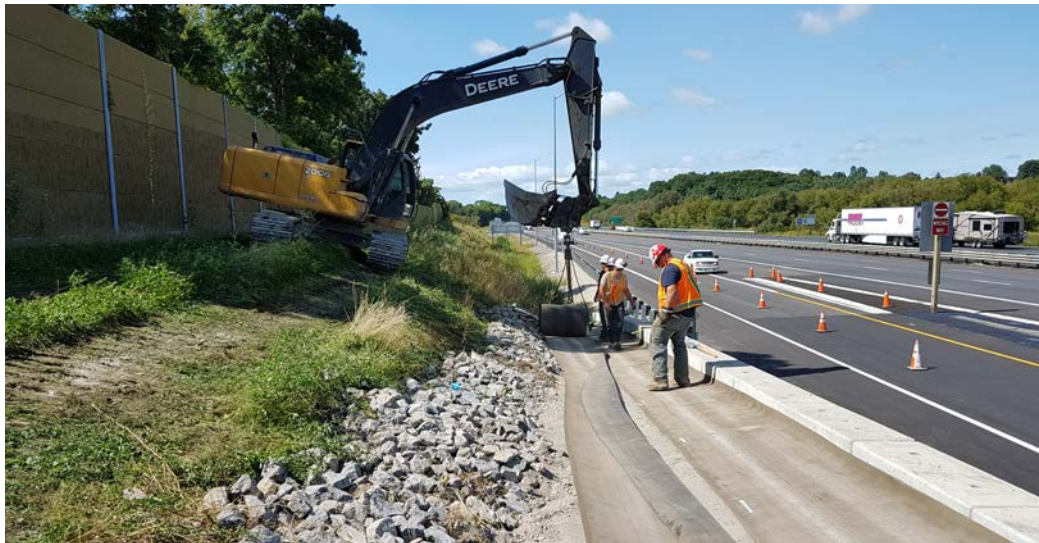
Longitudinal installation of CC

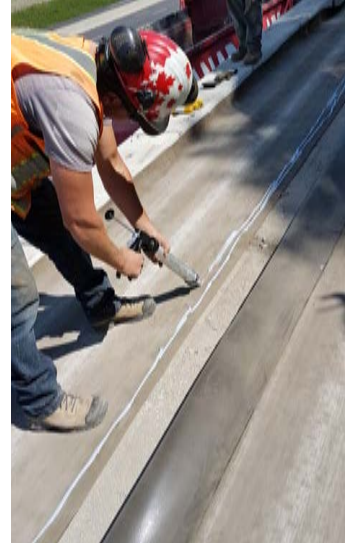
Sealant used to seal joints

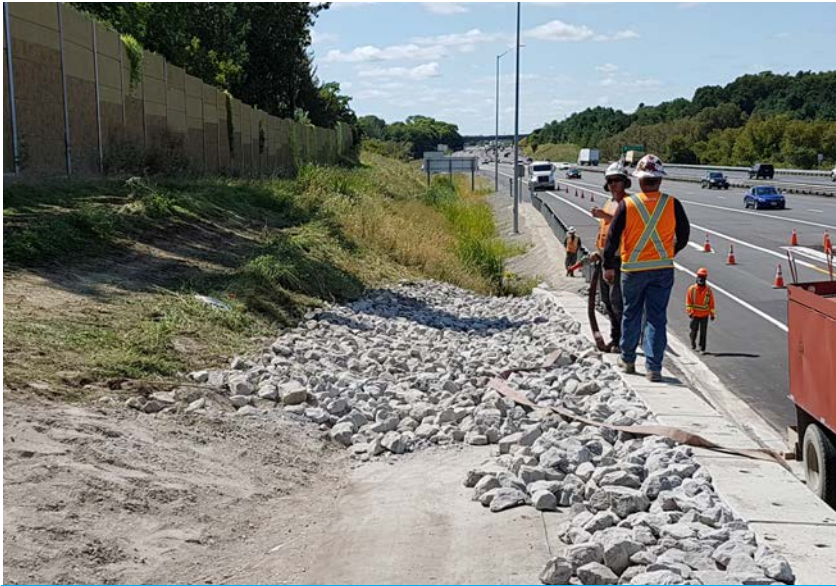
Rip Rap placed on CC prior to hydration

Rip Rap was then placed on top of the CC using the excavator prior to hydration. The total installation took 1 working day to complete.

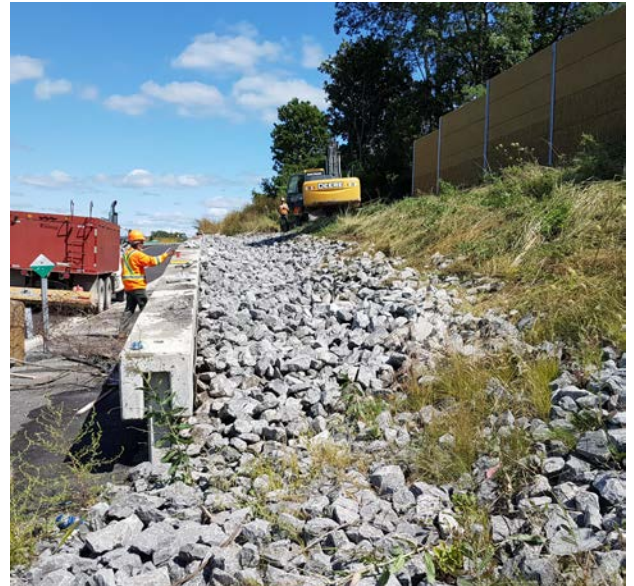
Completed rip rap placement

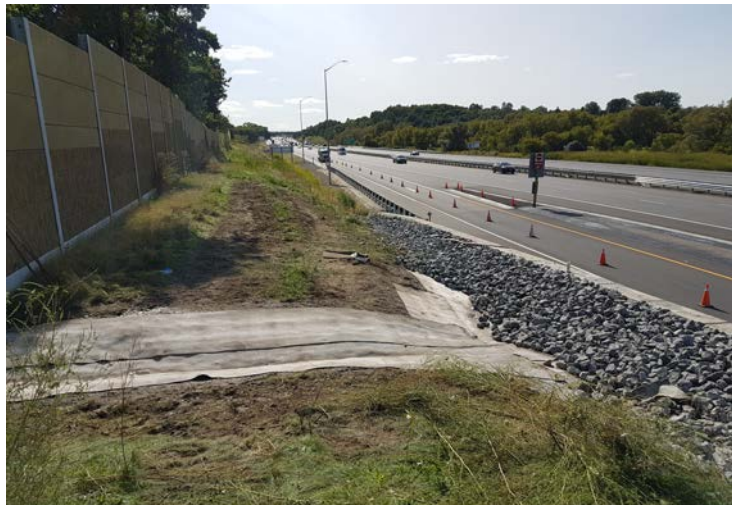
Top section joined to lower section in an L shape

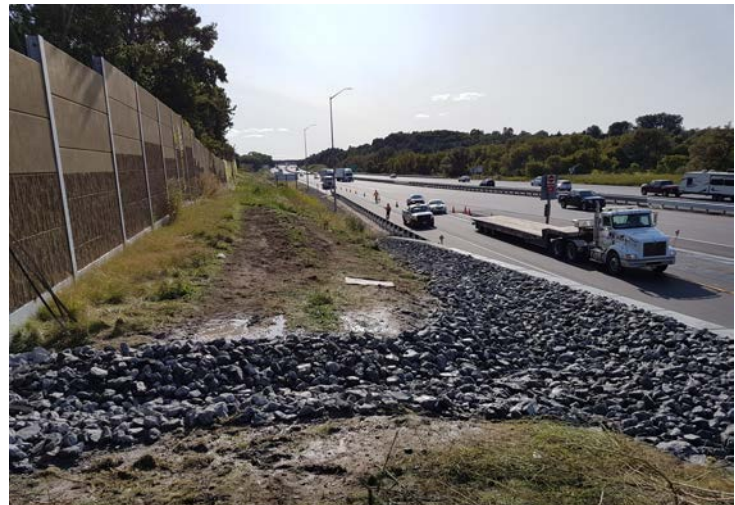
Completed installation
