CASE STUDY

Liquid Storage Tank Floor - Leak Detection Liner System

- ▼ **LOCATION:** Wonowon, BC
- ▼ **PROJECT TYPE:** Product Supply & Installation
- ▼ **PRODUCT USED:** 40mil Smooth LLDPE Leak Location Liner, Non-Woven Geotextile

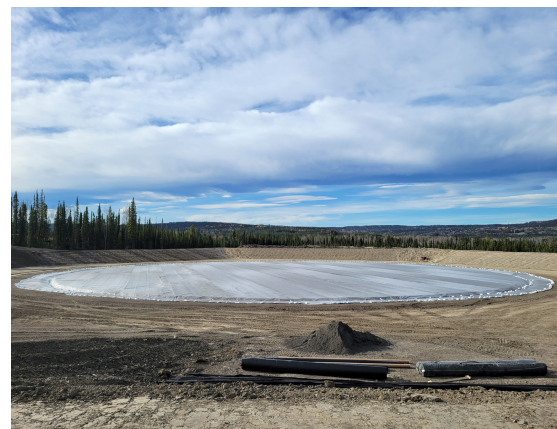
Titan supplied and installed a geosynthetic leak detection liner system for a storage tank floor containing hydrocarbon liquids. This system allows for frequent retesting, even after cover materials have been placed. The liner system involved layering 139,930 SF of non-woven geotextile, followed by 69,965 SF of smooth LLDPE Leak Location Liner.
