CASE STUDY

Drainage Channel

LOCATION: Aylesbury, Saskatchewan

PRODUCT USED: CCX-M®

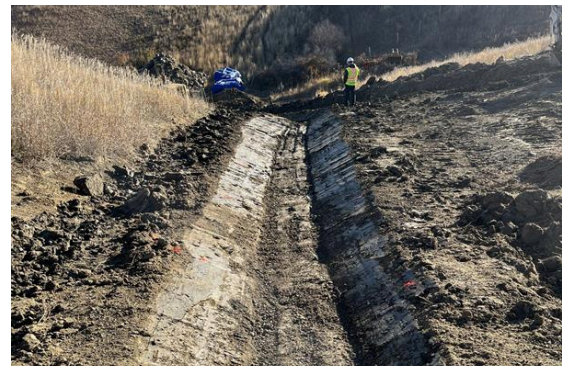
Before CCX-M® Installed

A severely eroded drainage channel along Highway 11 needed urgent attention. Water erosion had compromised the channel's structure, destabilizing the bank and threatening the stability of this vital route between Regina and Saskatoon in Saskatchewan. Given the highway's importance and the safety risks associated with ongoing erosion, a durable, long-term solution was essential.

The project site, located on a steep ravine, was exposed to constant erosion from multiple culvert outfalls along the slope. This erosion undermined the highway's structural integrity, necessitating an immediate and robust solution.

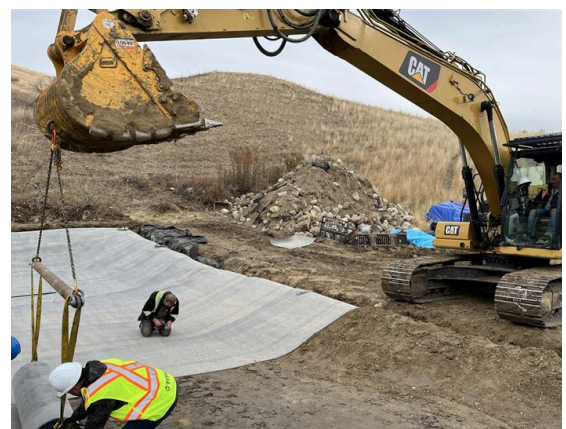
CCX-M® Being Installed

Titan proposed and implemented the use of Concrete Canvas® CCX-M®, an innovative and highly durable material ideal for erosion control and slope stabilization. Beginning with a collaborative design process in October 2023, Titan worked closely with the project team to finalize plans by July 2024. The installation, which began in October 2024, involved 700 m² (7,534 ft²) of Concrete Canvas® deployed across the rock pool and slopes of the drainage channel.

The installation process included pre-excavated v-trenches and anchor trenches to create a solid foundation. All debris and large stones were removed to ensure the Concrete Canvas® would lay evenly and bond securely to the surface. The material was installed horizontally across the slope and reinforced with Grippler anchors to maintain stability on the steep terrain. At the junction where the runs merged, the seams were carefully sealed and double-screwed to prevent ingress and ensure a watertight finish.

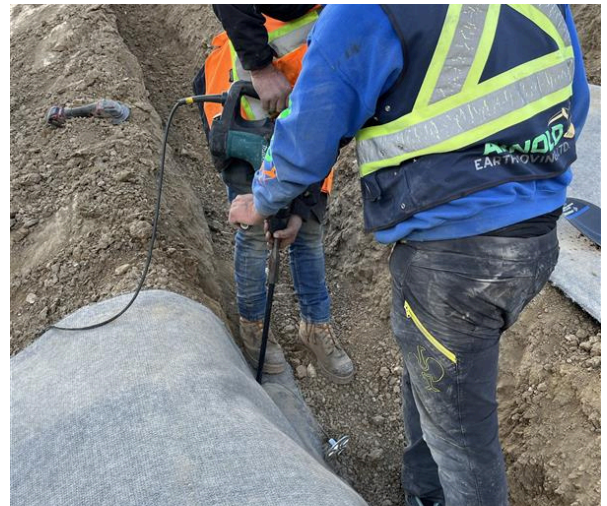
CCX-M® Being Anchored

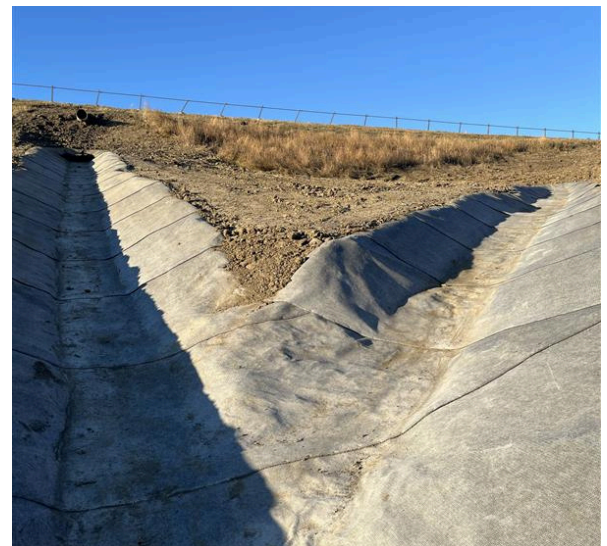
CCX-M® Merged

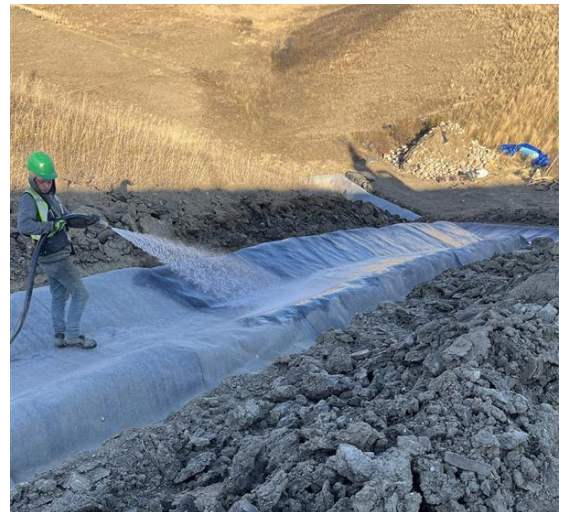
CCX-M® Being Hydrated

- **Steep Terrain:** Working on a steep slope required careful planning and anchoring to stabilize the Concrete Canvas®.
- **Low Temperatures:** Cold temperatures at night posed additional challenges, but installations during the day remained unaffected.
- **Water Supply:** Ensuring an adequate water supply on-site for installation was essential for activating the Concrete Canvas®.

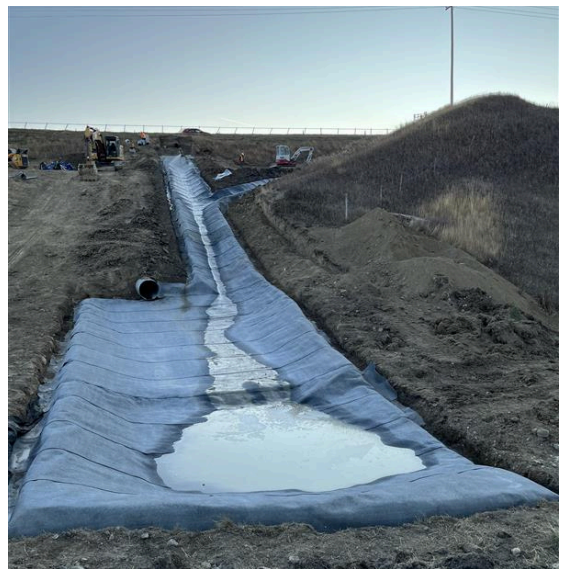
CCX-M® Completely Installed

Despite low nighttime temperatures and slowed progress due to anchoring on steep slopes, the project was executed efficiently despite challenges. The pre-excavated v-trenches and anchor trenches and meticulous debris removal provided a strong foundation for the installation. The result was a durable drainage solution covering 700 m² (7,534 ft²), reinforced with Gripple anchors on slopes and sealed seams to prevent ingress.
