The City of Calgary's early Experiences with use of Fiberglass Grids for Asphalt Pavement Rehabilitation

Venkat Lakkavalli P.Eng., Pavement Engineering, Construction, Roads – City of Calgary, Alberta, Canada
Sam Bhat & Jimmy Thomas, Titan Environmental Containment Limited, Manitoba, Canada

Geosynthetics 2018- 2nd International Conference on Technology and Application of Geosynthetics

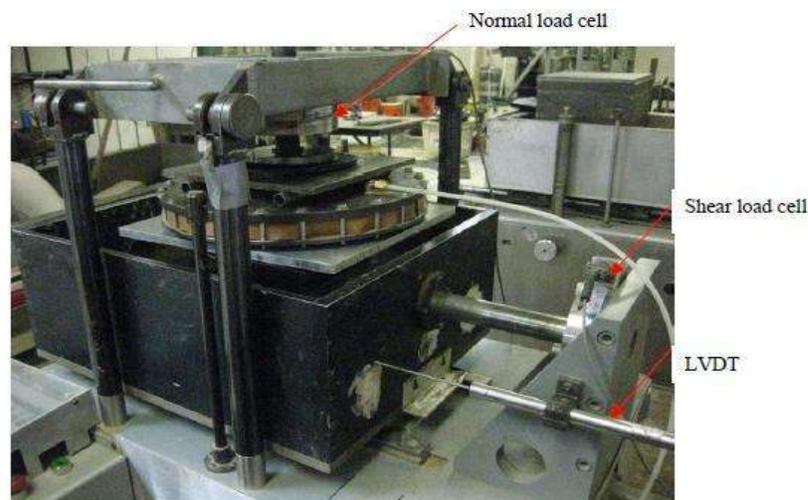
Cores of reinforced asphalt pavements were sent to SGI Testing Services (GAI-LAP accredited geosynthetics laboratory) Norcross- GA , USA to conduct interface shear testing as per ASTM D 5321 modified test method in order to determine the shear strength of the Fiberglass grid composite in the asphalt concrete. The test setup is shown in figure 9 and the core is shown in figure 10.

Figure 9 - Interface testing of reinforced asphalt concrete cores

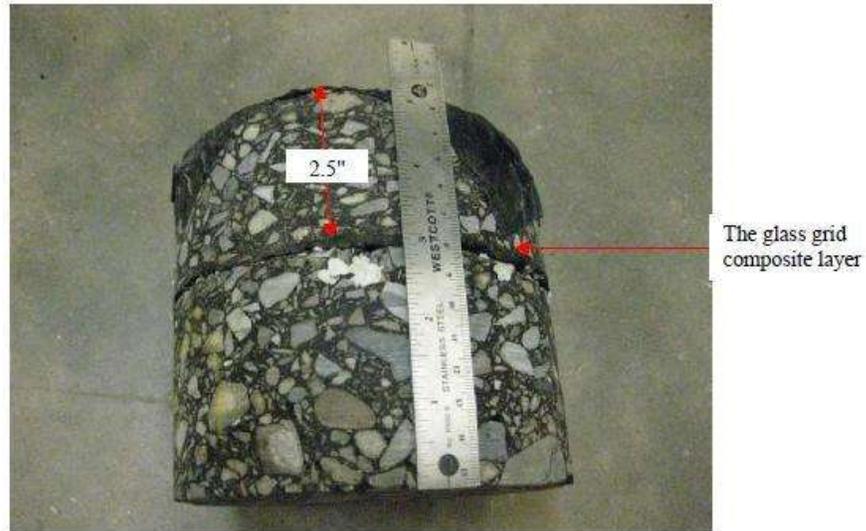
Figure 10 - Asphalt concrete core with fiberglass grid composite layer
