A Multi-Geosynthetics Sustainable Solution Case Study- ?apsčiik tašii (Upscheek Tashee)

Darryl Furey, M.Eng., P.Eng. WSP Canada Inc., Nanaimo, BC, Canada Sam Bhat, M.Eng (Tech Mgt), MIGS *Titan Environmental Containment Ltd, Toronto, ON, Canada* Jimmy Thomas, PhD *Titan Environmental Containment Ltd, Kochi, Kerala, India*

This paper presents a case study on technical, sustainability, and practical benefits of a multi-geosynthetics approach for Papsčiik tašii (Ups-cheek Ta-shee), a 25-km long, Multi-Use Pathway on Vancouver Island, BC, Canada. The geosynthetics based solution facilitated a reduced net CO₂ footprint primarily through protection of the sensitive rainforest ecosystem. While geosynthetics were used throughout, this paper focuses on the Wayii Segment where the pathway meanders between Veteran Class trees down a 23-m high foreshore slope with poor foundation soils, equipment access limitations, historical landslide activity and high seismicity. The design was flexible in response to tree root zones and ground conditions. Multiple types of geosynthetics were applied: knitted and polymeric coated, polyester uniaxial geogrids (Pyramid Grid[™]), high stiffness, polypropylen

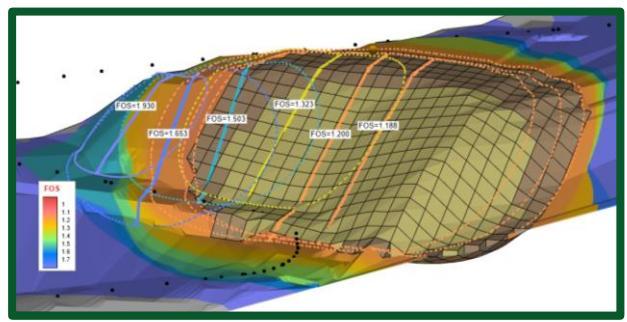
3D Limit Equilibrium Modelling (3D LEM), as illustrated in Figure 2, was used innovatively to quantitatively account for the beneficial geometric effect and resulted in cost savings relative to more involved Finite Element Modelling (FEM). Analyses indicated that a cumulative 30% increase in Factor of Safety for global stability would be achieved with the post-construction configuration relative to ambient conditions.

Figure 2. General view of typical 3D LEM Model Output

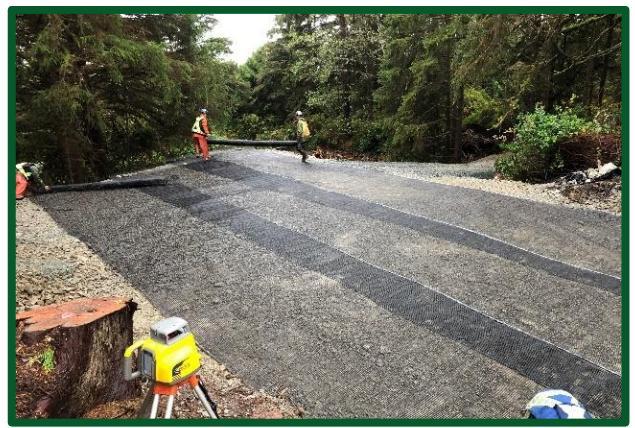
Geogrid reinforcement in the toe berm was a combination of high strength uniaxial geogrid aligned perpendicular to the strike of the slope and biaxial geogrid installed parallel to the trail centerline. A geotextile separator was installed at the interface of the buttress fill and the fine-grained natural soils. A veneer of granular fill was installed between the geotextile and the first layer of geogrid. The uniaxial geogrid was installed at a vertical spacing of 0.3 m with minimum 0.5 m overlap of adjacent grids and no joints permitted in the longitudinal direction (i.e. perpendicular to the slope). Geogrid was offset on each subsequent layer by approximately a third to a half a grid width to offset joints. Uniaxial geogrid extended from the cut slope to the front edge of the fill slope (Figure 3).

Figure 3. Photo illustrating installation of the uniaxial geogrid in the buttress.

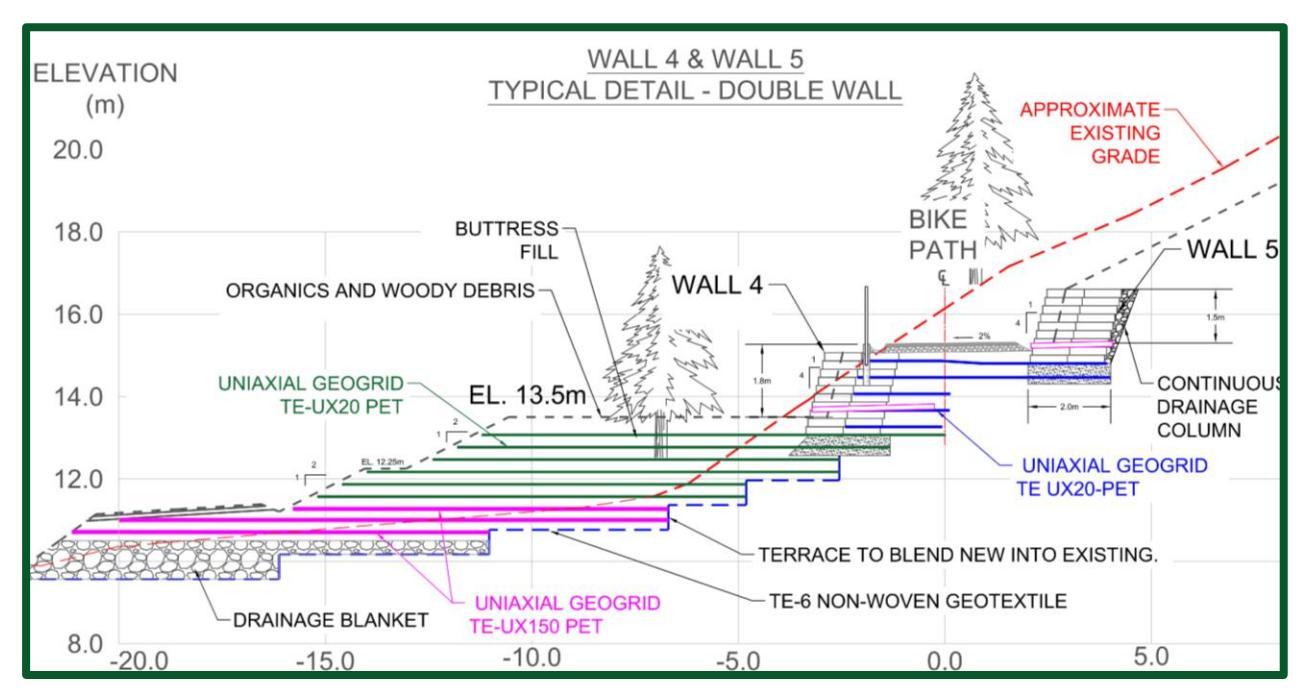
A typical cross-section illustrating the geogrid reinforced buttress, retaining walls and cut into the upper portion of the slope is shown in Figure 4. Further discussion on the biaxial geogrid is provided in Section 3.2 below.

Figure 4. General profile view of geogrid reinforced buttress, retaining walls, and cut into the slope. Note the multiple layers of geogrid with different strengths (different colours) and overall "integrated / connected" aspects of the system.

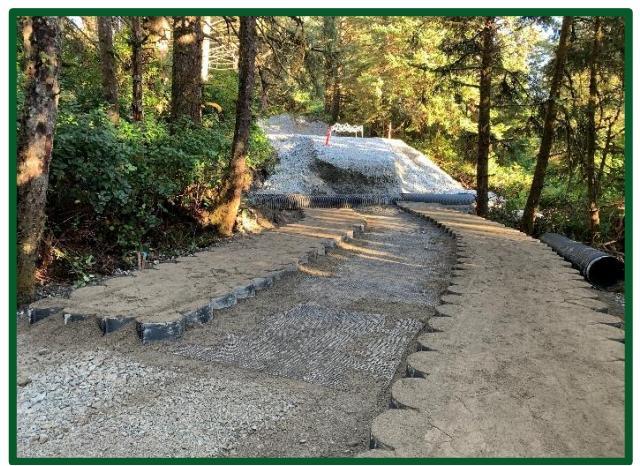
Near the base of the slope, a pair of walls was constructed on opposite sides of the trail to allow the trail to meander between trees rather than remove them (Figure 5). Geogrid layers were staggered, and lengths were modified to allow each wall to perform "independent" of the other. The MSE wall system with geocell facing was selected due to its flexibility in adjustment of alignment, ability to be moved and placed manually as needed, and its planting pockets that were created through stepping back each row.

Figure 5. Photo illustrating segment of trail with back to back retaining walls near the toe of the slope where trail meanders between trees. "Mushroom Cap" configuration was used locally on these walls (Refer to Section 4)

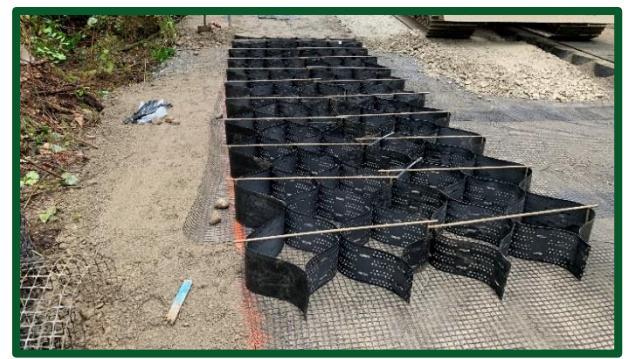
Placing and filling of geocell facing units are illustrated in Figures 6 and 7.

Figure 6. Photo illustrating typical layout of geocells prior to filling and compaction.

- Manual layout of the geocells with spreader bars and shaping to achieve the proper alignment.
- Placement of the geocells into position and zap strapping them to the adjacent constructed section of wall.
- Infilling the geocells with 19 mm minus, crushed sand and gravel and compacting. Slight overfilling allowed for the granular fill to consolidate and achieving a full cell after compaction.
- Placement and stretching of uniaxial geogrid.
- Placement, infilling and compaction of the next row of geocells on the geogrid.
- Placement and compaction of 0.2 m thickness of granular backfill the uniaxial geogrid after it has been pulled hard.

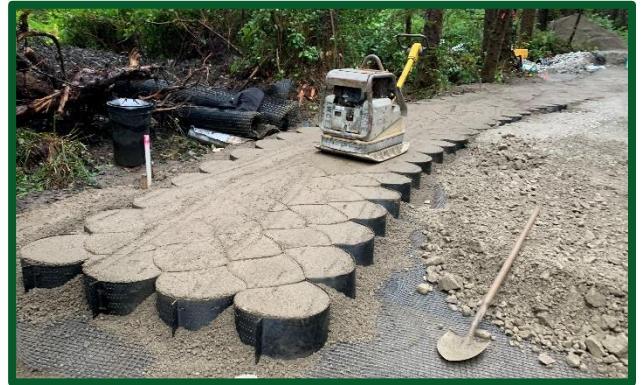
Figure 7. Photo illustrating typical wall construction.

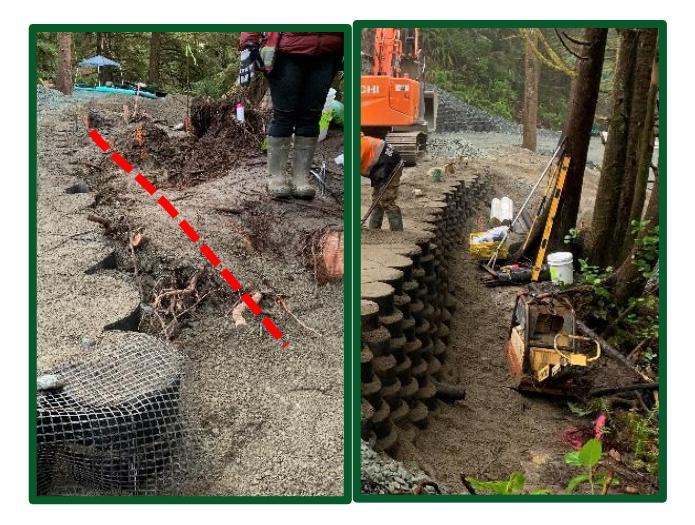
Figure 8.

The flexibility of the geocells and ability of the geocells to spread out loads and pressures led to innovative use of a "mushroom cap" configuration adjacent to tree root systems to avoid removal of trees or reduce impacts (Figure 8). The concept involved:

- Excavation towards the trees until encountering significant roots that should not be removed.
- Construction of the lower buried portion of the wall with geocells vertically in a couple of lifts to get to just above the roots.
- Placement of bedding sand to allow moisture and oxygen into the roots from ground surface.
- Subsequent lifts of the wall would step out a quarter to half a cell over the roots each lift until the design front face of the wall was achieved. Stepping out in this manner allowed for load transfer back to the main grid bearing on competent ground avoiding significant vertical loads over roots.

- Left Buried portion of mushroom configuration. Red line is approximate future front of wall over the roots.
- Right View of MSE wall after stepping out with "mushroom configuration" at same location.

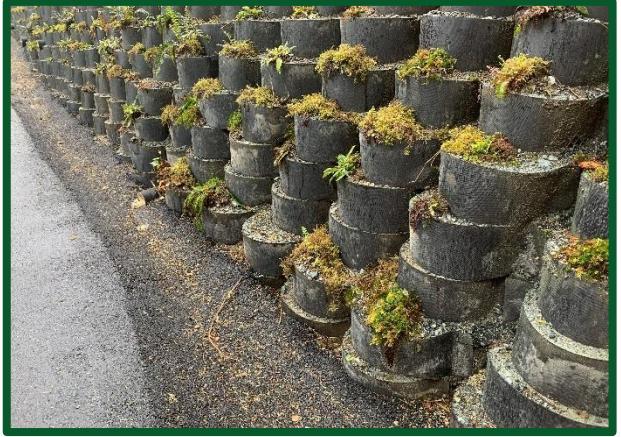
Figure 9. Photo illustrating the result of some of the challenges maintaining facing alignment and batter and providing a planting bench that are described in Points 5 to 7 of Section 4.1. The location is at the tightest curve in the wall where maintaining batter and alignment concurrently was most challenging.

2. The "flexibility" of the geocells allowed for movement of the geocells during infilling and compaction. A high level of quality control was required to achieve an aesthetically pleasing facing, maintain design configuration, and avoid facing cells extending beyond the underlying row of cells. The outside edge of the cells was also prone to collapsing/folding and required straightening with a stiff rod. The multiple ways that the geocells could move out of alignment had a noticeable negative impact on production. It also affected the mood/morale of the crew since they wanted to achieve a quality product and the cumulative impact of multiple small items missed made this challenging.

At locations where the connector "zap-straps" were not fully tightened, the geocells had a tendency to move apart during compaction or as the wall increased in height (i.e. increased pressures). This resulted in some slight misalignment of joints and sections that appeared not "vertical" or angled/crooked. 4. The high level of manual effort involved in placing the geocells, connecting them to the already constructed section of wall and adjustments required to maintain proper configuration was a safety consideration in tight spots such as locations with steep cut slopes behind them. At these locations, additional excavation, shoring and/or other temporary worker protections were implemented. A retaining wall system or updated procedure that requires less manual adjustments after placement would be preferred in such excavation conditions. A less steep wall facing would also reduce impacts of movements of geocell and require less worker access to maintain configuration.

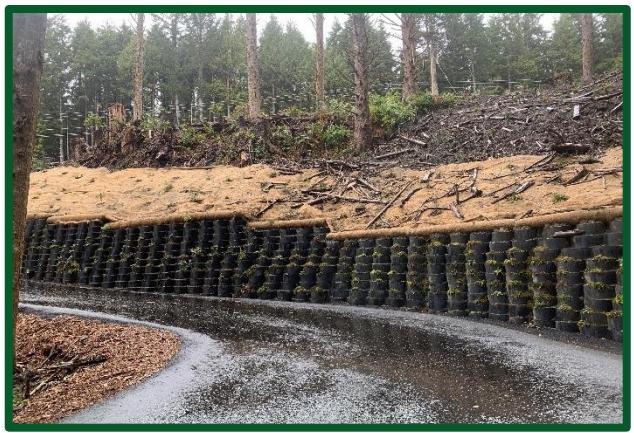
Figure 10. Photo illustrating the general limited overall impact of the localized issues on the visual appearance of the wall noted in Figure 9 due to the effort of the construction crew and consultant working together. The average trail user would not likely notice this. In addition, with time the vegetation that is planted will further mask these aesthetic imperfections.

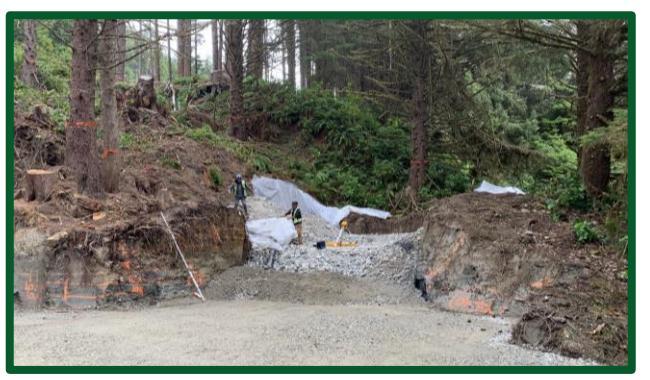
To protect several veteran class trees that were left in place a zone of undisturbed soil was left in place below the dripline of the trees. This required adjustments to the trail alignment that affected the retaining wall heights and finished trail grade. To maintain general connectivity of the buttress to function as intended in the design, vertical support for the trail and limit the downslope extent of works, geosythetically confined soil was created through placement of multiple layers of biaxial geogrid at 0.2 to 0.3 m vertical spacing (Figure 11). Where possible the orientation of the geogrid was rotated 90 degrees between layers to reduce the vertical continuity of joints between adjacent sections of geogrid. While geotextile could also have been used, geogrid was recommended (and was readily available on site) to provide further strength to the toe buttress in addition to the stronger uniaxial geogrid that was specified below this elevation.

Figure 11. Photo illustrating the "islands" of soil left adjacent to the root systems of mature trees prior to installation of the GRS geogrid described in Section 4.2

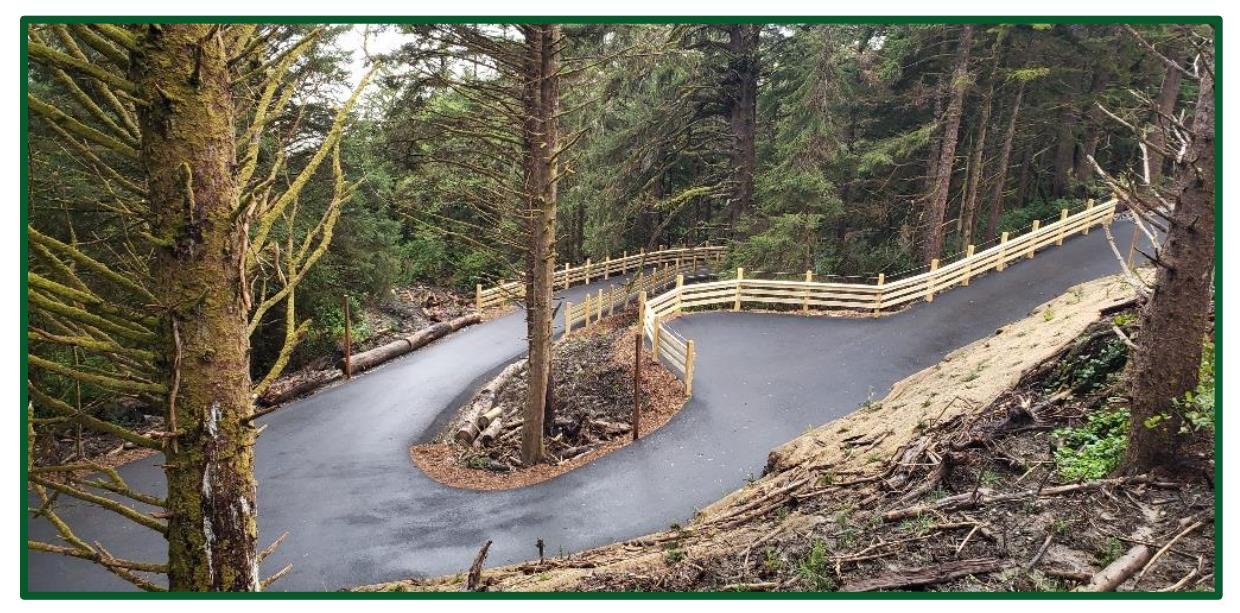
Figure 13 Photo illustrating the finished switchback trail looking down from above. (Photo courtesay of Parsons Inc.)

A photo illustrating the finished switchback trail looking down from above is shown in Figure 13. Note the mature trees in the photo that were able to be protected while simultaneously providing both vertical support to the trail and a slope stabilizing mass (buttress) using geotextiles.
