CC5 Bulk

Channel lining

Grassy Lake, AB

Test scenario
case study by
SMRID

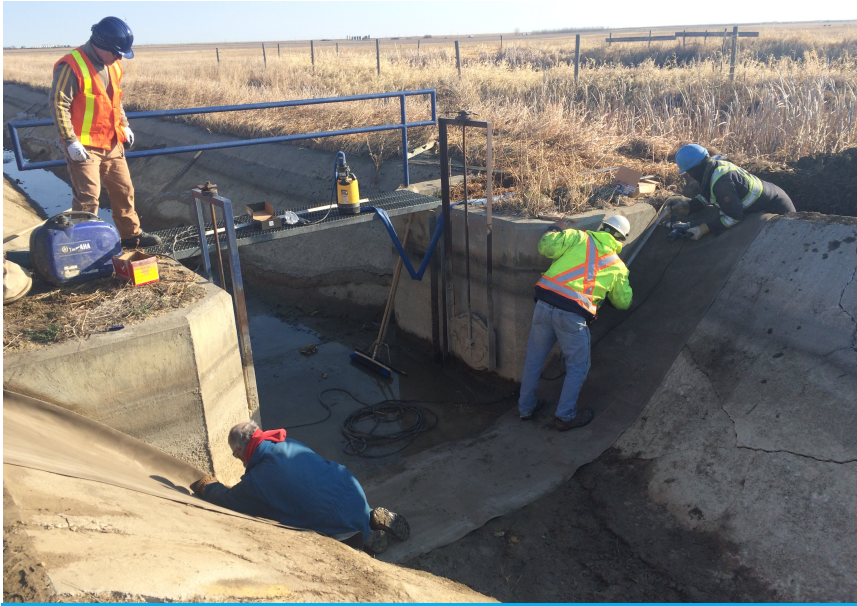
Fixing the first shingle of CC to the old existing concrete

The CC was installed over existing damaged concrete surface where cracks had previously been sealed by the SMRID. An anchor trench had been prepared to secure the cloth at the edges along with using 12" spikes. CC was then laid transversely, sealed with SikaFlex 1A and fixed with 1" SS self-tapping screws.

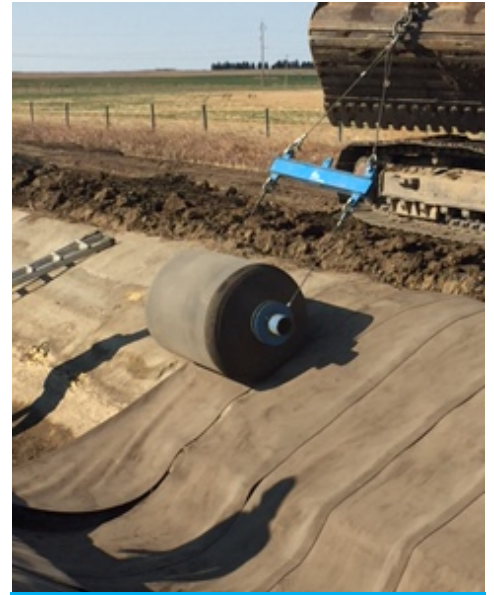
Unrolling of the CC bulk rolls

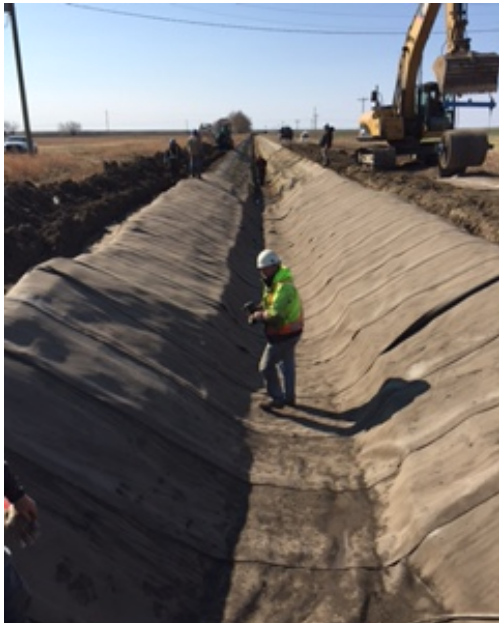
Transverse CC layup

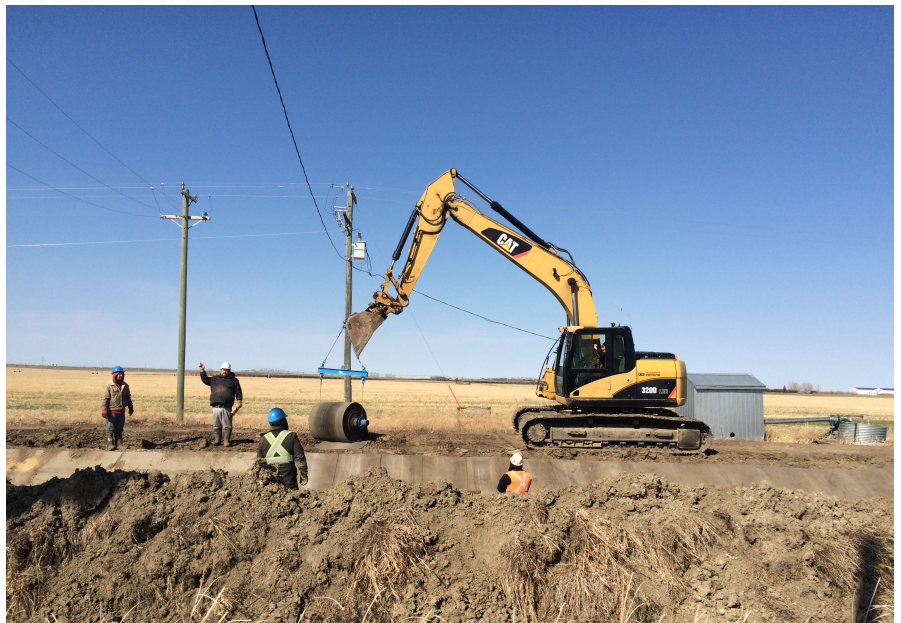
Overhead wires posed an installation challenge

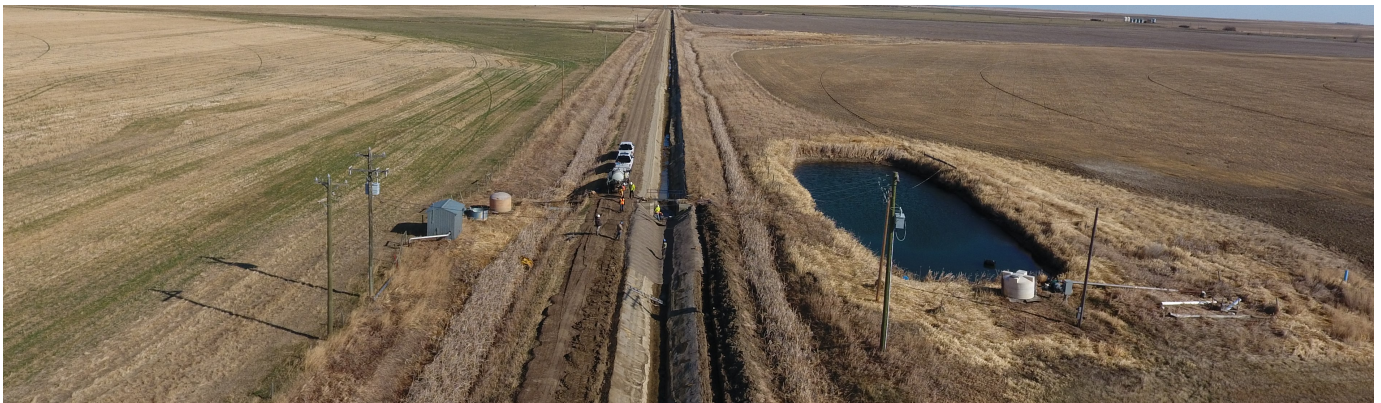
Bird's eye view of the CC installation process otop of the existing damaged concrete channel
