SLOPE PROTECTION

Fall 2023

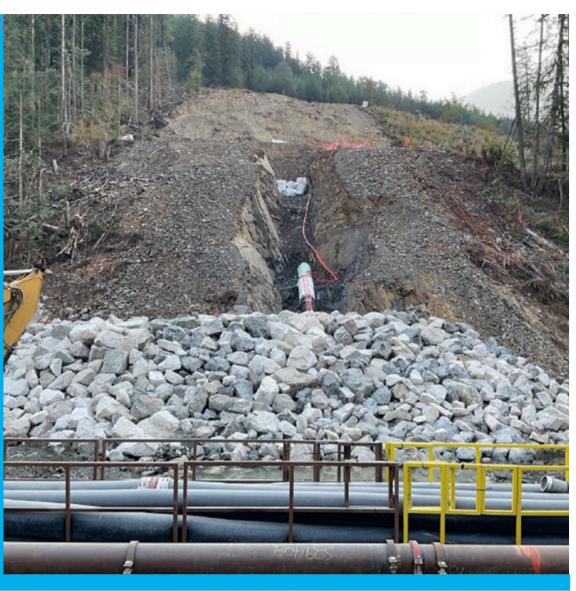
In the Fall of 2023 a construction project where the integrity of a slope and the safety of a buried pipeline were at risk due to erosion, weathering, and natural elements, needed a permanent and robust solution. The need to protect both the slope and the buried pipeline prompted the consideration of Concrete Canvas CCT2™ as a viable solution. CCT2™ was proposed to cover and safeguard the slope and pipeline, mitigating the risks posed by environmental factors.

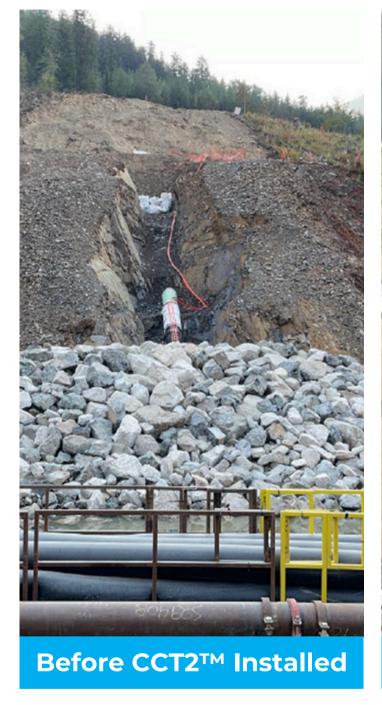
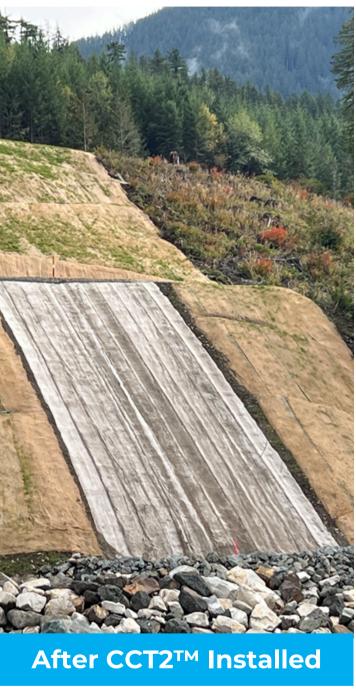
Five bulk rolls of CCT2™ were utilized for the project, strategically laid out longitudinally to provide comprehensive coverage. The installation process required thorough planning and execution to ensure effective slope protection and pipeline covering.

By laying the rolls longitudinally, comprehensive coverage was achieved, minimizing the risk of vulnerabilities or gaps in protection. The CCT2™ material formed a durable barrier, safeguarding the slope and the buried pipeline from external threats.
