Project information

CC13
-

Glencore Matagami Zinc and Lead underground Mine
-

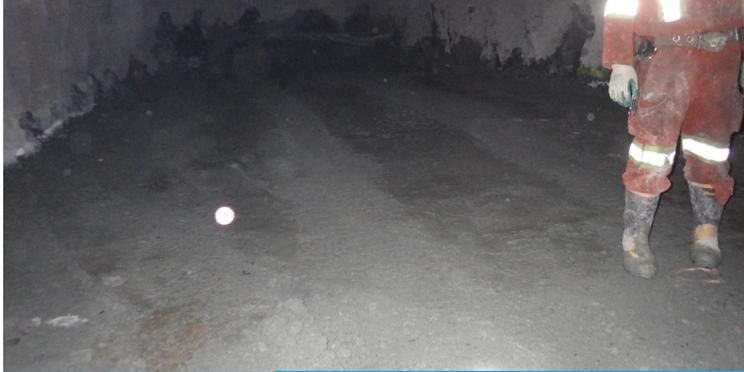
Ground preparation

The substrate consisted mainly of hard rock which provided an ideal base for CC13 which is supporting over 12,600lbs. Loose rocks and material were removed prior to installation to ensure there were no voids between the Concrete Canvas and the hard rock substrate. The CC13 bulk roll was dispensed by Glencore personnel using a forklift and a spreader beam bar.

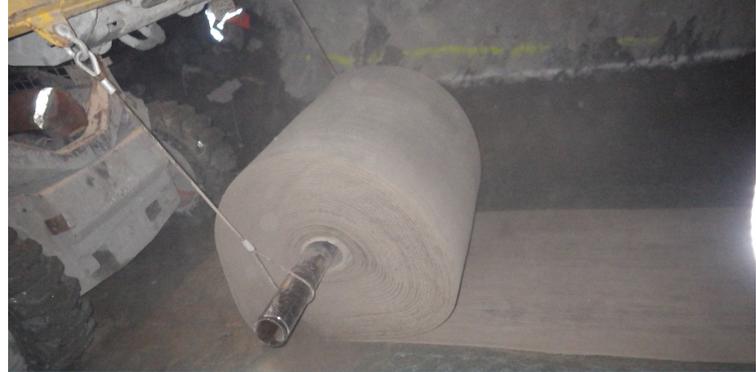
Concrete Canvas installarion

The installation crew cut rolls into 10m lengths using a standard utility knife and placed each piece into the correct position. A longitudinal layup was chosen and the rolls were butt jointed together to ensure the walkway surface remained flat around the electrical substation. An extra layer of CC13 was placed directly underneath the electrical substation for added support which gave the base area a total thickness of 26mm. The underlaying layer of CC13 was hydrated prior to screwing the additional CC13 layer on top with 20mm screws at 200m intervals.

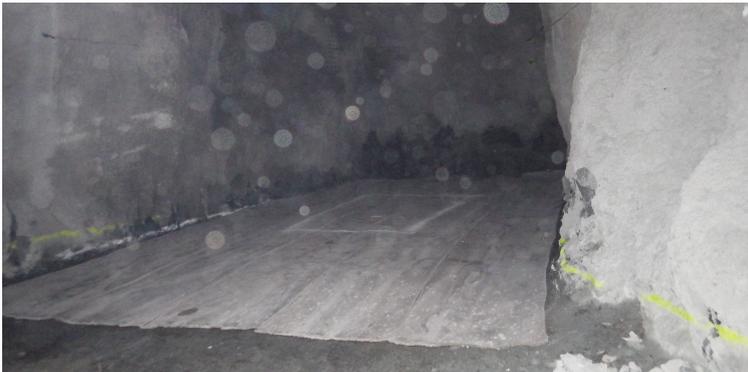
Concrete Canvas after hydration

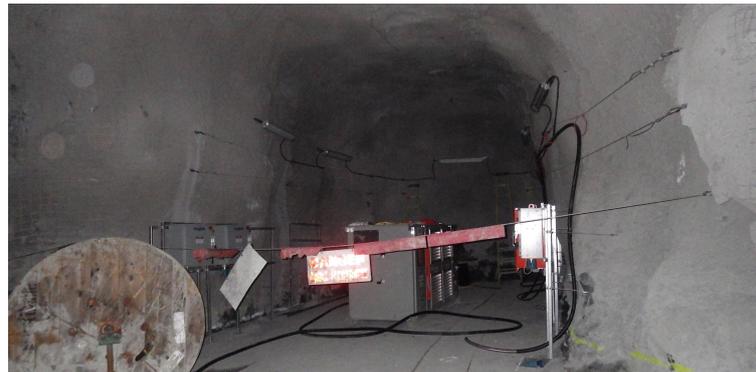
Completed Concrete Canvas installation

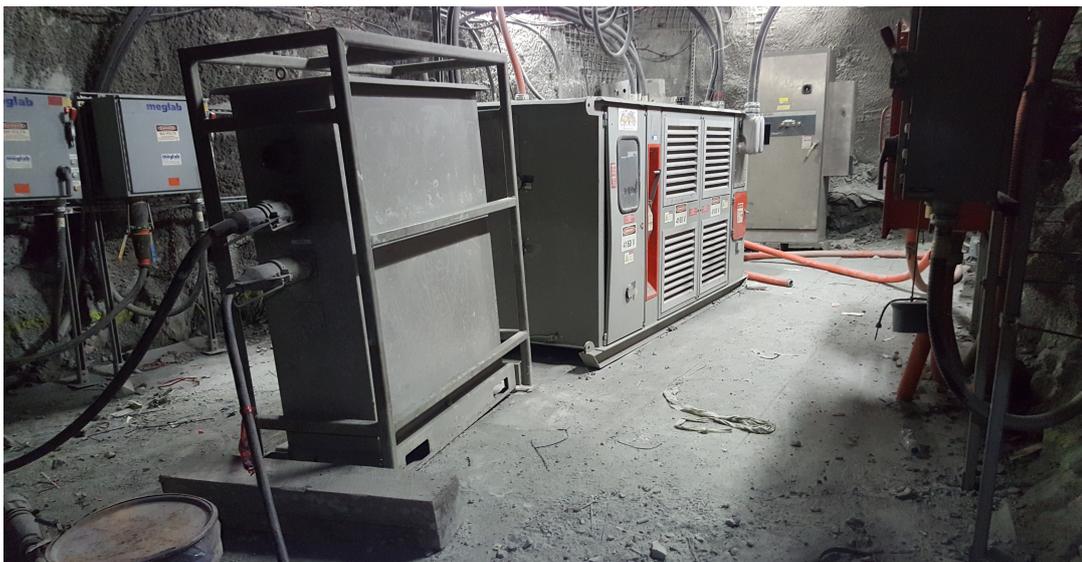
Installation 6 months later
