Project Info

Calgary, AB

Nuna Innovations Inc.

CC used to prevent
vegetation growth

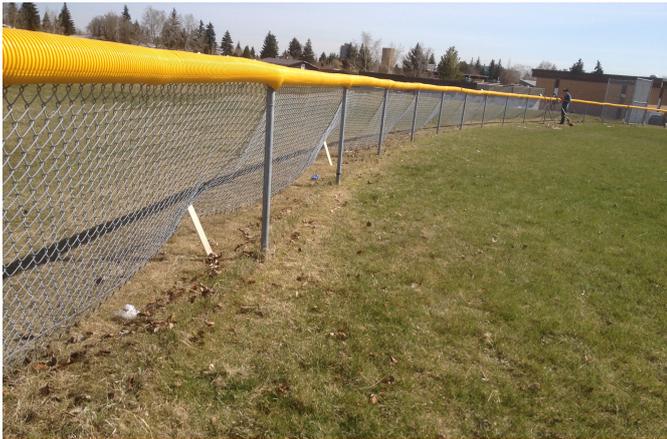
Site preparation before installation

470 square meters of Concrete Canvas were installed by a crew of two in less than two weeks. The existing fence line was able to remain in place. The crew removed the bottom fasteners that held the chain link onto the posts and pulled the lower 2 ft of fencing aside. Vegetation was trimmed from the area where the installation would take place in order to prepare the surface.

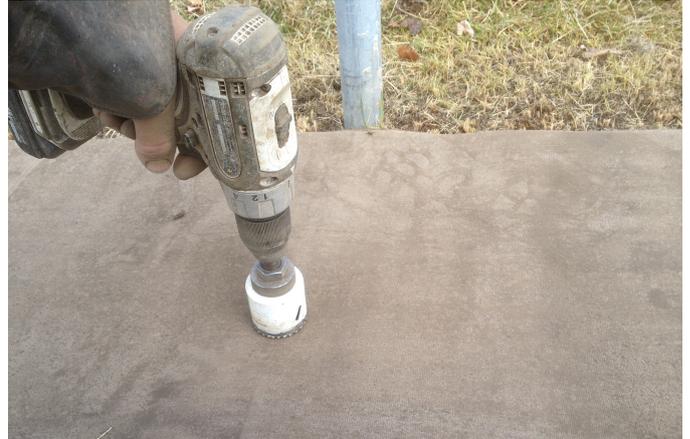
Drilling holes for placing CC around fence posts

Rolls of the CC were cut in half longitudinally and laid along the bottom of the fence line. The crew used a hole-saw drill-bit to cut holes in the Concrete Canvas to accommodate the fence posts. The strips of Concrete Canvas were then cut from the hole to the edge of the strip to wrap around the post.

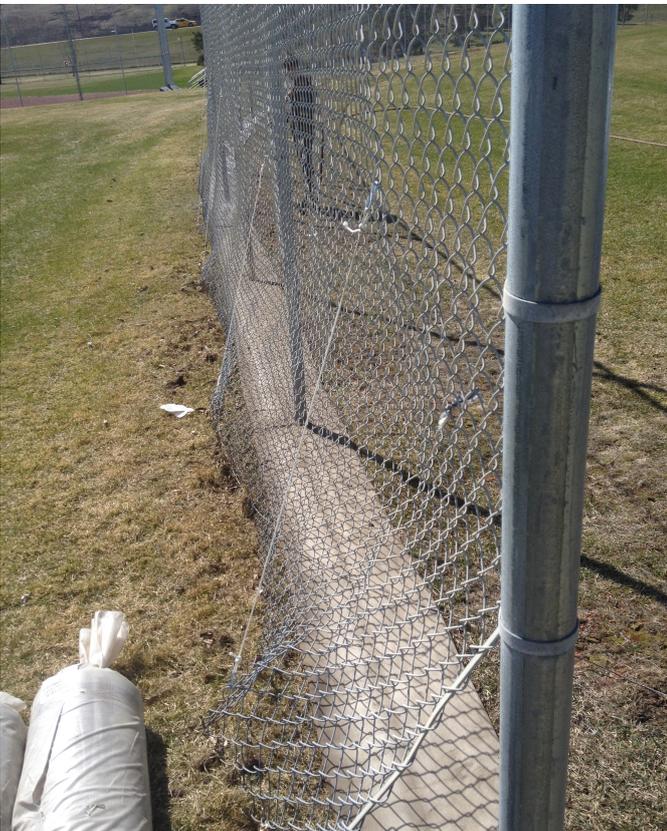
Fencing moved out of the way for installation

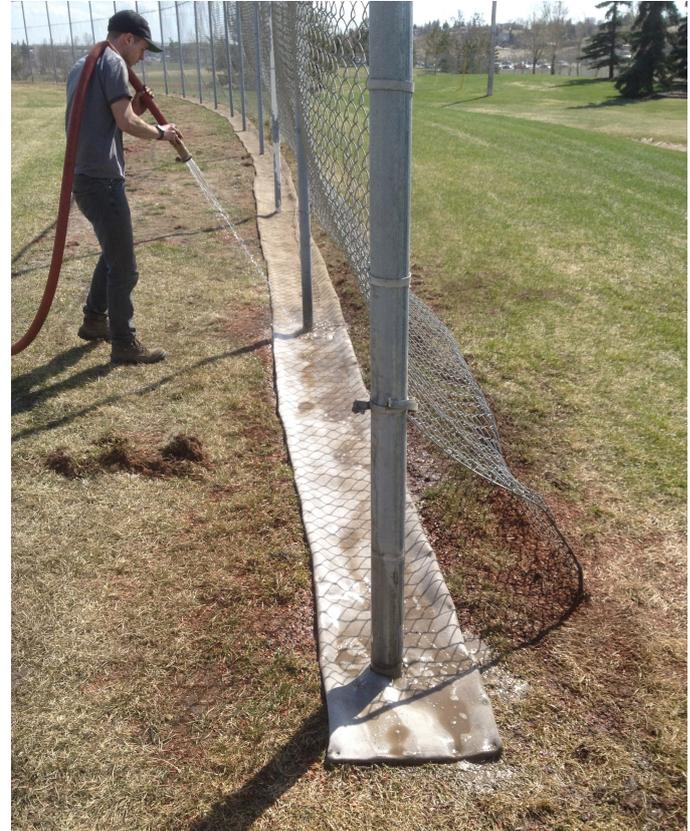
Hydration of installed CC

The Concrete Canvas was hydrated using portable water tank on a small utility trailer. No specialized tools or machinery were required for this installation. The Concrete Canvas installation was complete two hours after hydration.
