CASE STUDY

Titan Tubes - Lagoon Desludging

- ▼ **LOCATION:** Invermere Lagoon (Invermere, British Columbia)
- ▼ **PROJECT TYPE:** Supply and installation
- ▼ **PRODUCT USED:** 6- 60'x100' Titan Tubes

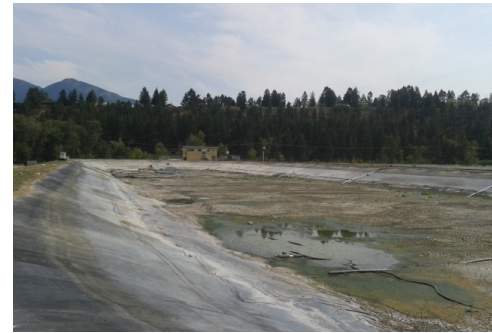
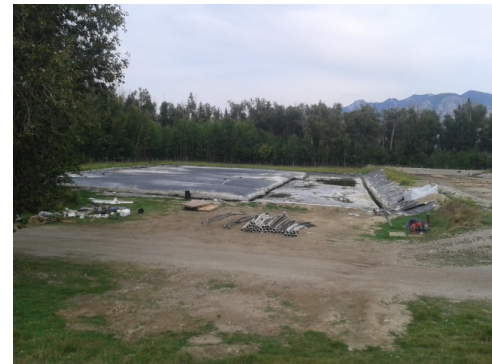
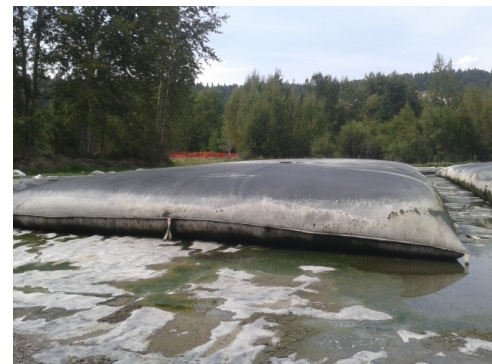
Over time the accumulation of bio-solids in municipal lagoons affects holding capacity which requires desludging. In this project, Titan Tubes were used to remove bio-solid sludge with the objective of increasing the lagoon's capacity. Slurry from the lagoon was pumped into approximately 6- 60'x100' Titan Tubes, which were contained in a temporary sloped berm lined with 20 mil Titan TRP-200R geomembrane. As the tubes dewatered, the liquid flowed into a depressed sump area where it was pumped out and the bio-solids remained in the tubes for disposal after drying.
